# Investigation Report

Type of Occurrence:	Serious Incident
Date:	20 December 2012
Location:	Phuket, Thailand
Aircraft:	Airplane
Manufacturer:	Airbus Industries
Type:	A330-223
Injuries to Persons:	No injuries
Damage:	Minor damage to aircraft
Other Damage:	None
State File Number:	BFU 6X015-12

Bundesstelle für  
Flugunfalluntersuchung

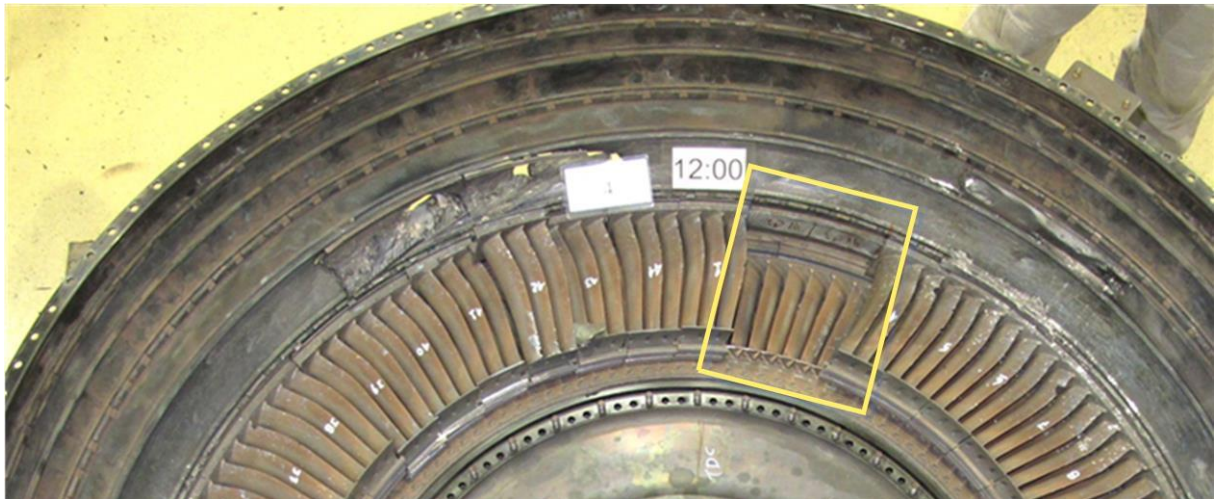
Except for the vane clusters Nos. 2 and 3<sup>19</sup> all others of this stage were within the housing. One vane cluster was found at the bottom of the LPT housing next to other debris. During the investigation, this vane cluster was named “A” because it was not possible to allocate it unambiguously to position 2 or 3. The other missing vane cluster was not found.

Fig. 21: View of the 4<sup>th</sup> guide vane stage. The yellow marking shows the position of the two missing vane cluster

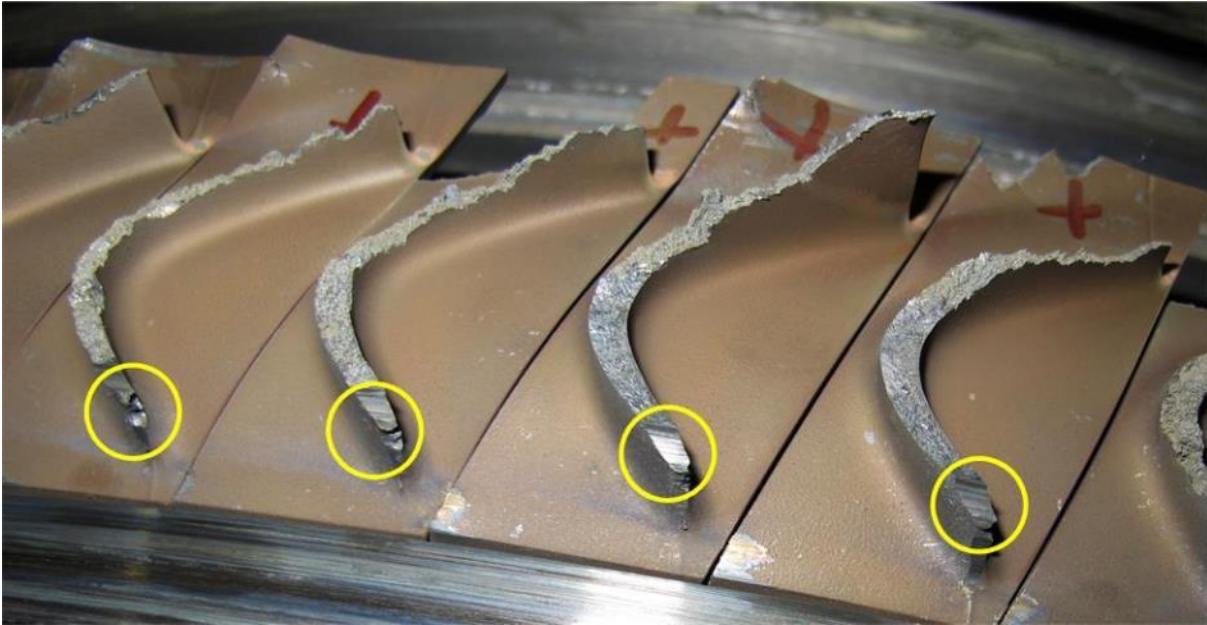
which began in the vicinity of the leading edges and progressed to overload fracture. The fracture surfaces of the remaining blades showed signs of forced ruptures.

Fig. 22: Turbine stage #4 (rotor) with rubbed in notch

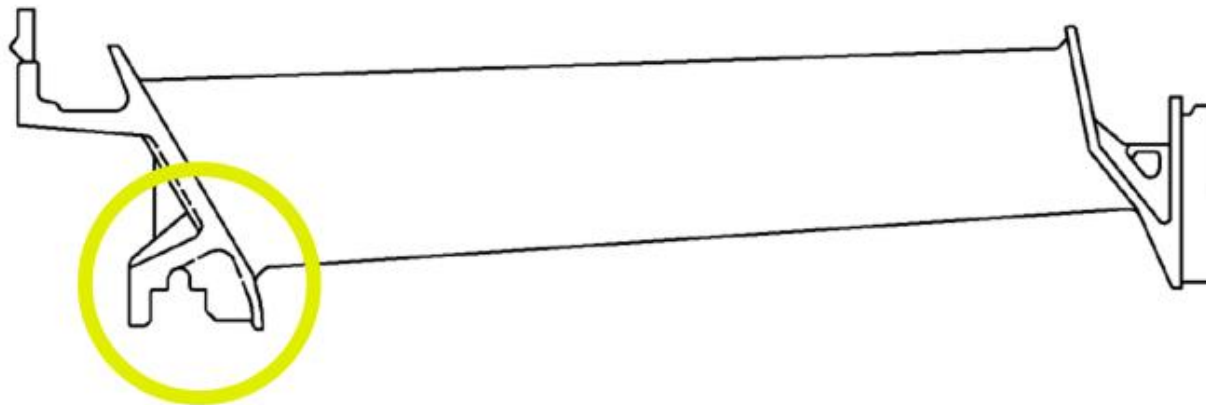
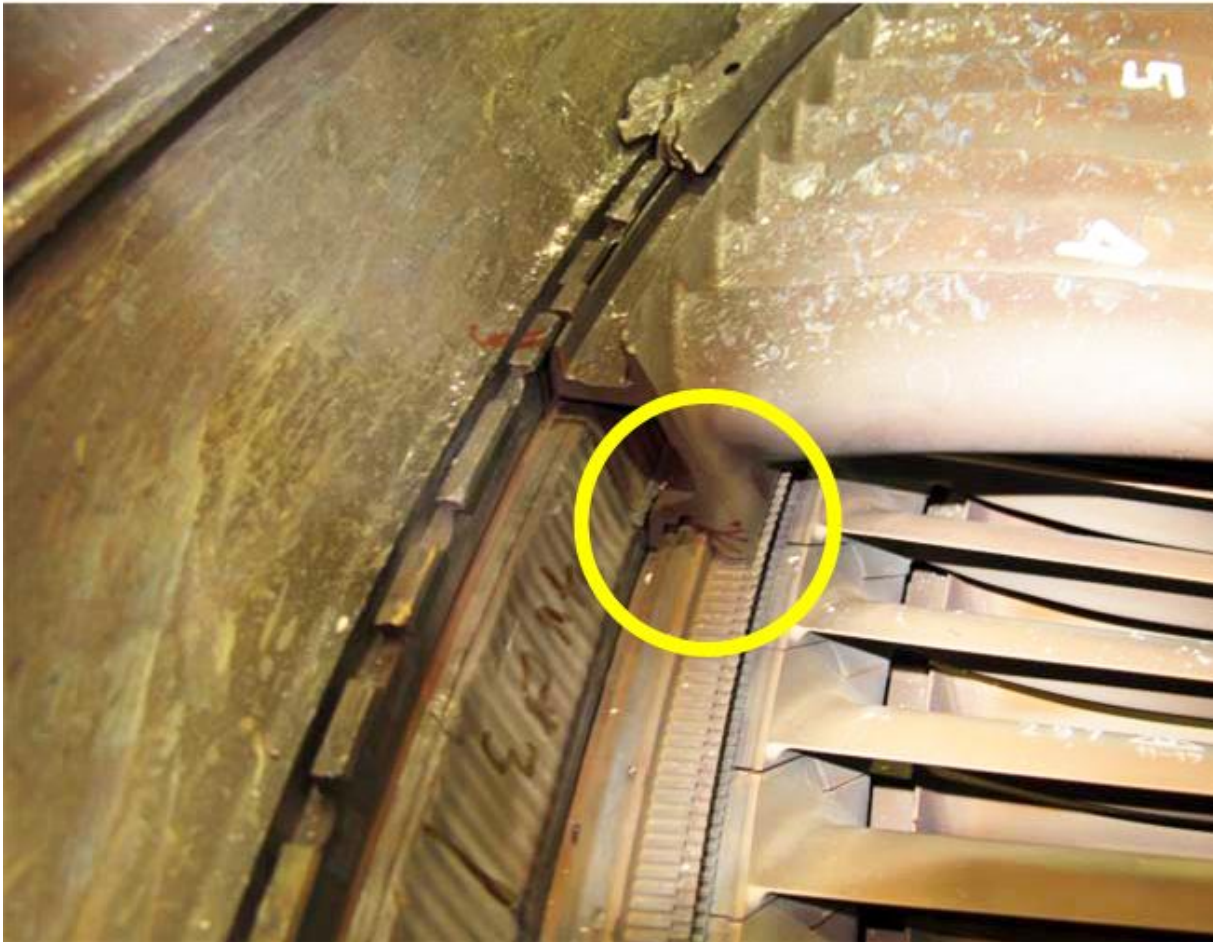
The visual inspection of all vane clusters revealed a small recessed area at Gusset 1<sup>20</sup>, apparently a result of the casting process. The break edges of the gusset 1 (vane cluster No. 4) measured 0.0508 mm (0.002 in.) According to the manufacturer's requirements a radius of 0.0762 to 0.381 mm (0.003 – 0.015 in) was required. The radii at the end face of gusset 1 on cluster "A" measured between approximately 1.6002 mm (0.063 in) and up to 0.6604 mm (0.026 in).

Fig. 23: Vane Cluster # 4, principle drawing and close up, yellow circle shows an outside diameter gusset

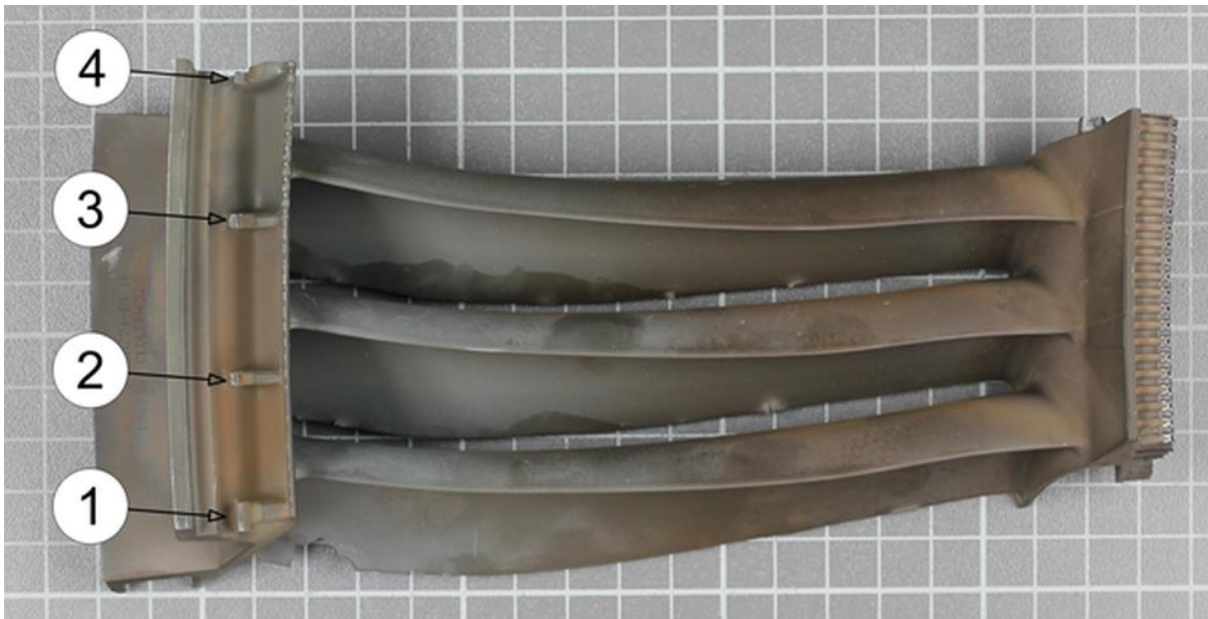
Five vane clusters showed visible cracks: No. 44 and “A” (each at gusset 1), No. 4 (at gussets 1, 3 and 4), and Nos. 14 and 19 (very small cracks at gusset 1). The fracture surface of vane cluster 4 (gusset 4) showed characteristics of forced rupture, whereas vane cluster “A” (gusset 1) showed signs of fatigue fracture.

Fig. 24: Vane cluster No. 4 including numbering of the gussets

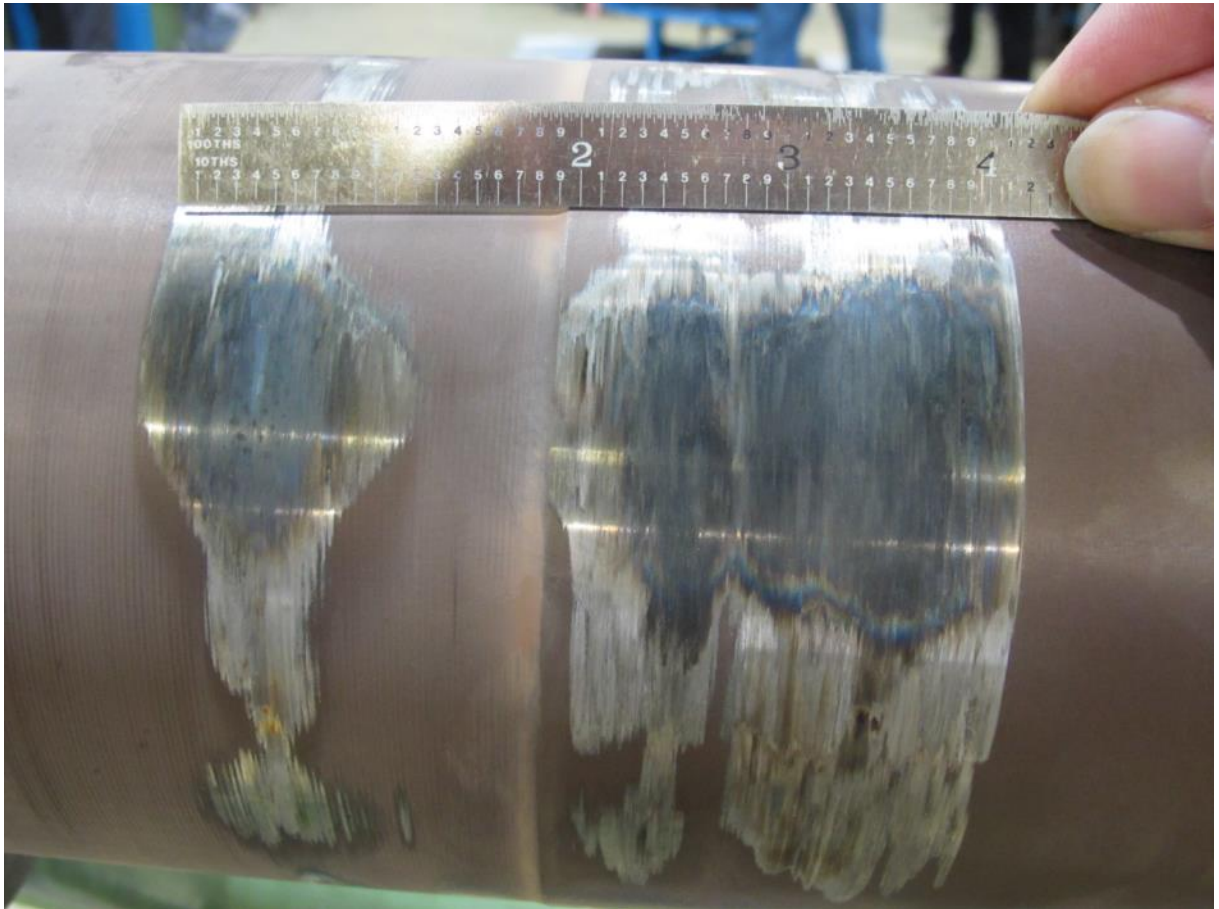
Fig. 35: Rub marks at the LPT shaft, measuring tape: inch.

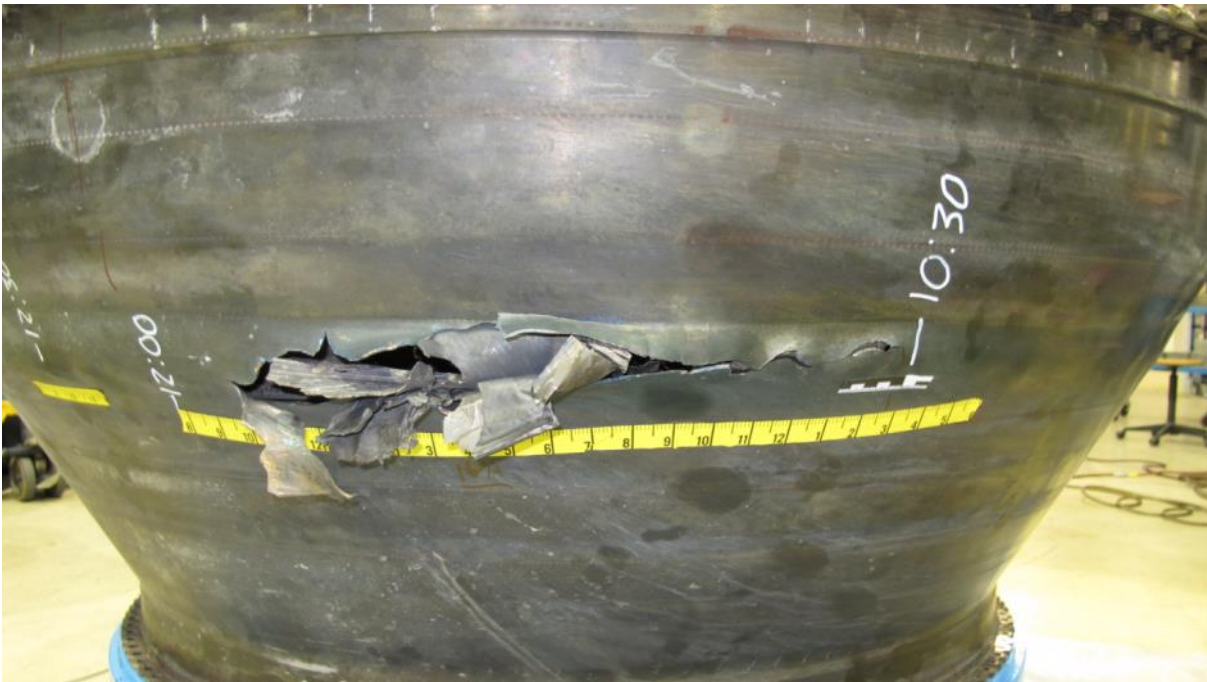
Fig. 36: Damaged LPT housing, white markings mark the position circumference (footnote 19)

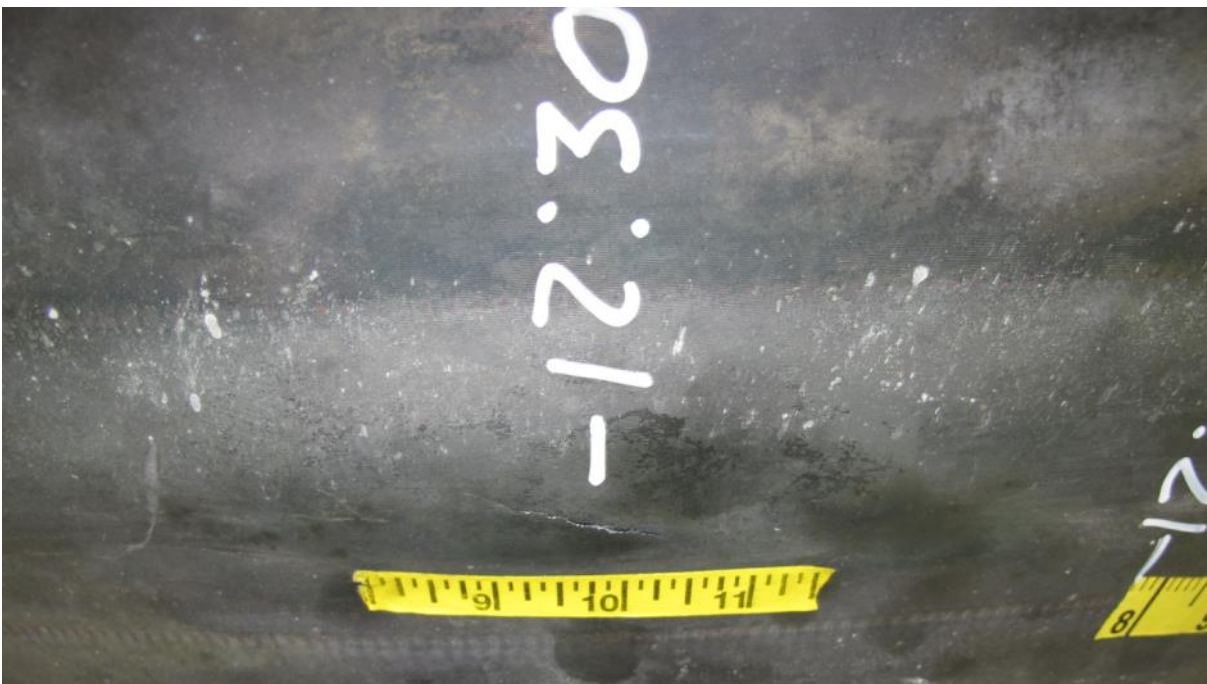
Fig. 37: Damaged LPT housing at 1230 position (footnote 1919)

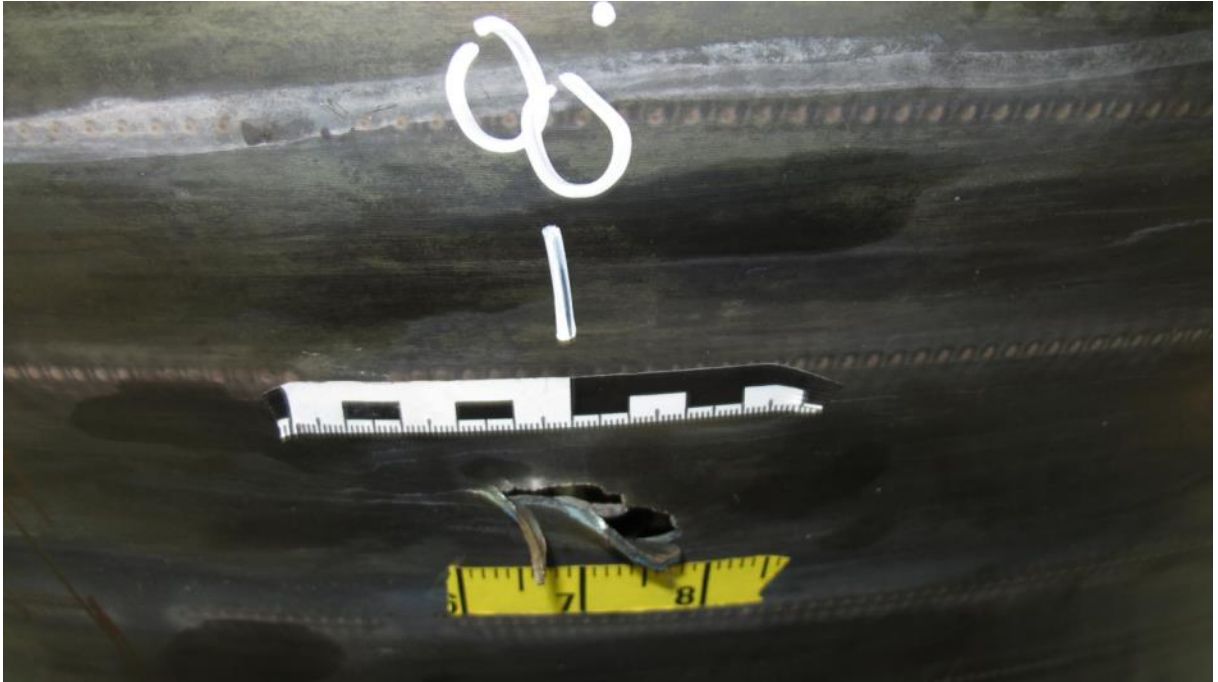
Fig. 38: Damaged LPT housing at 0830 position (footnote 19)

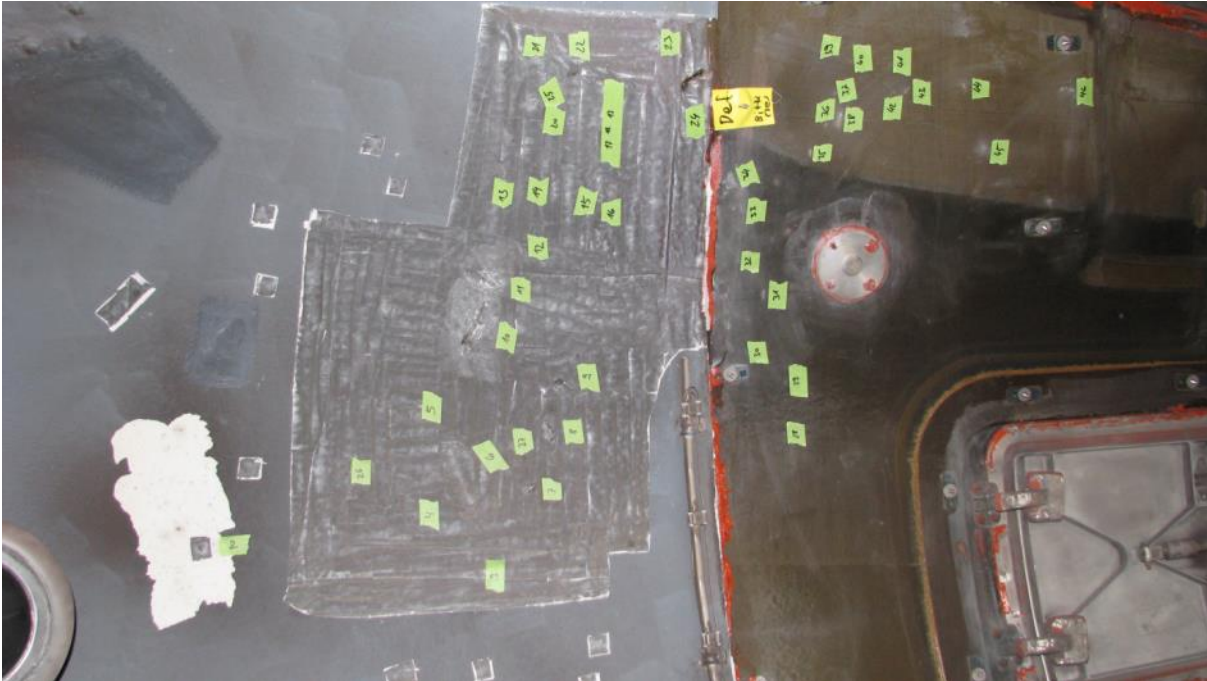
Fig. 39: Damage of the right thrust reverser door

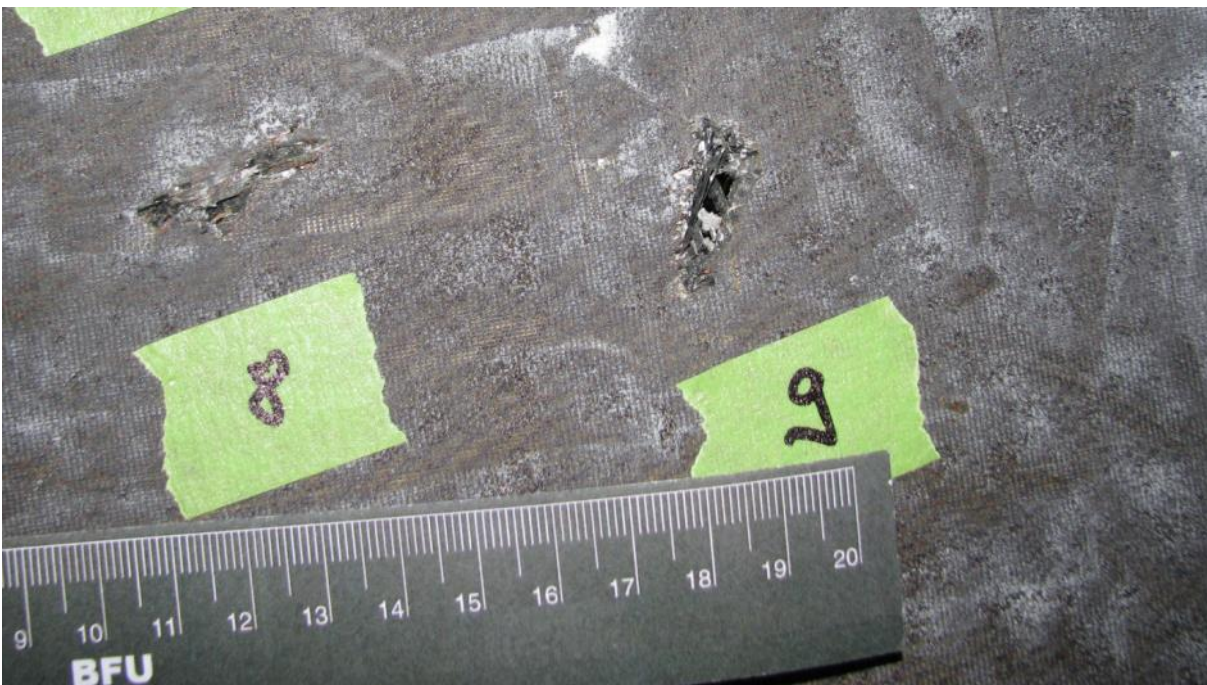
Fig. 40: Details of the damage of the right thrust reverser door

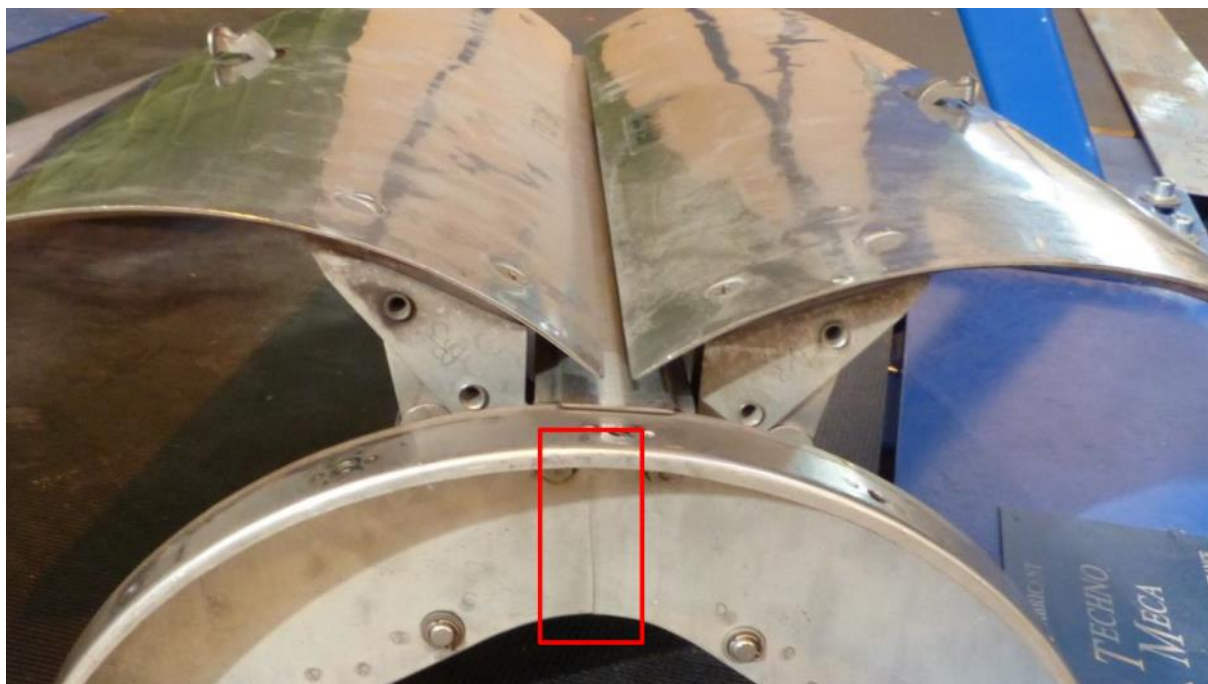
Fig. 41: Crack at the front fairing (Panel 451), red mark shows the position of the crack

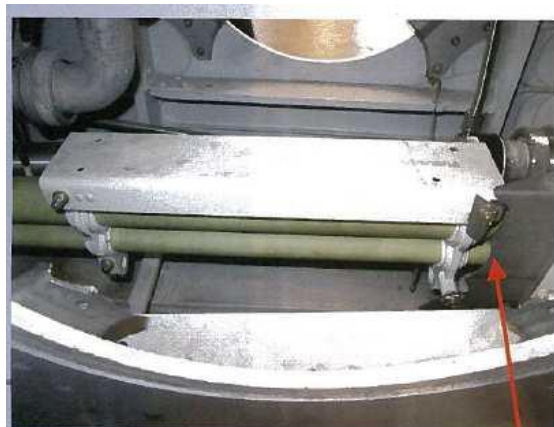
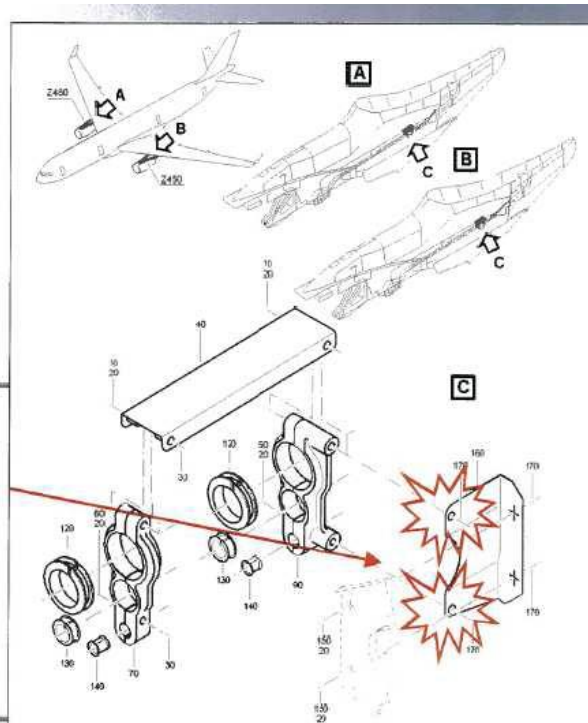
F290-30080 002

Fig. 42: Fatigue fracture at the Hydraulic Line Bracket F29030080

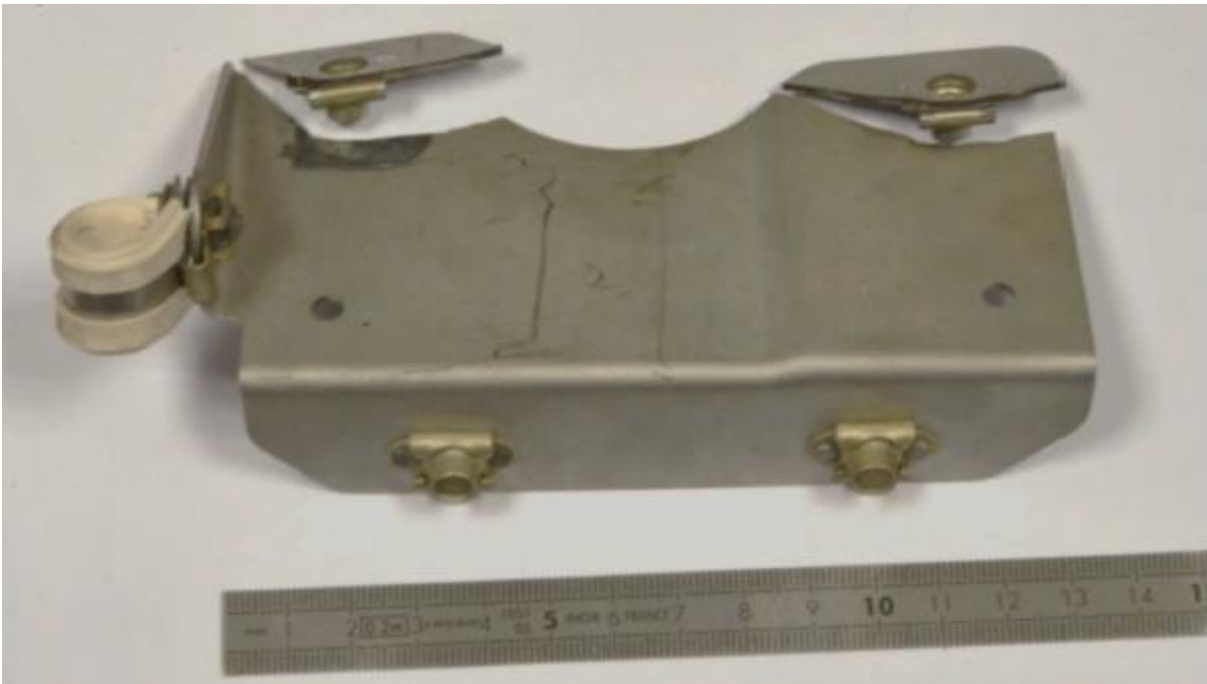
Fig. 43: Fatigue fracture at the Hydraulic Line Bracket F29030080, in detail
