# Flight preparation event involving Airbus A350-941, 9V-SHH

Brisbane Airport, Queensland, on 27 May 2022

AO-2022-032 Final – 15 March 2024

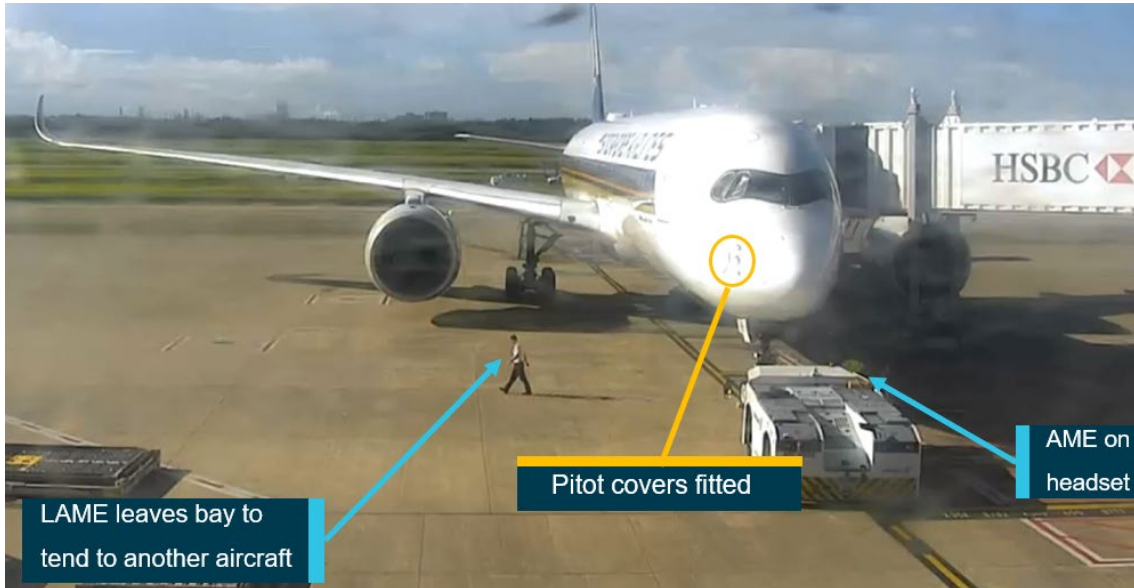
At 0913, the LAME returned to the tarmac at the nose of the aircraft and conversed with the AME for about 3 minutes. With 4 minutes remaining until the expected pushback<sup>3</sup> time, the LAME told the AME that they were going to the adjacent bay to complete the refuelling of another aircraft. The AME remained at bay 81 to conduct the pushback headset duties (Figure 1).

**Figure 1: Security footage of bay 81 showing SQ256 4 minutes before pushback with the pitot covers fitted and the LAME moving towards the adjacent bay**

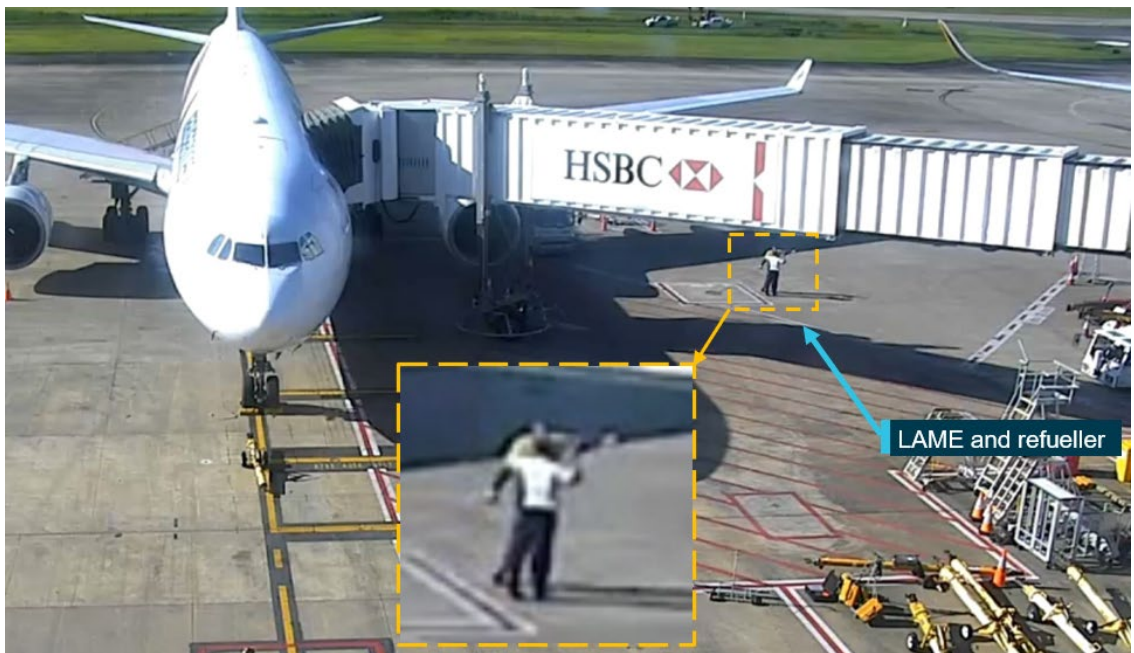
Around this time, an aircraft refueller on an adjacent bay observed that SQ256 appeared ready to pushback, but the pitot covers were still fitted. When the LAME reached the aircraft at the adjacent bay, the refueller immediately pointed to SQ256 and informed the LAME that the covers were fitted (Figure 2).

**Figure 2: Security footage of the refueller pointing towards SQ256 and informing the LAME that the pitot covers were fitted**

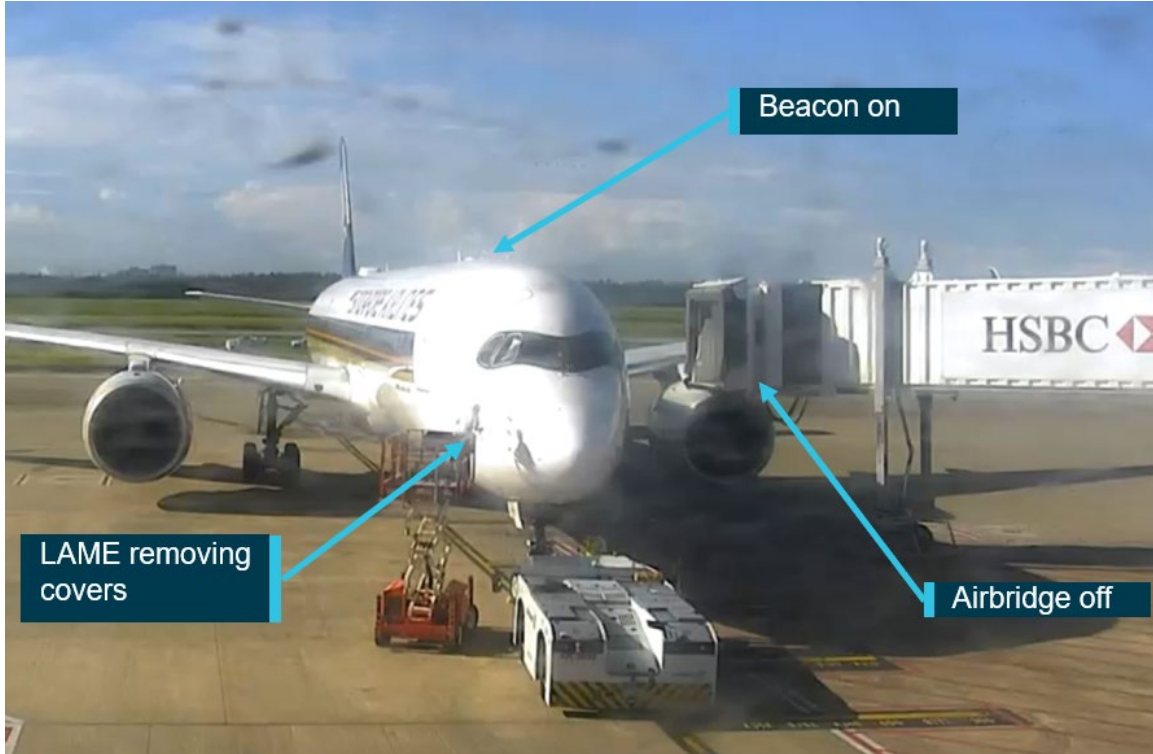
With 2 minutes remaining until the expected departure time, the LAME positioned an elevated work platform on each side of the nose and removed the pitot covers (Figure 3).

**Figure 3: LAME removing the pitot covers**

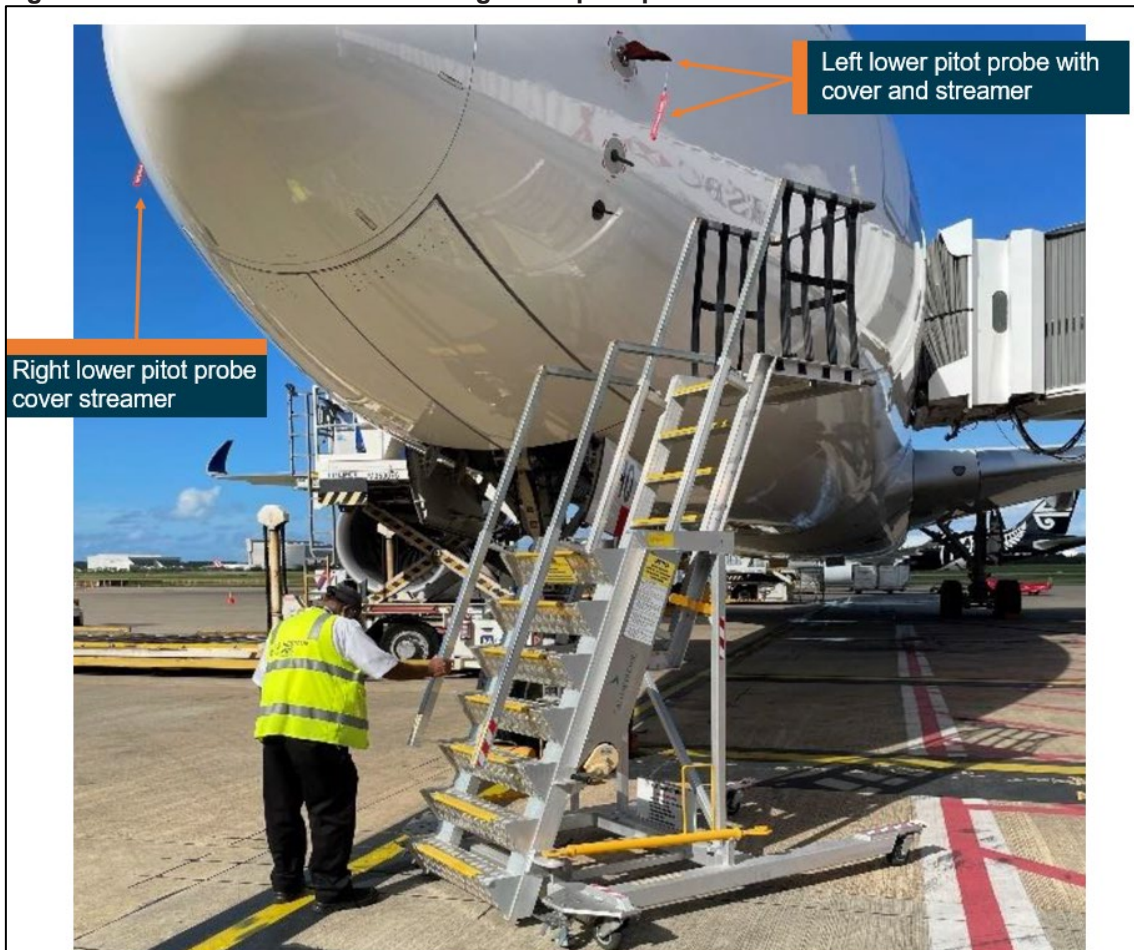
Lastly, the pitot probe covers fitted to the aircraft were about 3 m above eye height and had relatively short streamers, which were not conspicuous and limited the possibility of incidental identification.

Figure 5 shows standard pitot probe covers fitted to the lower probes of an Airbus A350, which were estimated to be about 3 m above eye level. The Heston MRO internal report into this occurrence noted that:

The Pitot Cover streamers used at the station were short. They are not long enough to bring about attention to passers-by below the aircraft – refer photos [attached as Figure 5].

**Figure 5: Airbus A350 aircraft showing lower pitot probe covers fitted**
