Final Report

**EgyptAir A320 Aircraft crash in the Mediterranean, registered SU-GCC,
flight number MSR804, from Charles De-Gaulle Airport, Paris to Cairo
International Airport, on 19/05/2016**

EGAI2016-01

October 2024

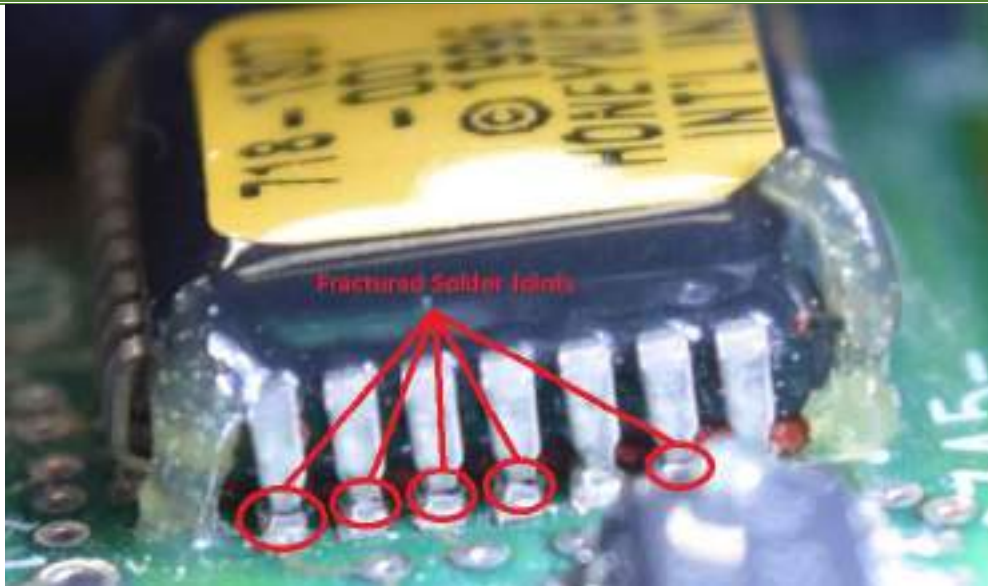
Figure 1.11/3: Solder Joint Fractures

Honeywell was advised of this small difference and assisted the Technical Group assessing the issues and reviewing the memory board schematic to identify a possible cause of the failed downloads. Pin 24 of the connector is a direct connection to pin 2 of the PAL chip. (The PAL is the chip on the memory board that manages the memory interface addressing from the SSFDR chassis). A microscopic examination of the PAL leads and solder joints was performed. The examination of the soldering points showed that more than 50% of the pins were fractured at or near the solder joints. Figure 1.11/3 shows the fractures on the pin 18–25 edge of the PAL.

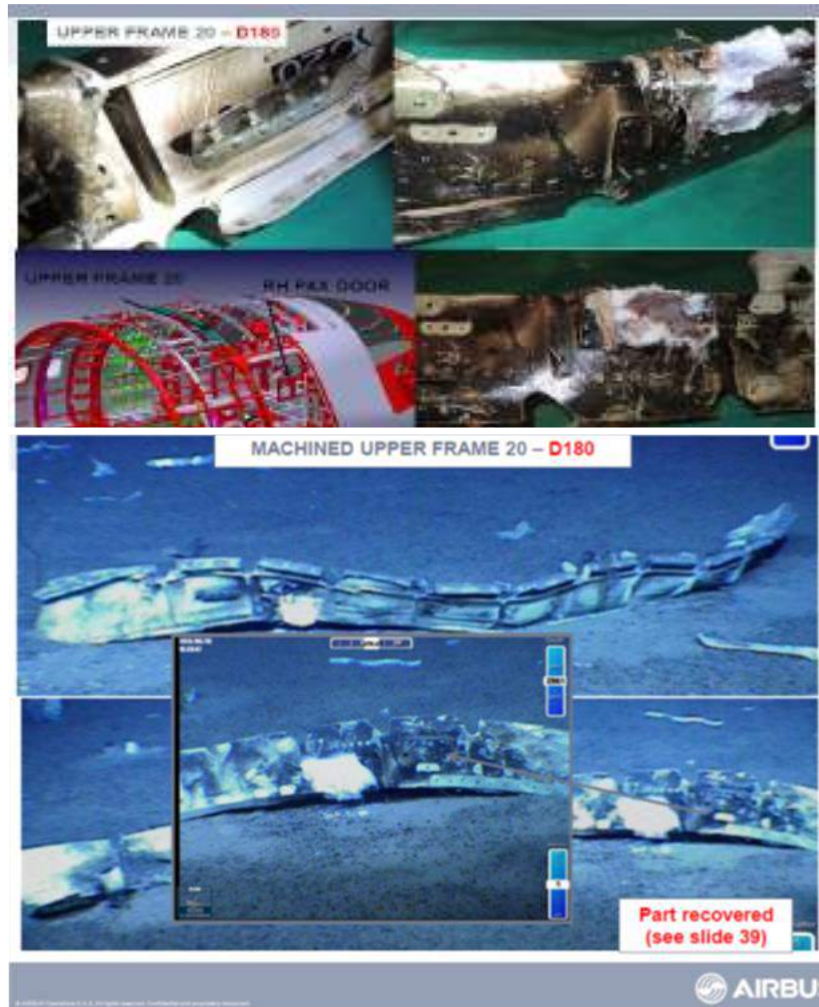
Figure 2.11/2 : Upper central segment of frame 20 Food trolleys

- The original crescent shape has deflected backward out of its original vertical plane.
- A bend was found in the center and edge.
- A change in the original metal color was identified on both edges.

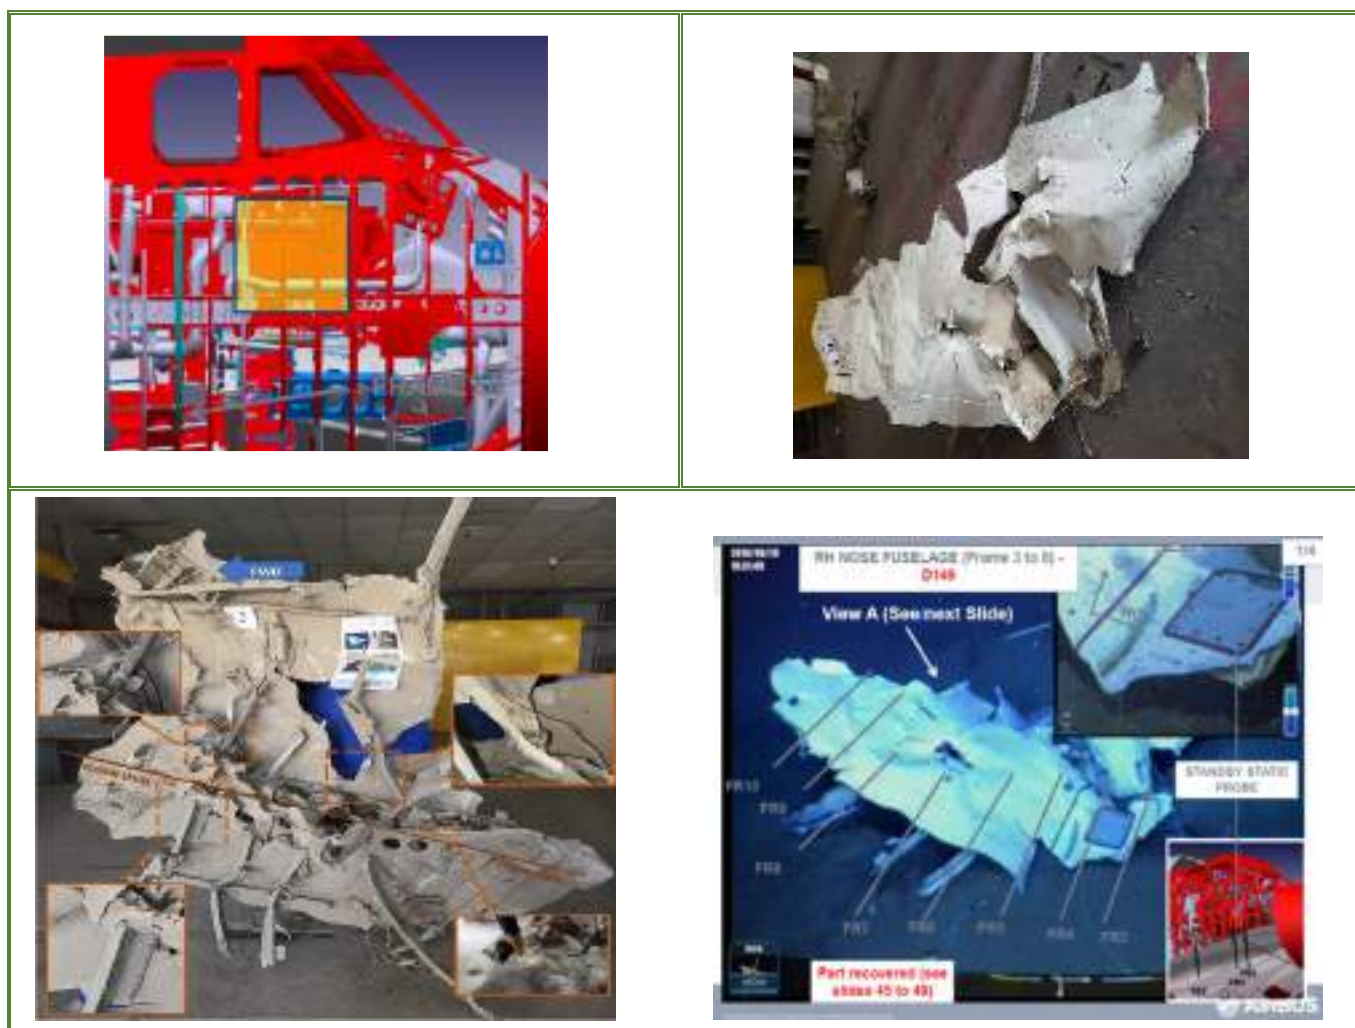
Figure 2.11/3 : Forward fuselage part with stand by static port

- Stringers /frames deformed outward in a backward direction.
- Electric cables with their insulation seemed to be normal (no apparent heat effect).
- A puncture was identified in the middle of the part.
- All edges were torn off, and dark spots were noted in the internal lower part
- Skin rolled outward and stringers bent outward.

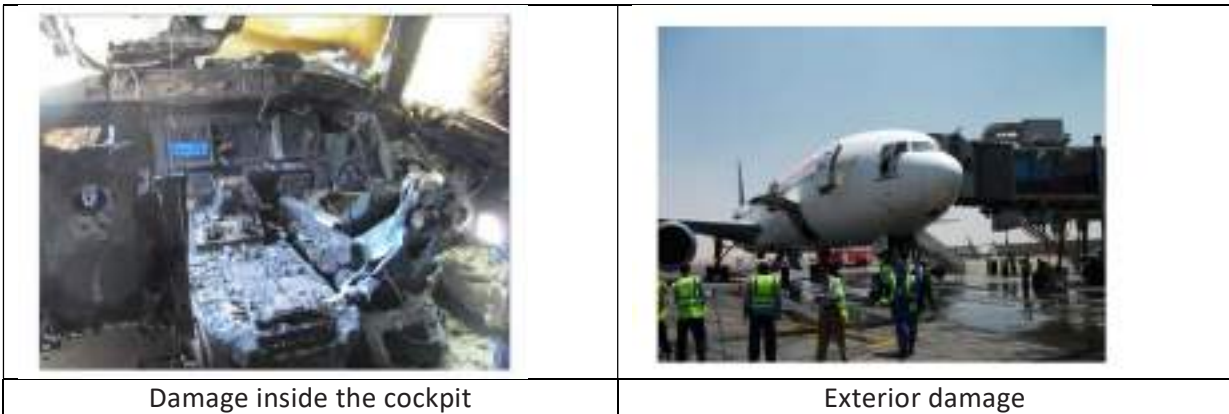
Figure 8: photos from investigation report (source: EAAID)

The captain asked the co-pilot to exit the cockpit and to warn the crew of the fire. The captain used the cockpit fire extinguisher, situated behind his seat, to fight the fire. This attempt was unsuccessful, and the fire continued to spread in the cockpit.

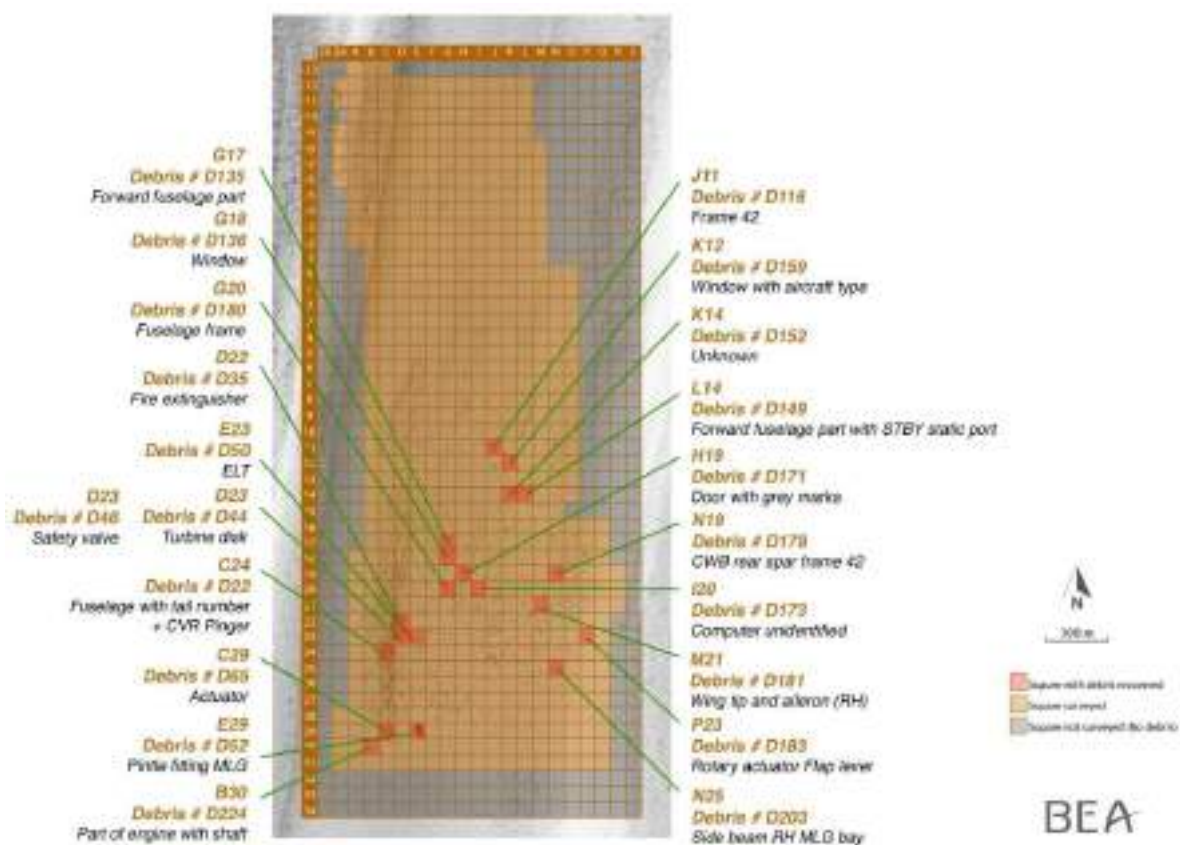
Figure 15: field of debris (source: BEA/EAAID)

A sonar search located the wreckage and defined the limits of the field of debris. The debris was scattered in a rectangle measuring 1.2 km by 525 m. The debris was then identified, mapped and some pieces recovered. All the extremities of the aeroplane were within the identified rectangle: the cockpit, the wings and the tail. These observations, together with the small size of the debris, made it possible to conclude that the aeroplane had collided with the surface of the water under high energy and ruled out the scenario of the aeroplane having broken up in flight.
