In-flight pitch disconnect involving ATR 72 aircraft, VH-FVR

47 km WSW of Sydney Airport, New South Wales on 20 February 2014

ATSB Transport Safety Report
Aviation Occurrence Investigation
AO-2014-032
Interim Report – 15 June 2016

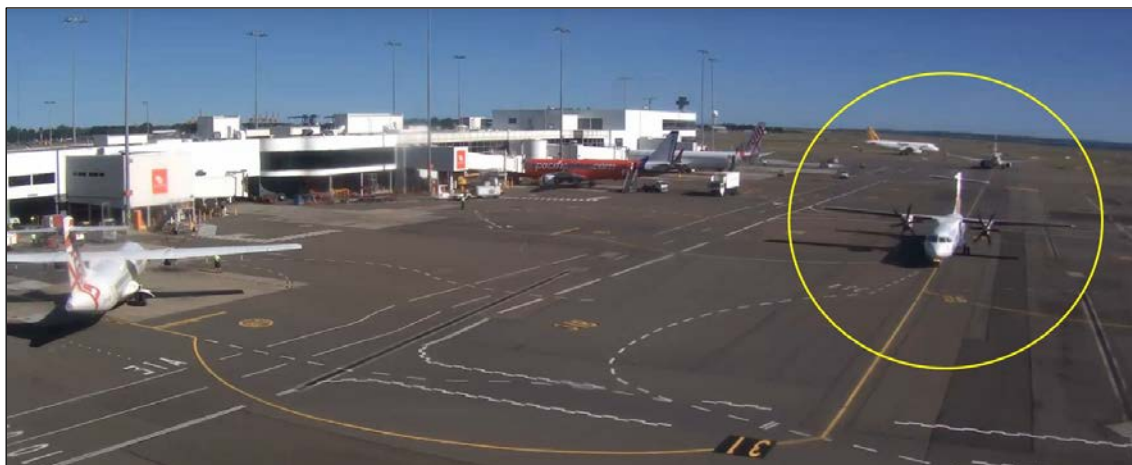
Figure 1: VH-FVR (circled) taxiing inbound at Sydney Airport on 20 February 2014 following the in-flight pitch disconnect (still image copied from closed-circuit television footage). Note the angle of the horizontal stabiliser relative to the wings

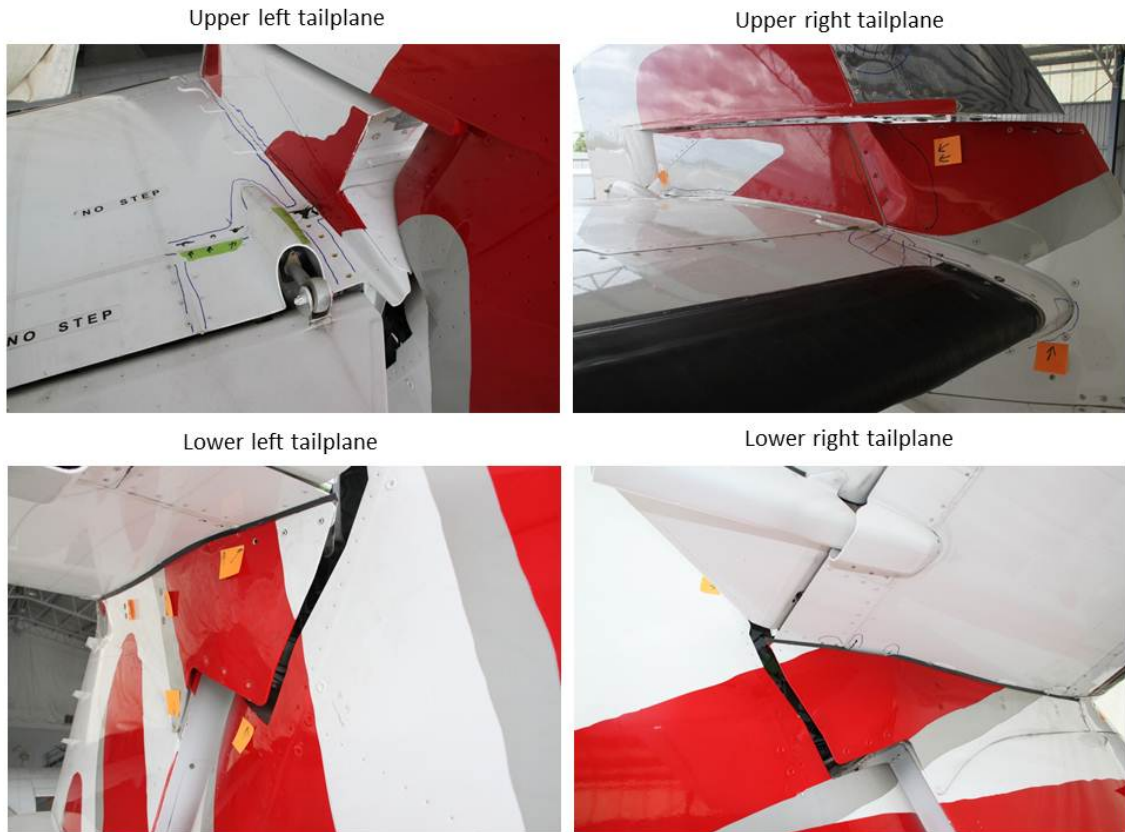
- external damage to the left and right horizontal stabilisers (tailplanes) (Figure 6)
- fracture of the composite structure around the rear horizontal-to-vertical stabiliser attachment points (Figure 7)
- fracture of the front spar web (Figure 8)
- cracking of the horizontal-to-vertical stabiliser attachment support ribs

Figure 6: Tailplane external damage (indicated by marks and stickers) with the aerodynamic fairings installed

Following assessment of the damage, the manufacturer required replacement of the horizontal and vertical stabilisers before further flight.

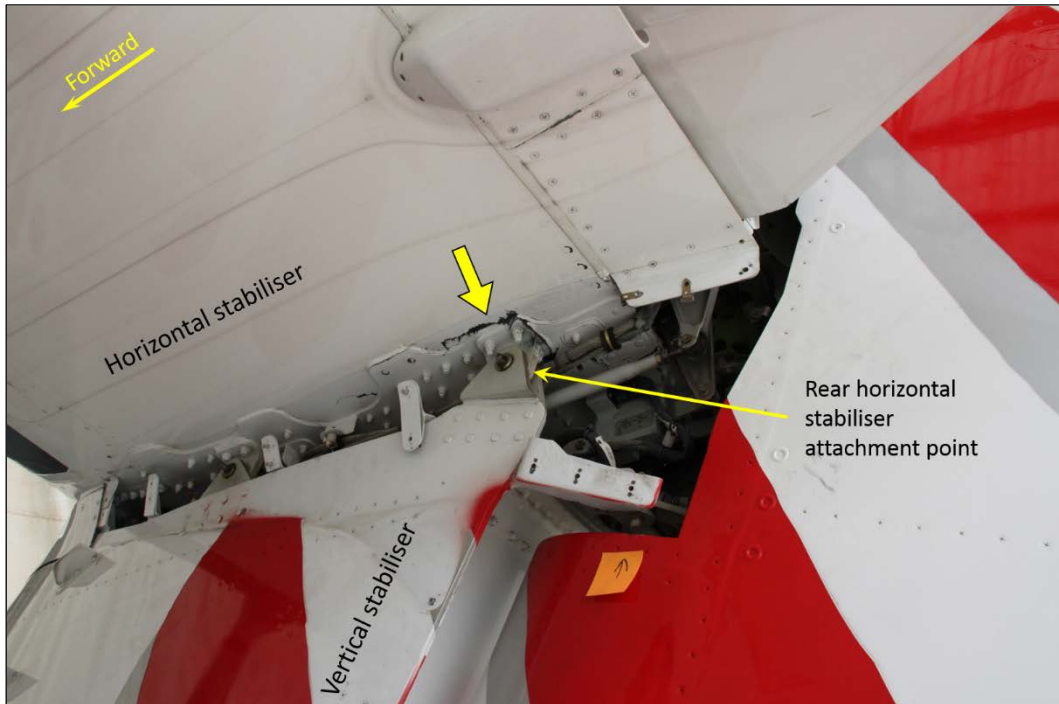
Figure 7: Horizontal-to-vertical stabiliser attachment with the aerodynamic fairings removed. View looking upwards at the underside of the horizontal stabiliser. The thick yellow arrow indicates cracking in the composite structure around the rear attachment point

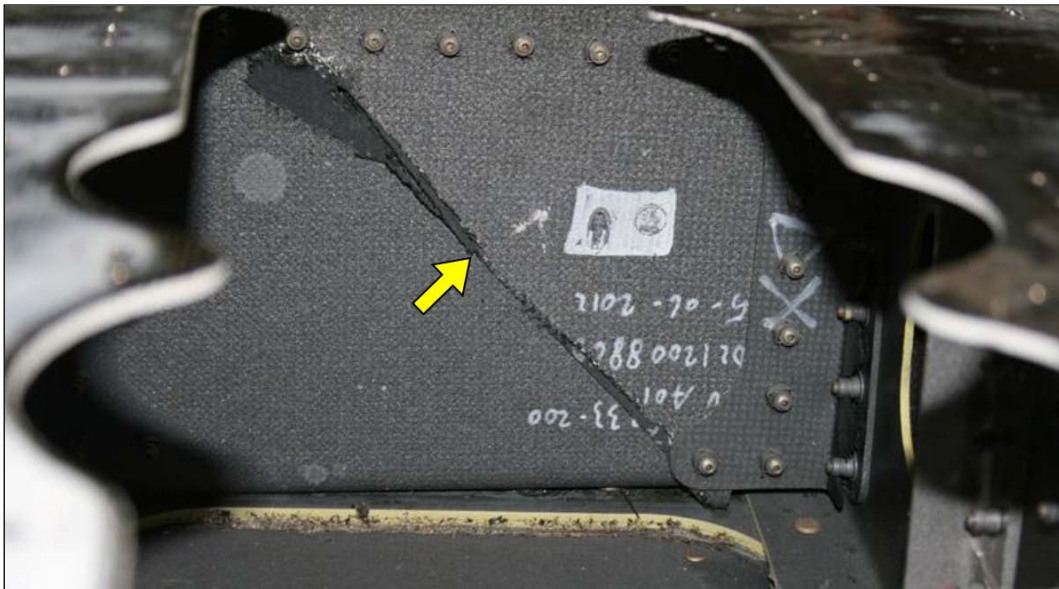
Figure 8: Crack in the horizontal stabiliser front spar. The diagonal crack in the spar web is identified by a yellow arrow

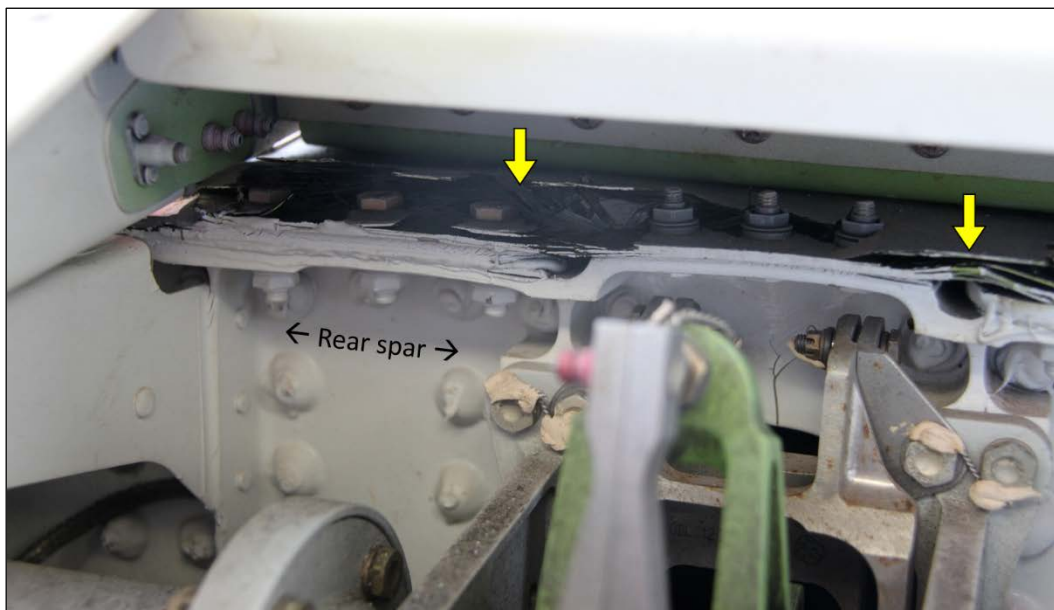
- cracking of the attachment support structure
- cracking and delamination of the skin panels at the rear spar (Figure 9).

Figure 9: Cracking and delamination of the upper skin on the horizontal stabiliser at the rear spar. View looking forward at the rear face of the rear spar. Damage identified by yellow arrows

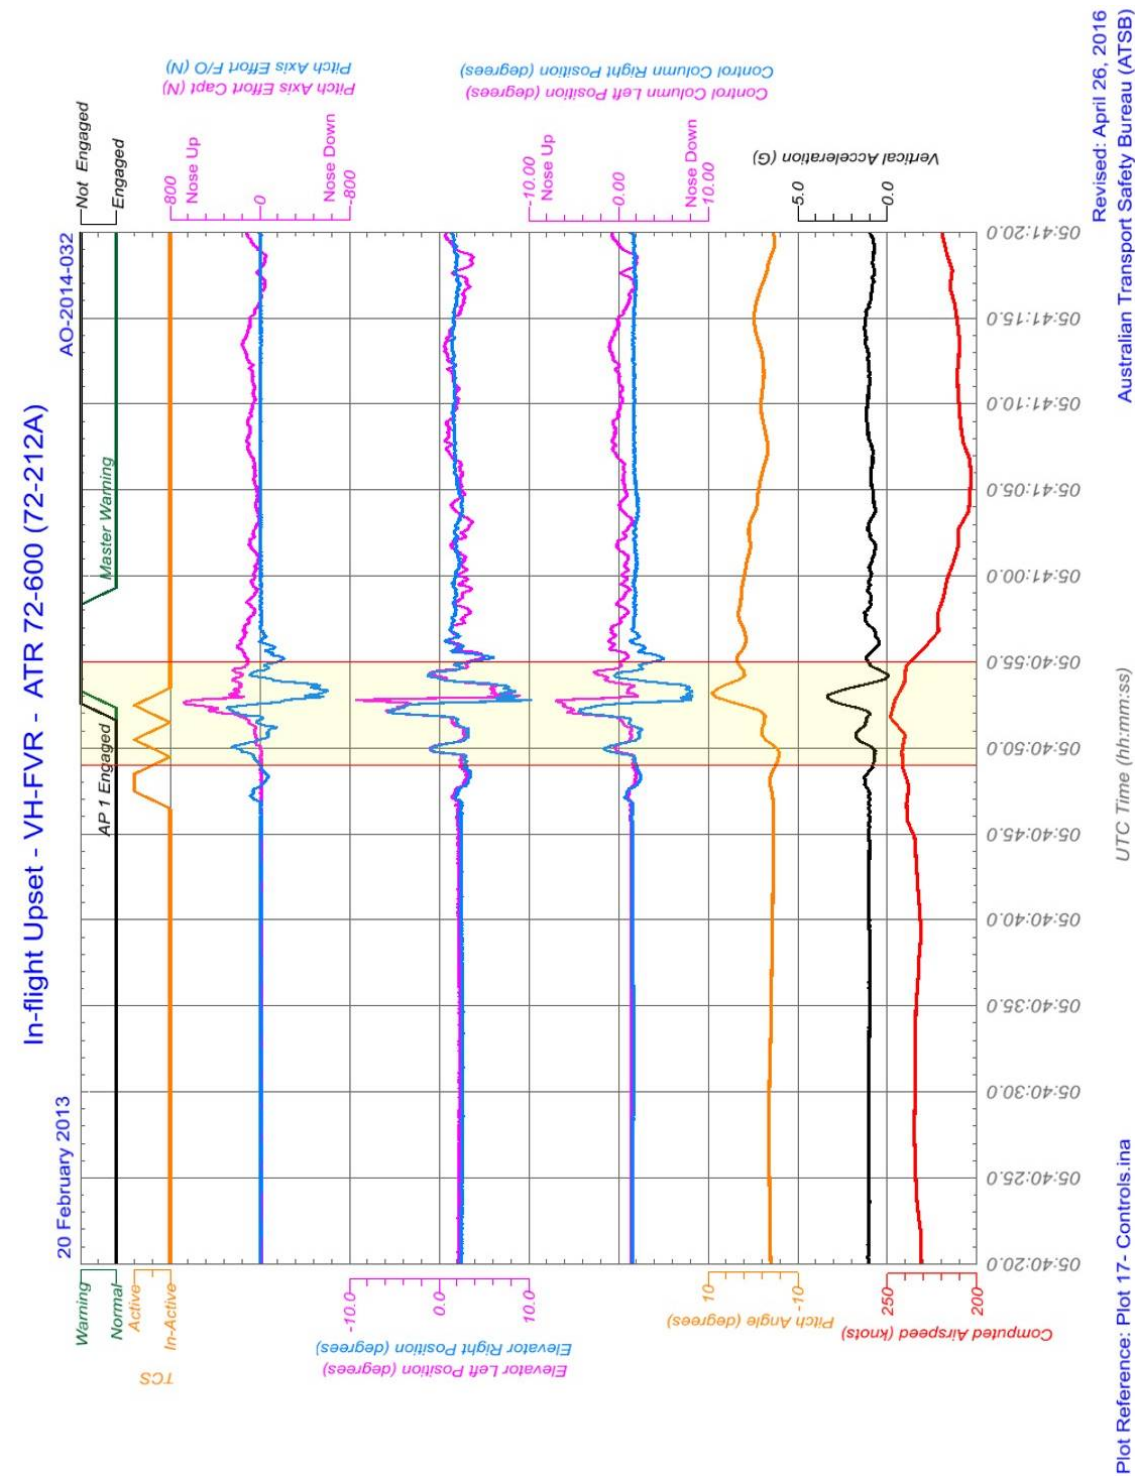
- Figure 10 shows selected data for a 60-second time period within which the occurrence took place. This includes a shaded, 6-second period that shows the pitch disconnect itself.
- Figure 11 shows an expanded view of the 6-second period in which the pitch disconnect took place.

Figure 10: FDR information showing the relevant pitch parameters for a period spanning about 30 seconds before and after the pitch disconnect

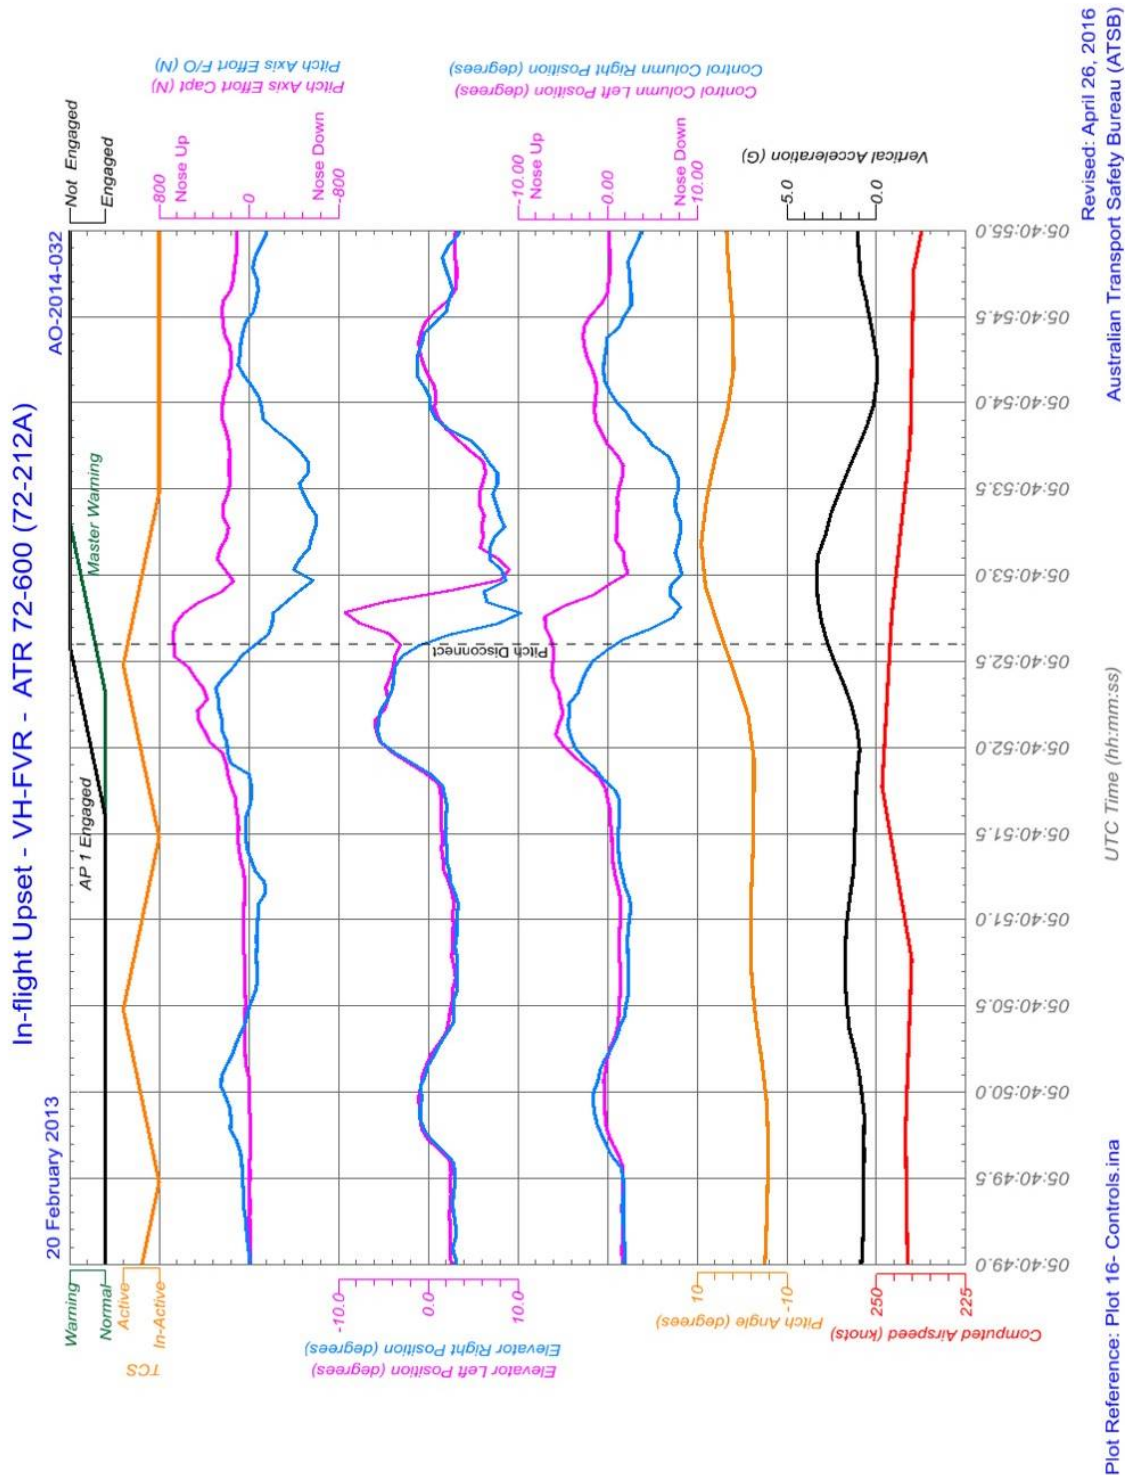
Figure 11: FDR information showing the relevant pitch parameters for the shaded 6-second period in Figure 10 during which the pitch disconnect took place. The estimated time of the pitch disconnect is shown with a black dashed line at time 05:40:52.6

- at 05:40:52.6 the elevators uncoupled. At that time:
 - the load on the captain's control column was 67 daN and on the FO's -8.5 daN
 - the aircraft pitch angle was increasing

- the vertical acceleration was about +2.8g and increasing
- after this time, the elevators no longer moved in unison
- peak elevator deflections of +10.4° and -9.3° were recorded about 0.2 seconds after the pitch disconnect

- about 0.25 seconds after the peak deflections, the captain moved the control forward until both elevators were in similar positions
- a maximum vertical acceleration of 3.34g was recorded at about 05:40:53.0
