Inquiry AO-2013-007: Boeing 737-838, ZK-ZQG,
stabiliser trim mechanism damage, 7 June 2013

Final Report

Boeing 737-838, ZK-ZQG
stabiliser trim mechanism damage

7 June 2013

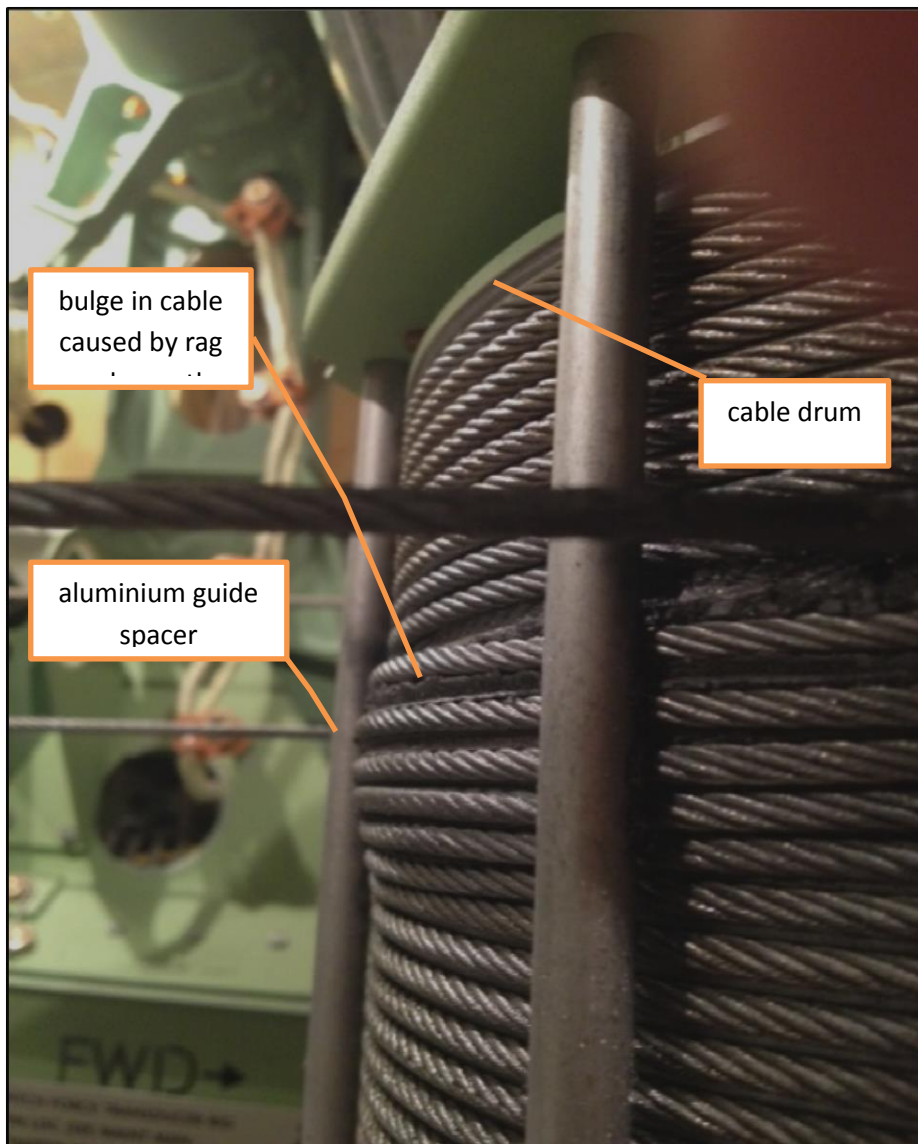
Figure 2
Photograph of forward cable drum

- 1.2. The rag had made the cable windings bulge outwards, which caused the cables to contact the cable guides, creating the metal filings and damaging the guides. The rag had increased the cable tension of the stabiliser trim system, which resulted in damage to a number of cable pulleys through which it was rigged. The control cables had also started to wear through contact with the steel bolts that held the cable guide spacers in place.

- 3.1.3. On further investigation the maintenance engineer found damage to the cable guides on the forward stabiliser trim cable drum. He found that a rag was trapped under the steel cable that was wound onto the cable drum (see Figure 2). The rag was causing the steel cable to bulge out from the drum and make contact with the aluminium spacer on the cable guide as the cable drum rotated. The metal filings he had initially noticed were from the softer aluminium spacer being worn by the steel cable.

- 3.1.4. In places the stainless steel cables had worn right through the aluminium spacer and had started to wear through the harder steel bolts that held the guide spacers in place (see Figure 3). The stainless steel trim cables themselves had begun to wear as a result. The situation had increased the tension on the trim cables, which had also damaged the cable pulleys that were located between the forward and rear cable drums.

- 3.1.5. Both trim cables, four cable pulleys and the forward trim cable drum were replaced with new parts. The trim system was then checked for correct rigging and normal operation before the aircraft was released for service.

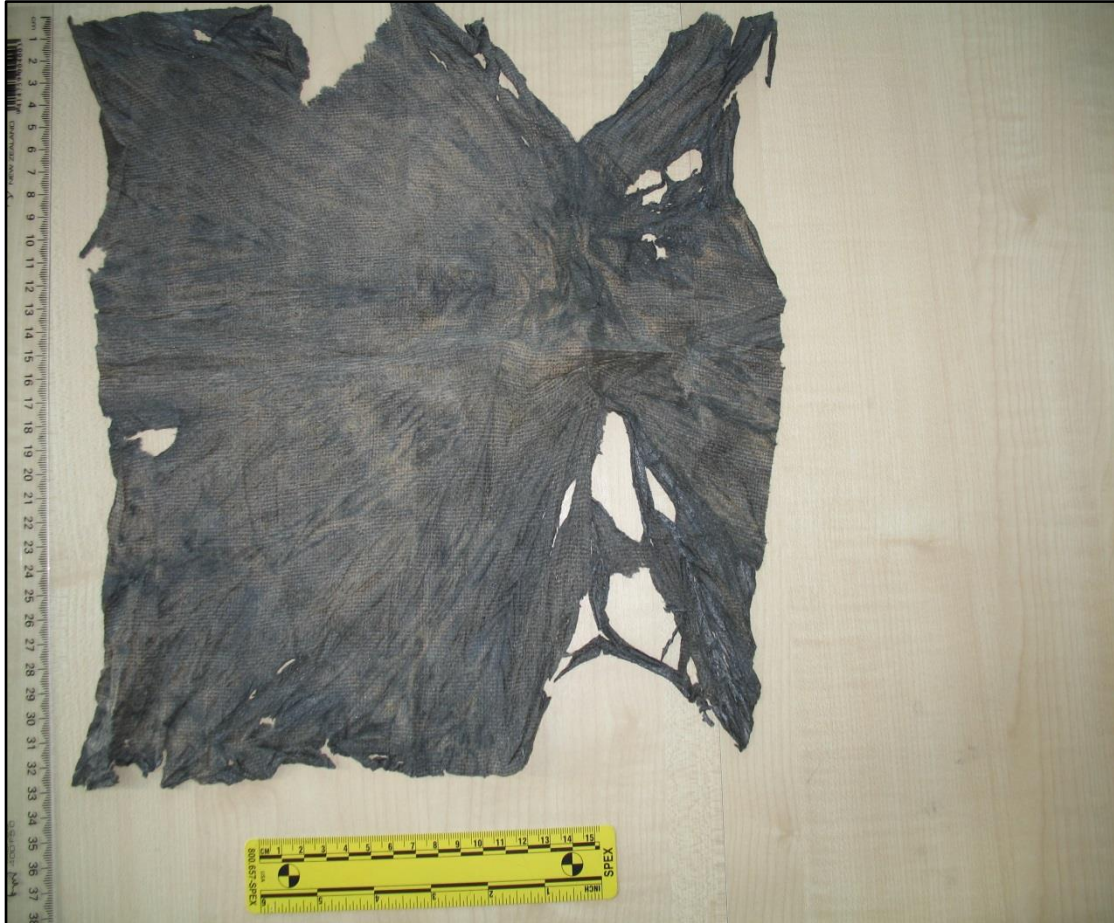
Figure 4
Incident rag

- 3.3.1. The rag recovered (see Figure 4) from the cable drum was sent to the New Zealand Wool Testing Authority for analysis, to determine the type of material, method of manufacture and, if possible, where it was made.

- 4.6. A sample (see Figure 5) from this roll and the incident rag were sent to the New Zealand Wool Testing Authority for comparison. The fibre content was assessed using chemical dissolution tests. The test report¹⁰ showed that both samples were made from a cellulosic or paper-based fibre and polypropylene. The frequency and position of the needling marks made during manufacture were compared and the samples matched. The test report concluded that it was "very likely that the two cloths [rags] are the same" and that "the crease pattern in the cloth [rag] is consistent with the cloth [rag] having been caught and dragged".

- 4.7. The findings of the New Zealand Wool Testing Authority and the fact that the Sydney maintenance facility was the only one where that type of rag was used, make it highly likely that the rag found trapped on the forward cable drum originated from the Sydney hangar.
