AIRCRAFT INCIDENT REPORT AND EXECUTIVE SUMMARY

Reference:	CA18/3/2/1067	
Aircraft Registration	ZS-NMF / ZS-SZZ	Date of Incident	10 July 2014		Time of Incident	1108Z
Type of aircraft	Bombardier CL600 / Airbus A320		Type of operation		Part 121 - Commercial	
Pilot-in-command licence type		Airline Transport	Age	38	Licence valid	Yes
Pilot-in-command flying experience		Total flying hours	8 724.1		Hours on type	1 657.5
Last point of departure		King Shaka International aerodrome (FALE), Kwa-Zulu Natal province				
Next point of intended landing		Port Elizabeth aerodrome (FAPE), Eastern Cape province				
Location of the incident site with reference to easily defined geographical points (GPS readings if possible)						
Overhead Port Elizabeth (GPS position: 33°59'38.02" South 025°35'35.30" East)						
Meteorological information		Surface wind; 040°5 knots, Temperature; 18°C, Visibility; +10 km				
Number of people on board	3 + 27	No. of people injured	0	No. of people killed	0

AIRCRAFT INCIDENT REPORT

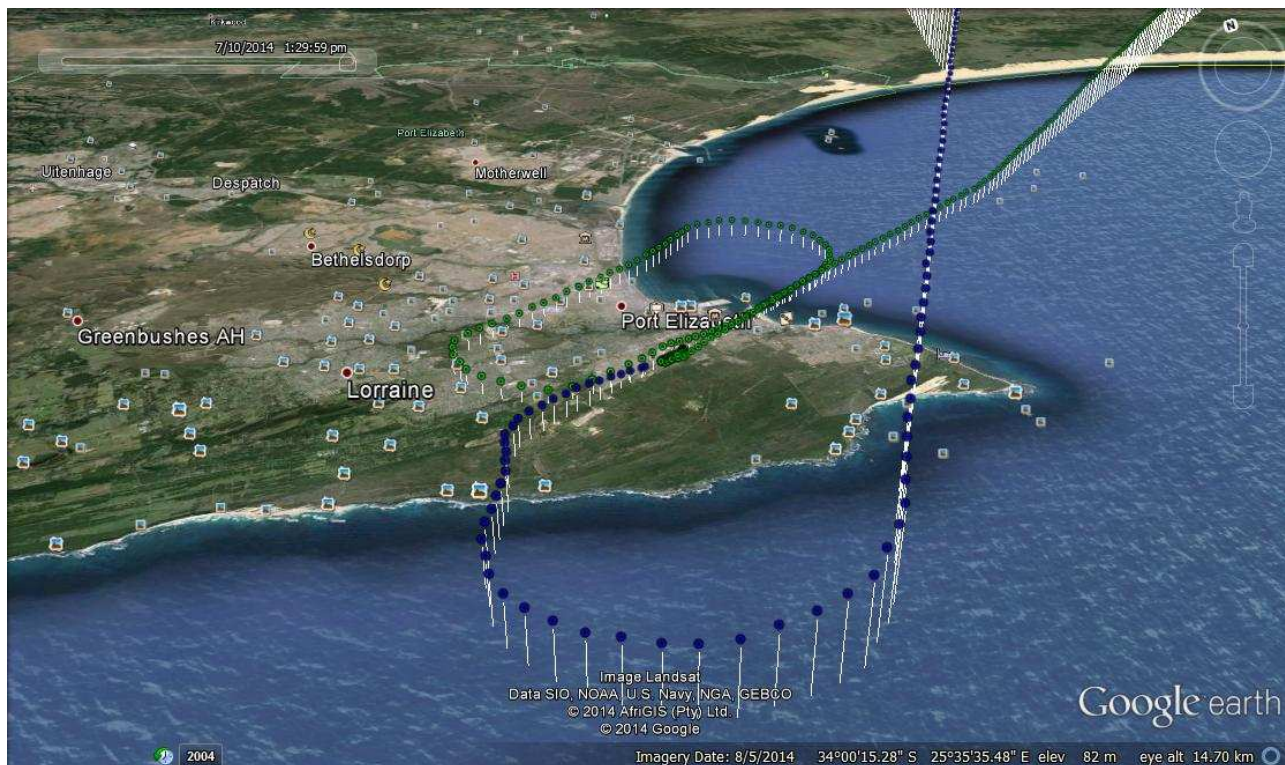
- 1.1.6 The radar data depicted in figure 1 indicates the flight path flown by EXY336 (green track), which approached FAPE over the sea from the northeast and following the go-around flew a right-hand circuit followed by a full stop landing on runway 26. The blue track indicates the flight path flown by SAA410, which was instructed to

Figure 1. The radar data display of the track flown by EXY336 (in green) and SAA410 (in blue)

- 1.1.7 According to radar data, the vertical separation between the two aircraft was 263 feet (80 m) and the horizontal separation was 0.2 nautical miles (370 m).
- 1.1.8 The serious incident occurred during daylight conditions at a geographical position that was determined to be 33°59'38.02" South 025°35'35.30" East.

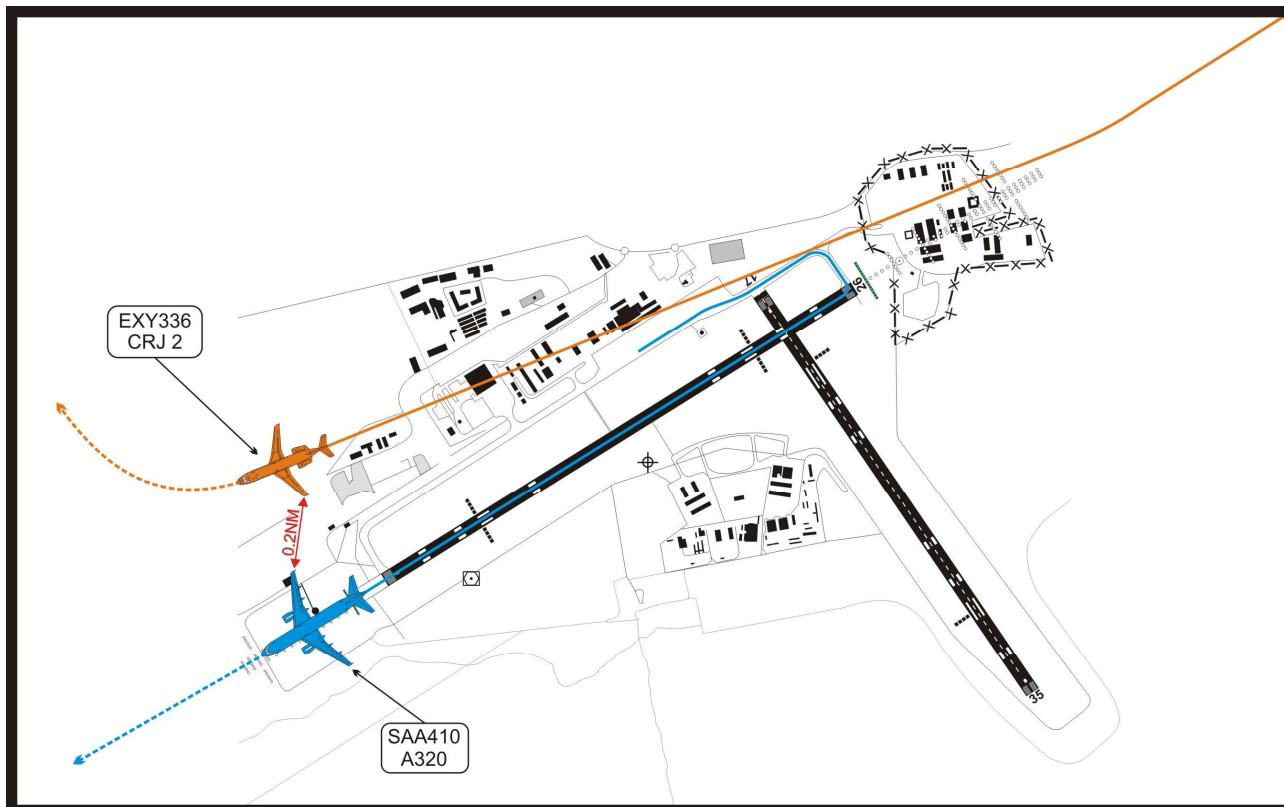
1.12.1 According to radar data obtained the vertical separation between the two aircraft decreased to 263 feet (80 m) and the horizontal distance to 0.2 nm (370 m), as illustrated in Figure 4.

Figure 4. Illustration of the separation between the two aircraft in the horizontal plane.

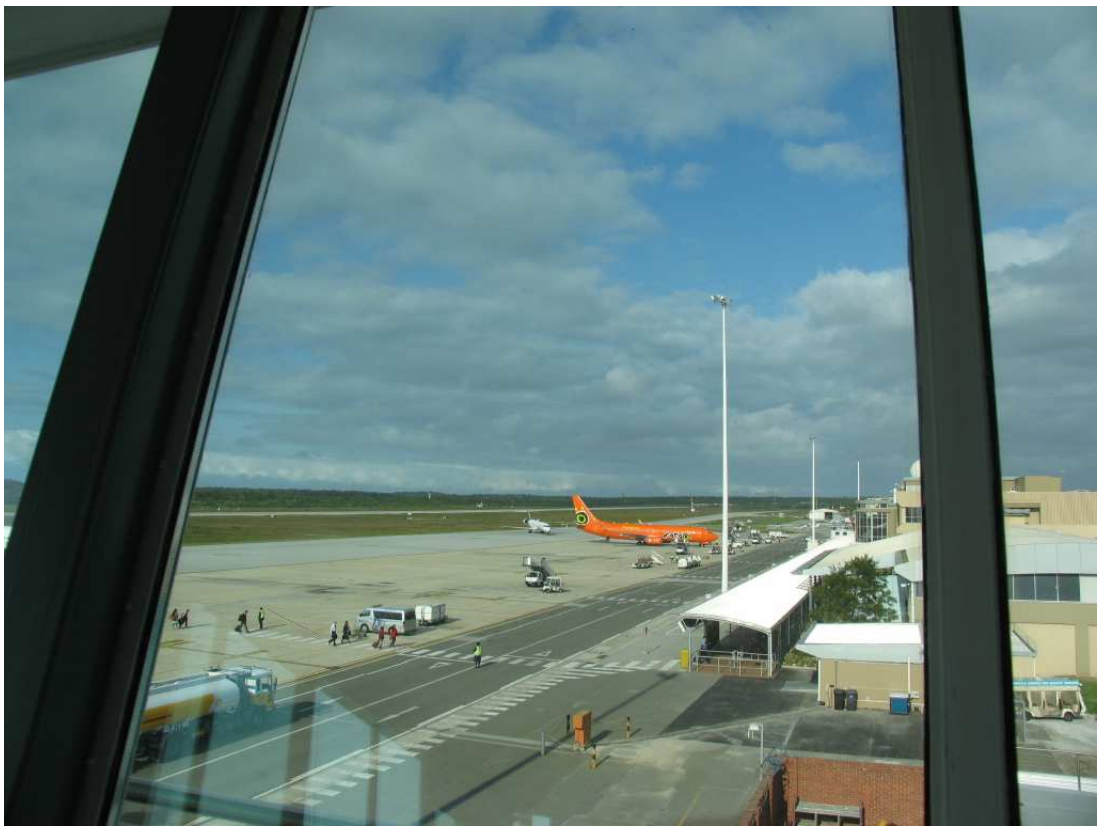
The control tower is located on the north-eastern side of the aerodrome and elevated above the administration building, which is a single-level building. The tower was found to be low if compared with several other control towers in the country and abroad, taking into consideration that the aerodrome held an international licence. For illustration purposes a photo (figure 6) was taken from inside the tower onto the apron area and in the direction of the threshold of runway 08.

Figure 6. View from the control tower onto the apron area and threshold of runway 08

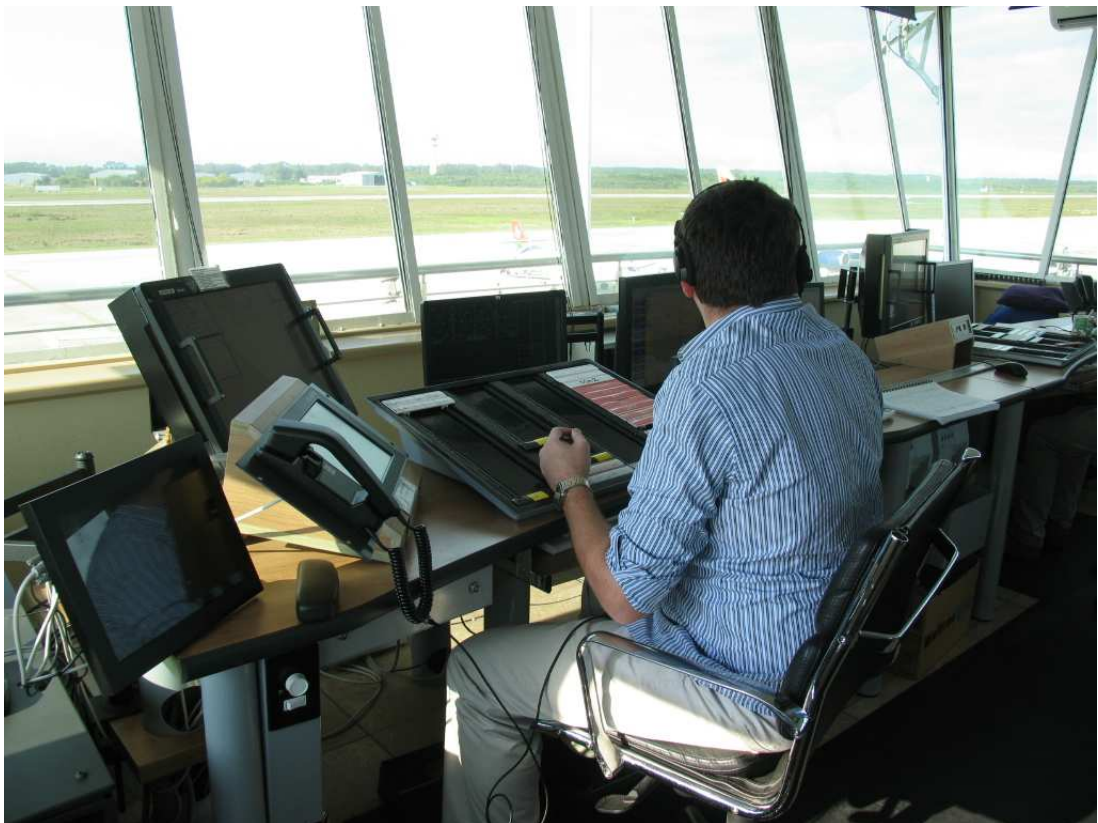
Figure 7. The aerodrome controller's work station in the tower

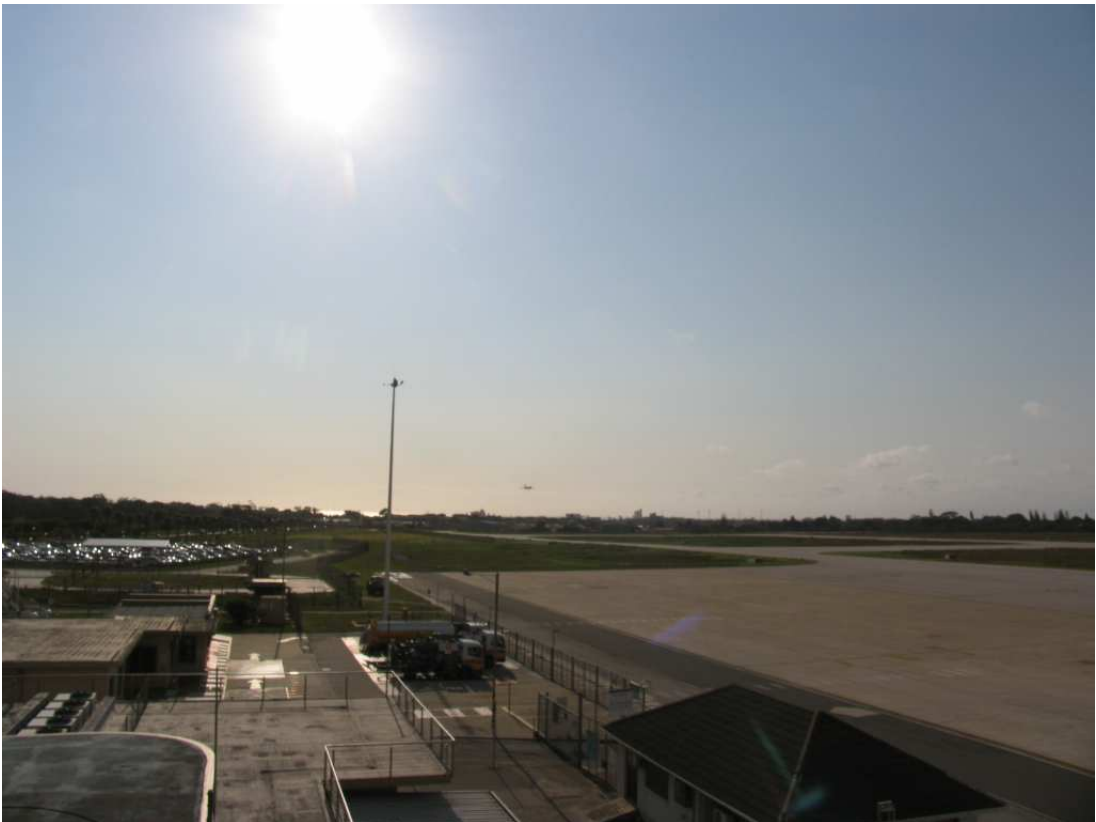
Figure 8 illustrates a view from the control tower looking towards final approach to runway 26. During daytime, in good weather conditions, the sun causes a substantial brightness/reflection/glare on the sea (photo tried to illustrate this

phenomenon) for a substantial period of the day, which makes it very difficult for the controller to visually observe aircraft on final approach, even if the aircraft are properly illuminated by external lights. Glare shields had been installed inside the tower, and the controller can move them up or down to try and alleviate the problem; however, if the controller took his eyes off the approaching aircraft and wanted to refocus, he or she might not be able to pick up the aircraft again. Estimating the distance to an aircraft on the approach by looking at it poses a challenge, and the radar display screen does provide such information; but with the aircraft on short final approach the controller does not look at the radar display. With Port Elizabeth being one of the windiest places in South Africa, wind can have a profound effect of the ground speed of the aircraft on the approach, as upper winds might vary substantial in speed, strength and direction relative to surface winds. Aircraft might therefore be flying much faster (greater ground speed) on the approach than the controller might anticipate.

Figure 8. A view from the control tower looking towards final approach of runway 26

The control tower at FAPE was found to be very low when compared with a number of other control towers in the country and abroad, taking into consideration that this is an aerodrome with international status. It was observed that the reflection of the sun on the sea during a certain time of the day can cause the controller(s) to have some difficulty following an aircraft visually on the approach for runway 26, something that could not be ruled out as a contributory factor to this incident. The tower was found to be equipped with glare shields to limit this phenomenon; however, there might be instances where the glare shield might not be properly adjusted for a certain controller at a certain time and the aircraft might not be immediately visible to the controller.
