# **Air Accident Investigation Sector**

**Serious Incident**

**- Final Report -**

## **Hydraulic Fluid Mist and Protective Breathing Equipment Fire in the Passenger Cabin**

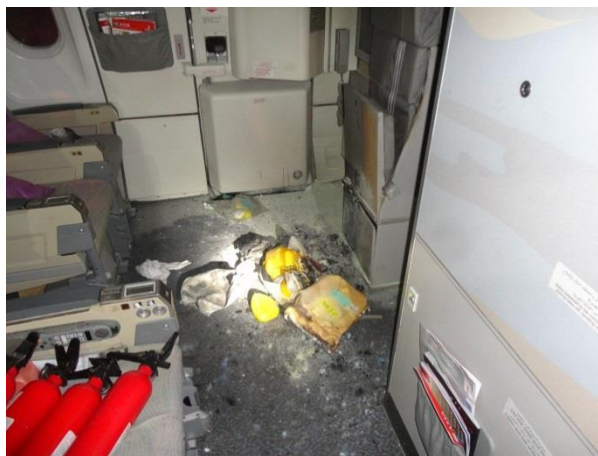
Damage to the Aircraft was limited to the area adjacent to L3 door. The cabin floor between fuselage frames 53.5 and 53.7, and seat tracks Y1456-Y1959, sustained burn damage.

Three floor panels (including one heated panel) were found badly damaged and required replacement (figure 1).

The cabin crewmember L3 seat was burnt.

Figure 1. Aircraft damage [Source: Karachi Airport]

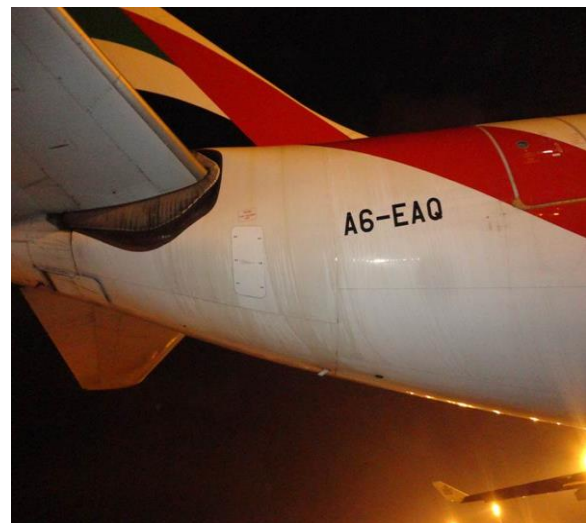
The mist that filled the cabin was generated by heated atomized hydraulic fluid leaking from the yellow hydraulic system hose which was connected to the center rudder servo (figure 3). The atomized hydraulic fluid was drawn into the APU intake, and then entered the cabin through the airconditioning system. This vaporized hydraulic fluid generated a “mist like” cloud that filled the cabin.

The hydraulic leak was caused by a fractured hose connected to the rudder hydraulic servo powered by the yellow system. The Aeroquip, high pressure hose, was fitted with straight-to-single elbow (45°) end fittings, and was constructed of three layers: a thin wall Teflon inner tube, a Hi-Pac outer braid consisting of densely packed small diameter stainless steel wires, and a fabric sleeve.

Figure 3. Traces of hydraulic fluid leak  
[Source: Karachi Airport]

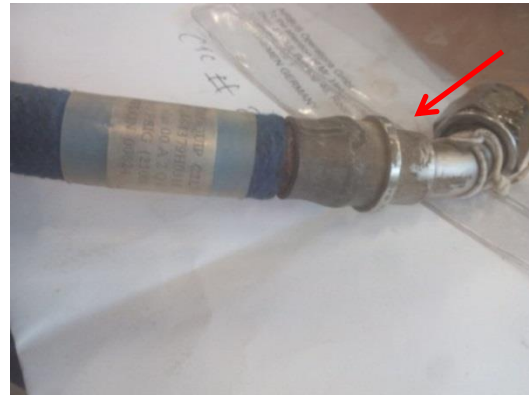
The hose assembly drawing indicates that an identification tag is fixed to the side of the elbow end fitting. This tag shows the hose manufacturer's name, the hose manufacturer part number (P/N), the customer P/N (if available), the month and year of manufacture, the manufacturer code, the material of the hose inner tube (Teflon), and the operating pressure (3,000 psi). This tag was not found on the affected hose after removal from the Aircraft.

**Figure 4.** Similar hose to the failed hose  
[Source: Airbus]

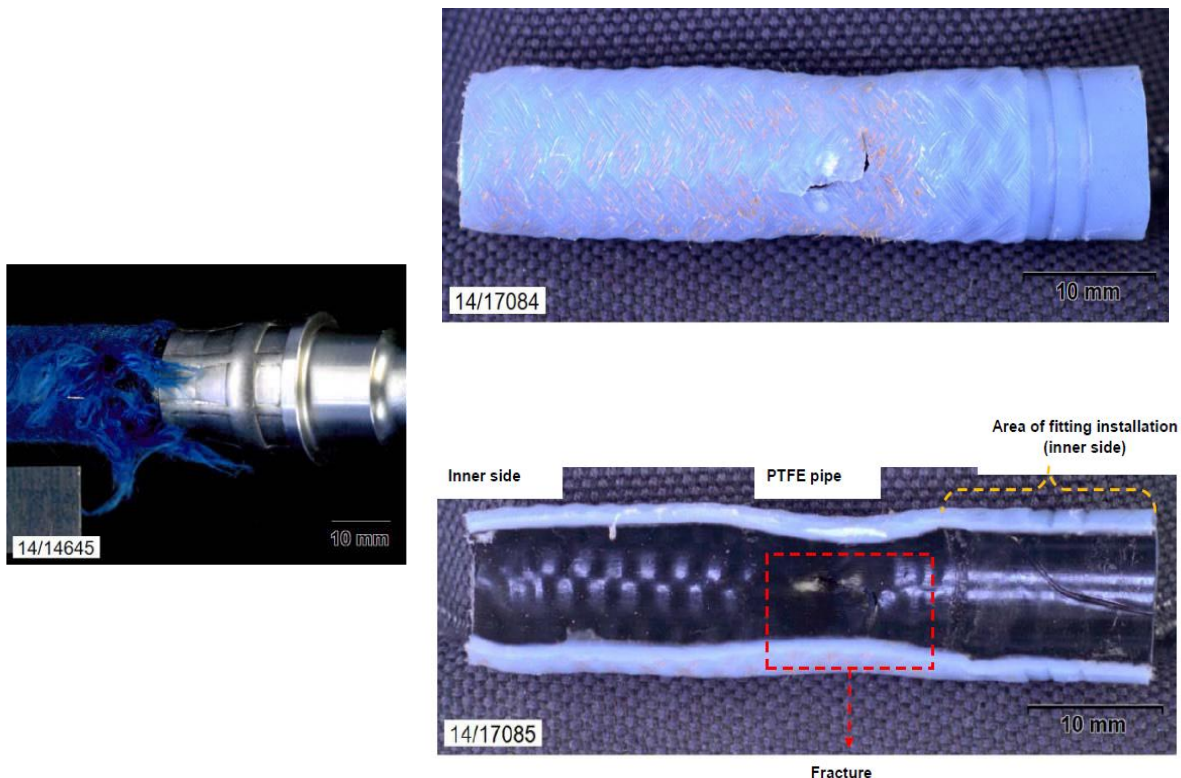
A visual inspection of the hose revealed a torn textile sleeve and abrasion marks on the metal braiding. The crack on the PTFE<sup>11</sup> pipe surface was opened in the laboratory and no obvious evidence of fatigue was found on the crack surface (figure 11). Microscopic analysis showed striations and beach marks on the braiding, indicative of fatigue failure. The microscopic examination also showed dirt on the surfaces of the failed braiding wires. The fractographic examination did not show any signs of corrosion on the surfaces of the failed braiding wires (figure 12).<sup>12</sup>

The report concluded that the main failure cause was, most probably, fatigue failure of the metal braiding which caused the failure of the PTFE pipe.

**Figure 11.** The torn textile and cross section of the failed tube. [Source: Airbus]

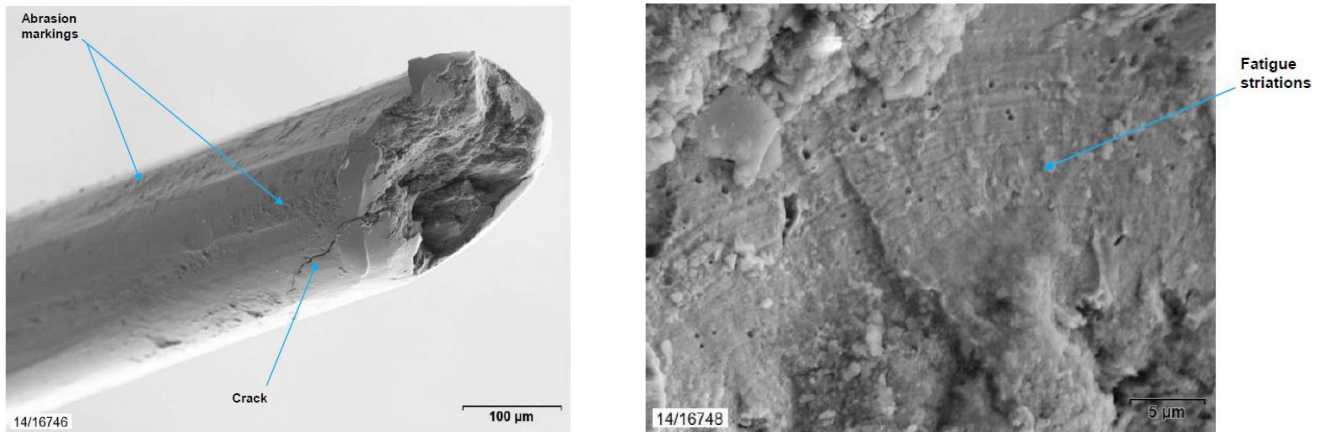
**Figure 12.** Microscopic image of the fractured braiding wires. [Source: Airbus]

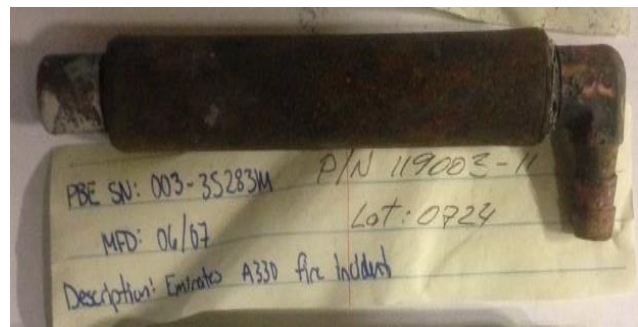
- The candle from the PBE unit that caught fire during activation by the cabin crew on the Incident Aircraft (S/N 003-35283M) (figure 13).
- The candle from a PBE unit (S/N 003-35282M) tested at the Operator's facility that had caught fire.
- The candle from a PBE unit (S/N 003-35280M) tested at the Operator's facility that had generated some black deposits after activation.

**Figure 13.** The candle from the PBE unit involved in the Incident [Source: B/E Aerospace CT scan report]

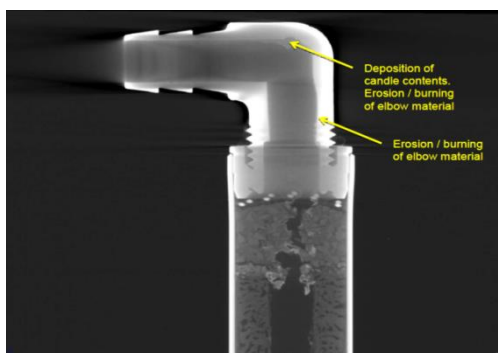
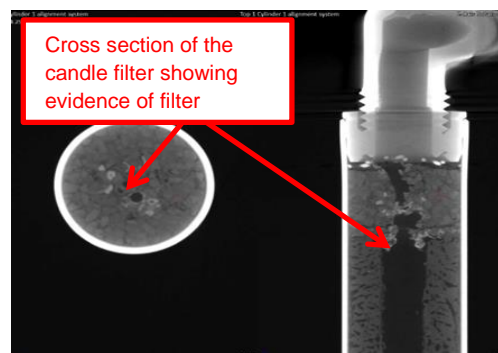
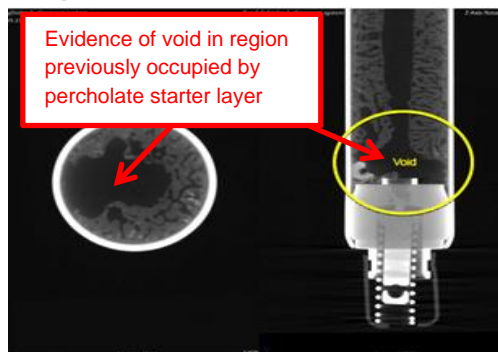
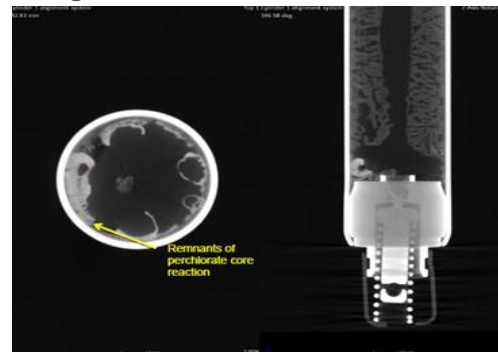
Photos related to the Incident PBE unit candle. [Source: B/E Aerospace CT Scan Report]

The two PBE units that had been exposed to fire (S/N 003-35283M and 003-35282M), exhibited residues of the core and filter in the oxygen path. The candles also showed evidence of localized outlet elbow burning and material loss in the vicinity of these compacted core/filter materials, or in the preceding flow path. In addition, residue from the perchlorate based starter layer of the candle, that is the region normally occupied by the starter layer, was essentially void and the starter layer residue assumed a displaced position in the direction of the candle outlet. (Figure 14a, 14b, 14c, 14d).

Figure 14a. The candle outlet end elbow

Figure 14b. Cross section of the candle

Figure 14c. The candle activation end

Figure 14d. The candle activation end
