# Power plant failures in turbofan-powered aircraft

2008 to 2012

**ATSB Transport Safety Report**  
Aviation Research Report  
AR-2013-002  
Final – 19 June 2014

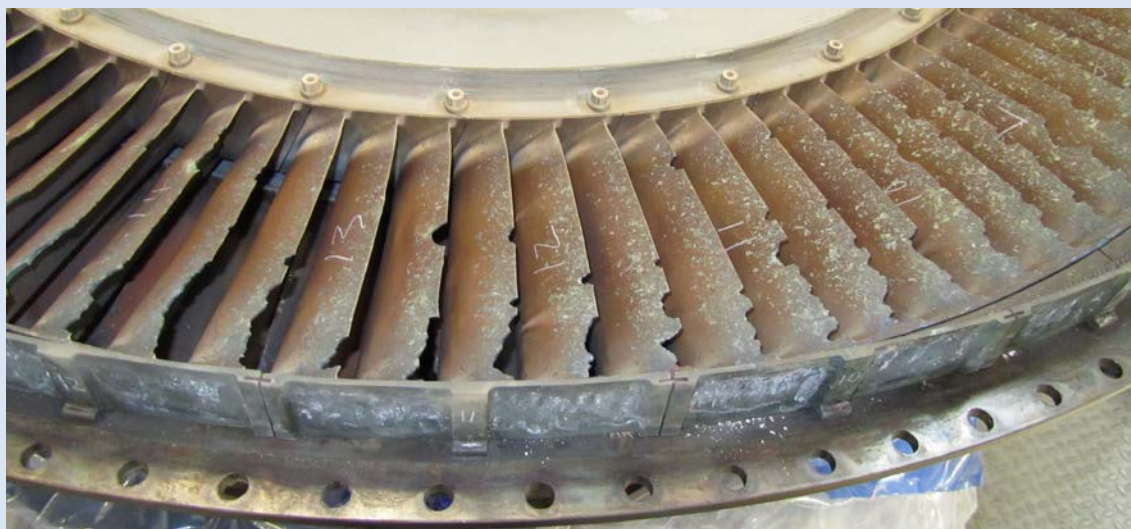
The increase in the exhaust gas temperature and vibration from the No. 4 engine was a direct result of the failure and separation of a single intermediate-pressure turbine blade. The turbine blade had fractured following the initiation and growth of a fatigue crack from an origin area near the blade inner root platform. Detailed modelling and analysis was undertaken by the engine manufacturer, Rolls-Royce, following the occurrence, and while the root cause for the intermediate pressure turbine blade failure was not fully identified at the time of this report, it was considered that the wear and loss of material from the turbine blade outer interlocking shrouds had reduced the rigidity and damping effects of the shroud and may have contributed to the high-cycle fatigue cracking and failure. The engine manufacturer has advised that they are continuing work to understand the underlying mechanism of the failure and will advise the ATSB if any further information is obtained.

Turbine blades from the damaged Rolls-Royce RB211-524G2-T

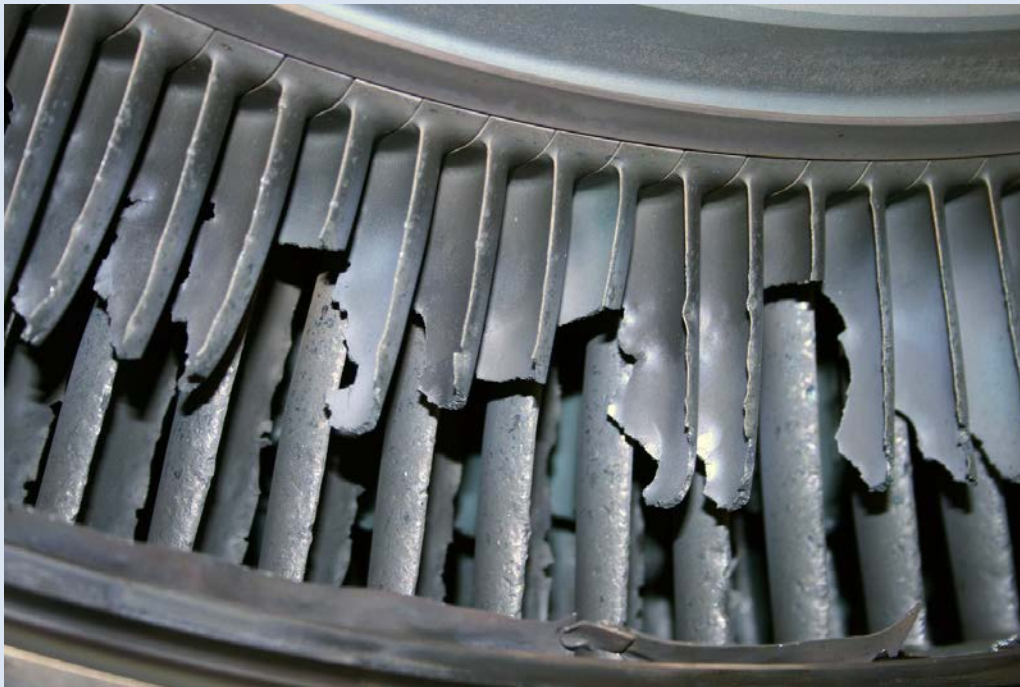
A preliminary inspection by the operator's engineering staff revealed significant damage to the low pressure turbine (LPT) assembly. The CFM56-3C-1 engine was subsequently returned to an overhaul facility for disassembly and inspection, overseen by ATSB investigators.

Creep rupture was identified as the likely failure mechanism in previous stage-1 LPT blade failures in this engine type investigated by the ATSB and the engine manufacturer. As a result of this occurrence, the engine manufacturer revised service bulletin SB 72-1113 to expand the range of blade manufacturing batch numbers that had previously been identified as being predisposed to creep-related failure. Blades in the identified batches were to be withdrawn from service as soon as they are next removed from the engine.

LPT stage 1 blades on the damaged CFM56

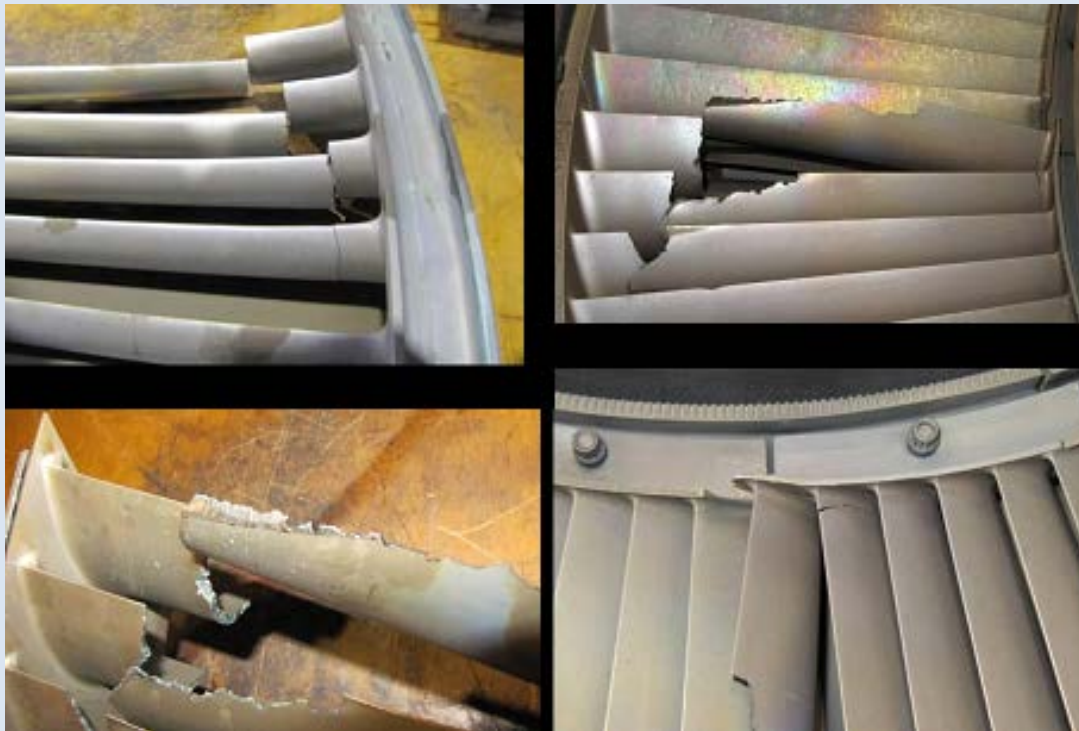
The aircraft operator carried out an initial examination of the aircraft and engine. The engine was found to have seized and metal pieces were found in the tail pipe. The engine was replaced and the aircraft returned to service. The engine manufacturer conducted an investigation into the failure of the LPT stage 3 nozzle segments. The investigation identified that the most probable reason for the failure was a transient mean stress of the segments during take-off, coupled with other operational stress and mechanical factors.

The damaged General Electric CF6-80C2 engine

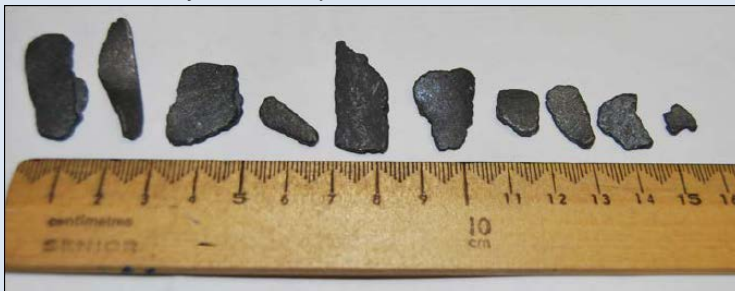
A witness to the event reported hearing a distant bang on the night of the occurrence, followed by impact noises on the tile roof of their property in NSW. Pieces of suspected engine debris were later collected by the NSW police service.

Pieces of engine debris recovered from Riverstone, NSW. Source: NSW Police

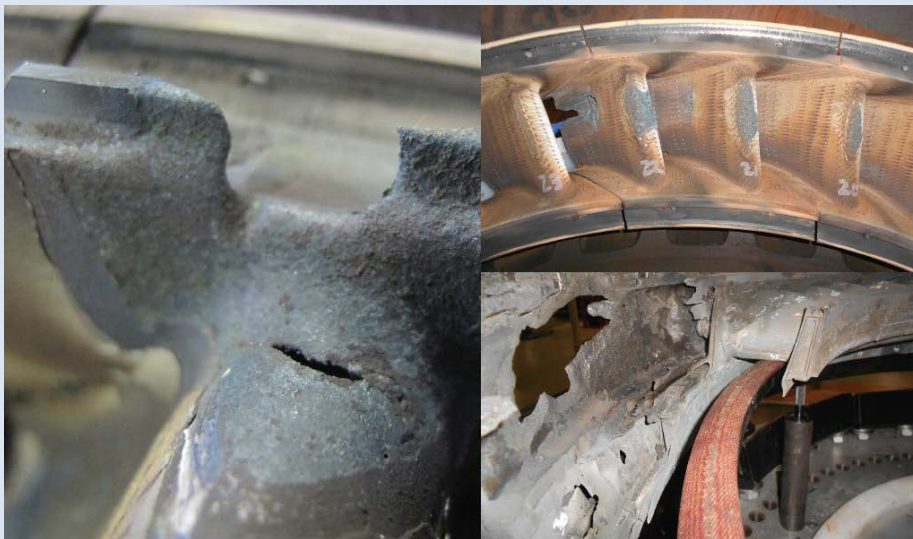
The investigation found that the increase in the exhaust gas temperature and subsequent engine shut down was a result of significant internal damage that had initiated within the high pressure turbine (HPT) module. The damage had resulted from the effects of HPT stage-2 nozzle distress, likely caused by exposure to hotter than expected operating temperatures. The nozzle distress led to eventual failure and separation into the gas flow path. Over the preceding weeks there were two other engines within the operator’s fleet that had experienced a similar problem, and a number of steps had been taken by the manufacturer to address the issue, including the increased monitoring of distress development. During the previous flight, the engine health and trend monitoring program had identified a performance trend shift with this particular engine, and it was due to be inspected upon return to the main base in Dubai.

The damaged Engine Alliance<sup>15</sup> GP7200. Clockwise from left; HPT stage-2 nozzle distress, HPT stage-1 nozzles (forward looking aft), Hole in HPT case and missing stage-2 nozzles
