**KOMITE NASIONAL KESELAMATAN TRANSPORTASI
REPUBLIC OF INDONESIA**

Aircraft Accident Investigation Report

PT. Kalstar Aviation

Embraer 190-200LR; PK-KDC

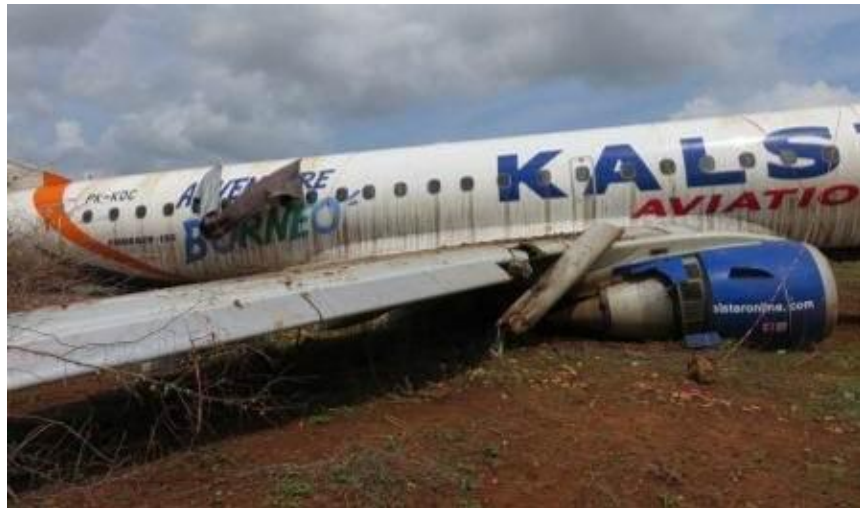
Figure 1: The damaged right wing

- Both nose wheels were minor damage. Reverted rubber marks found on both nose wheels.
- The right wing had severe damage with the details:
 - The navigation light broken,
 - The inner flap damaged,
 - The inboard slat detached from its mounting,
 - The wing leading edge behind the detached slat damaged by impact and torn (Figure 2).

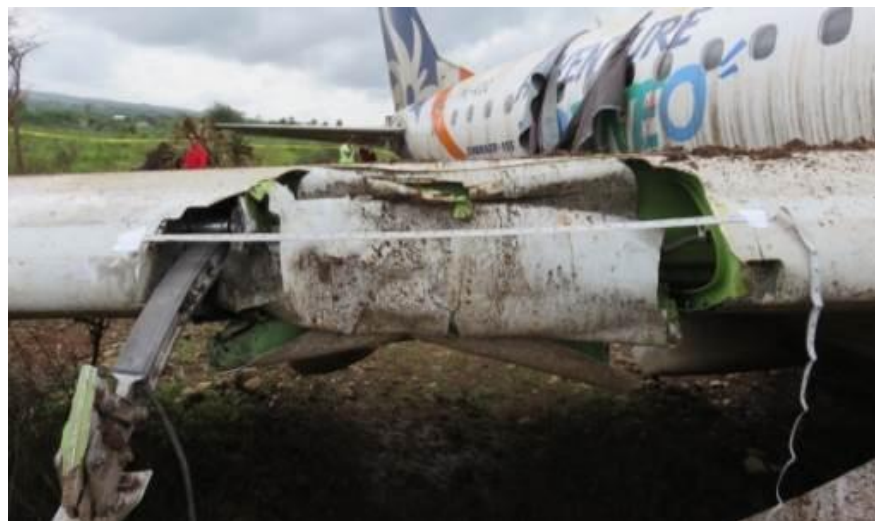
Figure 2: The impact damage on the right wing

Approximately 185 meters from end of runway 07, investigators found a collapsed palm tree. The dimension of the tree was approximately 40 cm in diameter with 5 m height. It is most likely that the right wing hit this tree damaging the leading edge of the right wing.

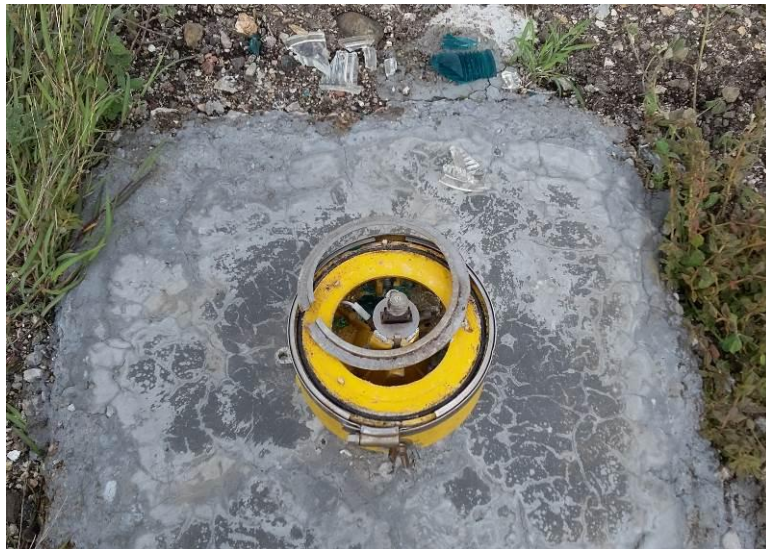
Figure 3: Broken runway light

There was a broken runway light at the end of runway 07.

A broken runway light was found at the end of runway 07 on the path of the aircraft movement.

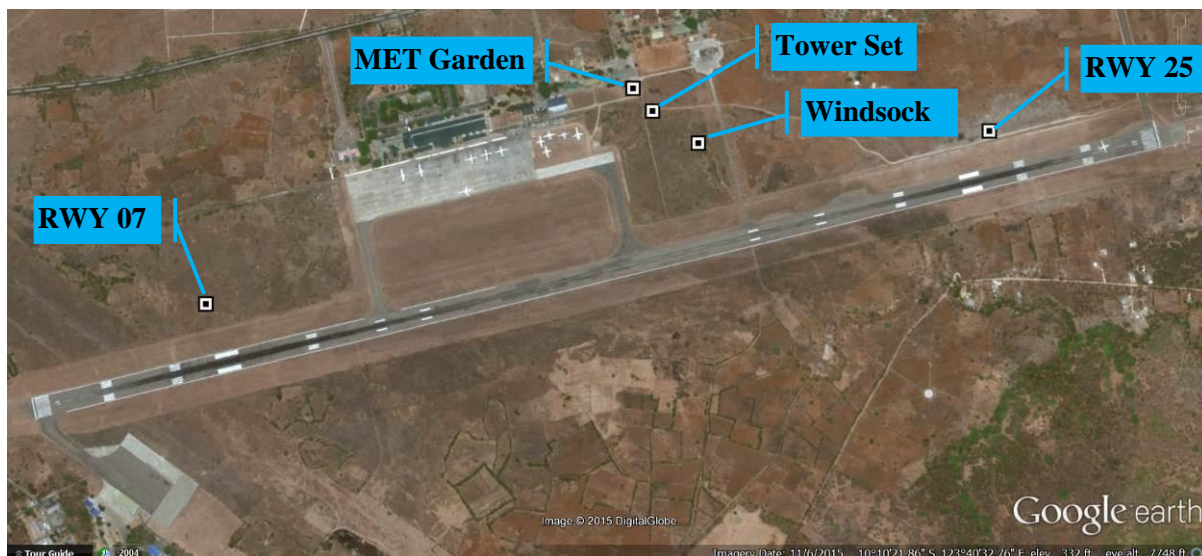
Figure 7: Meteorological sensor and windsock locations

There were three different sources that provided the latest wind information to air traffic controller which were the AWOS display, the Tower Set display and a windsock. Based on the interview, the air traffic controller stated that they used the information from AWOS display of runway 07 and the windsock near the tower building as comparison before providing the latest wind condition to the pilot of the accident flight.

The investigation could not find the standard procedure to determine the wind information from the three different sources (Figure 7).

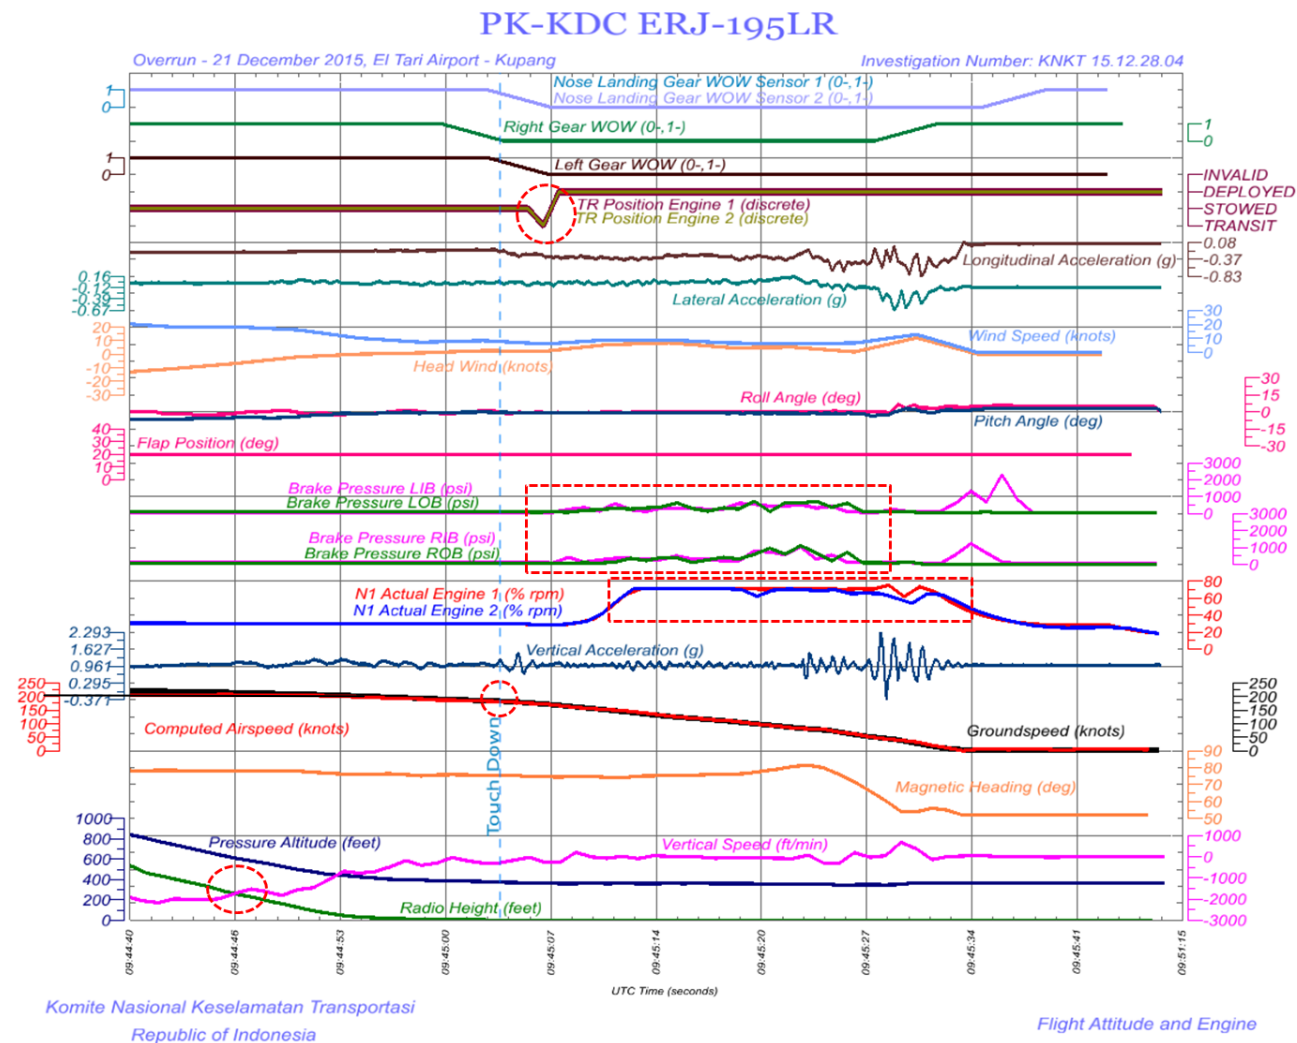
Figure 12: The graph of several flight data parameters of the accident flight

- When approach passed altitude 500 feet AGL, the rate of descent was more than 2,000 feet/minute and while passed altitude 200 feet AGL, the rate of descent was more than 1,500 feet/minute.
- Aircraft speed at 50 feet above runway was approximately 200 knots and 180 knots on touchdown.
- The thrust reversers deployed immediately after touch down.
- Brake pressures of both inboard and outboard were below 1,000 psi until the aircraft commenced to stop.
- The engine N1 rotation increased after the thrust reversers deployed.

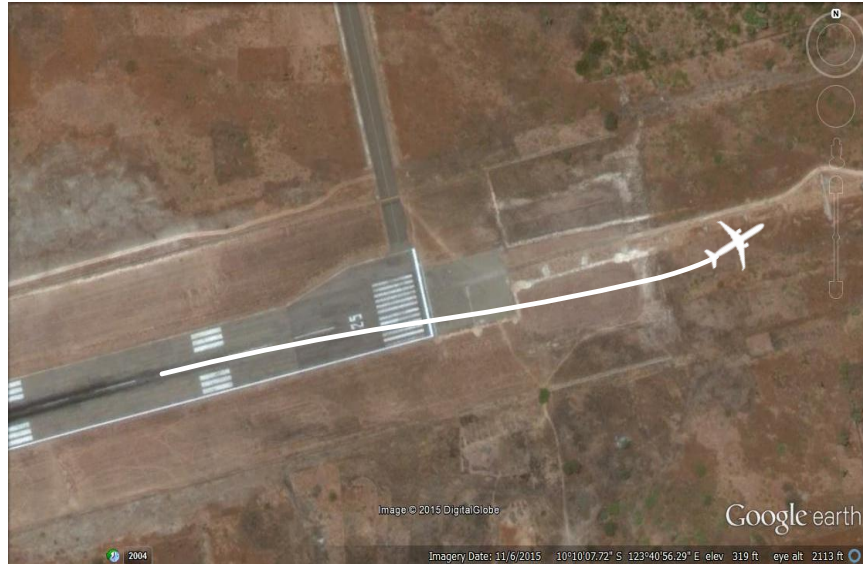
Figure 15: Illustration of tire mark when the aircraft started to veer from runway centerline (white line)

The investigation found tire marks began at 220 meters before end of runway 07 and indicated the aircraft started to veer to the right (Figure 15).

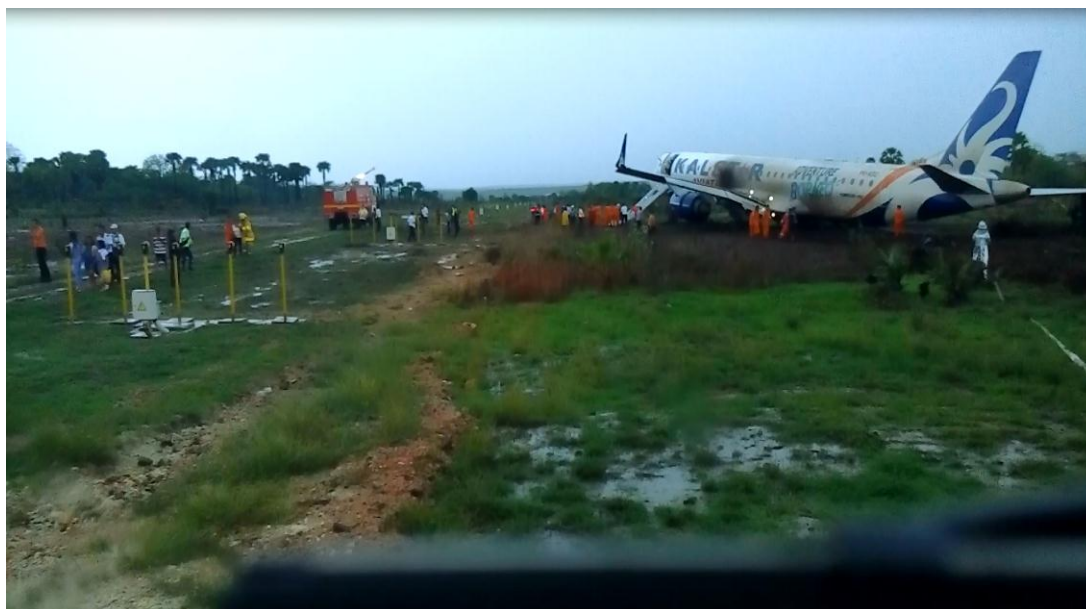
Figure 17: The aircraft final position

The aircraft stopped approximately 200 meters from the end of runway 07 on a heading of 060° . The relative angle of the aircraft and the ground was approximately 7° and the nose wheel was lifted about 50 centimeters from ground. The wings were tilted about 4° to the right (Figure 17).

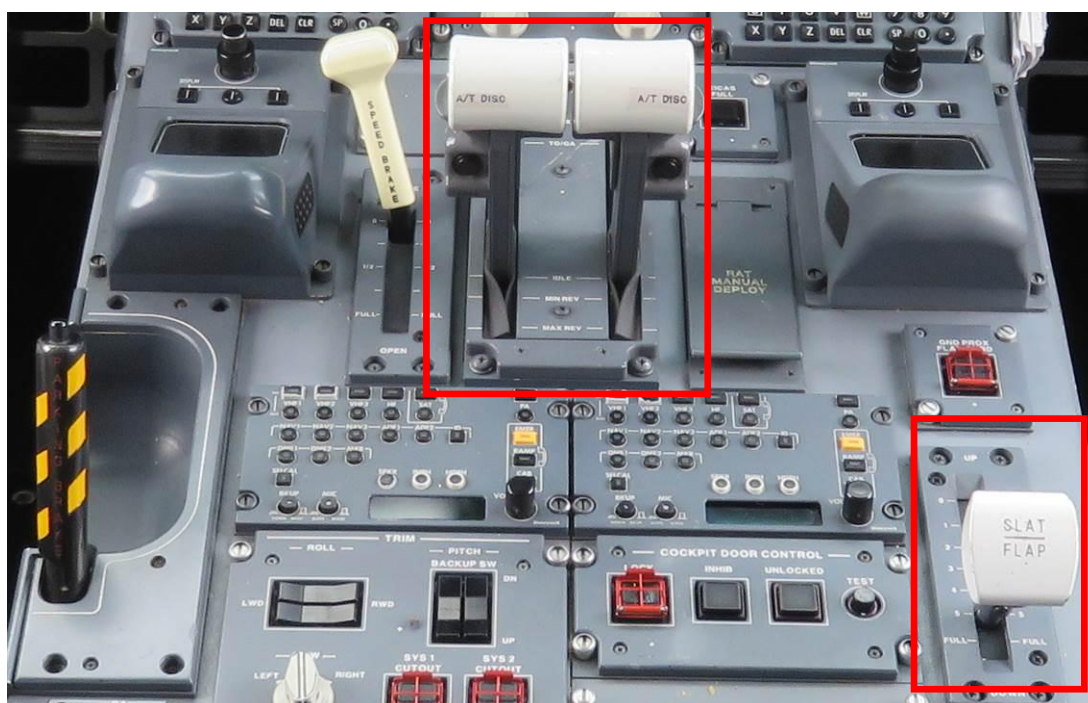
Figure 18: The thrust levers and flap selector observed after the aircraft stopped

The right main landing gear collapsed and contacted with the right inner flap. The flap selector was found at the Flap 5 detent (20 degrees wing flaps - Figure 18).

All wing flaps were extended to approximately 20 degrees.
