# Investigation Report

Type of Occurrence:	Serious incident
Date:	25 April 2013
Location:	Near Regional Airport Frankfurt-Hahn
Aircraft:	1. Transport aircraft 2. Powered glider
Manufacturer / Model:	1. Boeing Company / B737-800 2. Alexander Schleicher GmbH & Co / ASH 25 Mi
Injuries to Persons:	None
Damage:	None
Other Damage:	None
State File Number:	BFU EX005-13

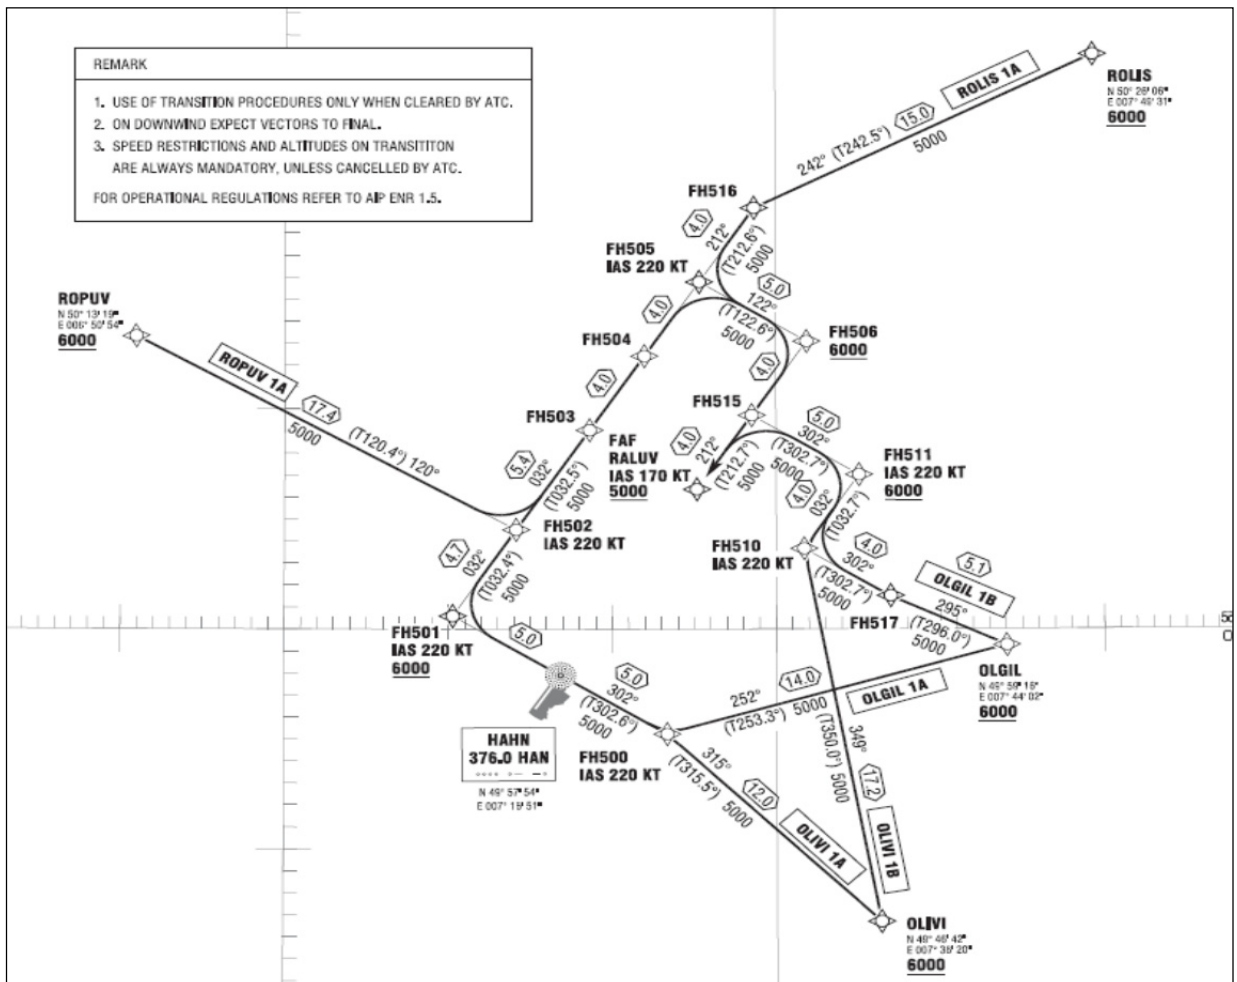
At 1733:04 hrs the controller issued descent clearance to 5,000 ft AMSL with the words: “[...] descend altitude 5,000 feet, QNH 1,021.” At that time the Boeing B737-800 was cleared for transition OLIVI 1B (see Image 2).

**Image 2:** GPS/FMS RNAV Arrival Chart Transition to Final Approach (Overlay to Radar Vector Pattern) RWY 21
