AVIATION INVESTIGATION REPORT

A98Q0087

IN-FLIGHT FIRE—LANDING GEAR WELL

SWEARINGEN SA226-TC C-GQAL

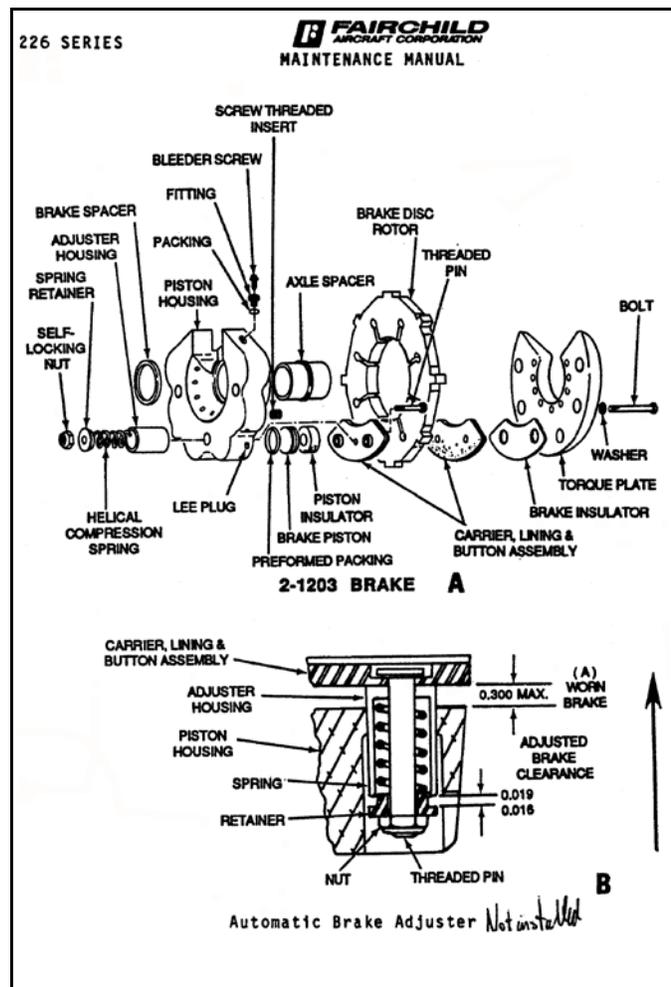
The aircraft was equipped with single-disc brake assemblies manufactured by BFGoodrich and identified by part number 2-1203. Each brake assembly consists of a forged aluminum alloy torque plate associated with a piston housing assembly. On both sides of the brake disc are three brake carrier, lining, and button assemblies. Adjustment for wear in the brake carrier, lining, and button assemblies is normally done by three automatic, equally spaced adjusters in the piston

housing assembly. The brake adjusters provide clearance between the brake pads and the disc. Installation of the brake adjusters decreases sensitivity by increasing the amount of fluid required to fill the brakes so that the pilot needs to pump the brakes under certain conditions. As a result, the brake adjusters were not installed on most SA226 and SA227 aircraft, including the occurrence aircraft. Removal of the brake adjusters was approved by Fairchild and BFGoodrich.
