This document is an English translation of the Final Report on the fatal accident involving the Boeing 747-412F aircraft registered TC-MCL that occurred on January 16th, 2017 at Manas International Airport, Bishkek, Kyrgyz Republic.

**INTERSTATE AVIATION COMMITTEE
AIR ACCIDENT INVESTIGATION COMMISSION**

**FINAL REPORT
ON RESULTS OF THE AIR ACCIDENT INVESTIGATION**

Type of occurrence	Fatal accident
Type of aircraft	Boeing 747-412F
Registration mark	TC-MCL
Owner	LCI Freighters One Limited (Ireland)
Operator	ACT Airlines
Aviation Authority	Directorate General of Civil Aviation of Turkey (Turkish DGCA)
Place of occurrence	Near Manas International Airport, Bishkek, Kyrgyz Republic, coordinates: N 43°03.248' E 074°2.271'
Date and time	16.01.2017, 07:17 local time (01:17 UTC), night time

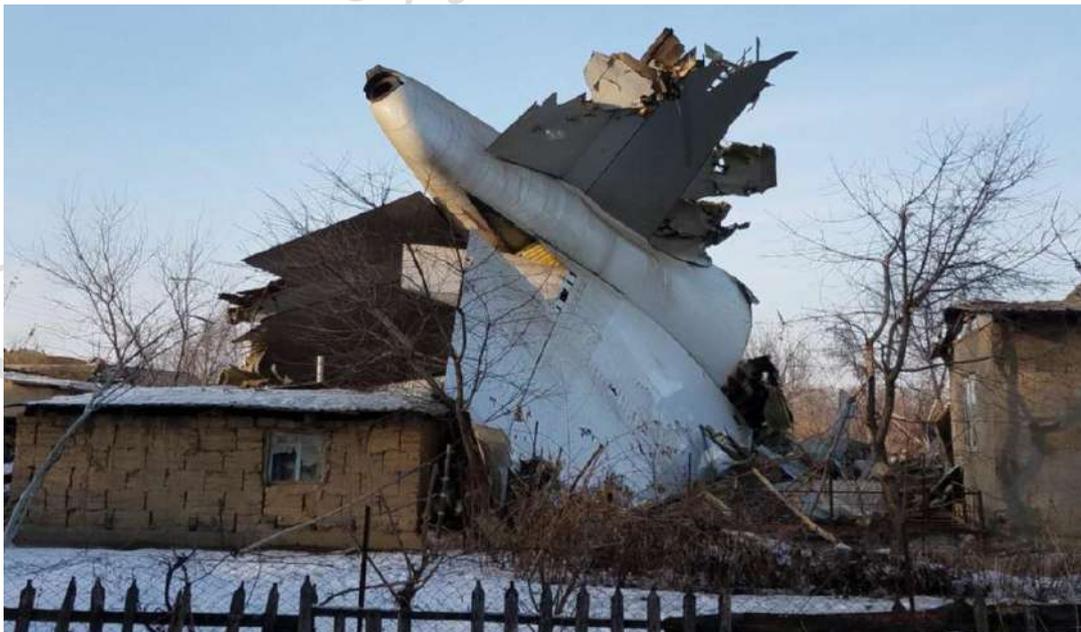
The fin and the horizontal stabilizer (Figure 4) have been found attached to the tail fuselage section, extending from the aft pressure bulkhead to the tail cone. The leading edges of the fin and the rudder show damage caused by the terrain impact. No traces of fire or soot have been found.

Figure 4. Tail fuselage section

The horizontal stabilizer fragment has remained in its standard position and has been found at the accident site in the turned-over position. The center box section, connecting the two parts of the stabilizer, the stabilizer trim drive mechanism and the jackscrew show no outer damage. The left part of the stabilizer and the elevator have been damaged as a result of the impact with the obstacles, part of the assembly is missing. The right part of the stabilizer has remained in its standard position and shows damage.

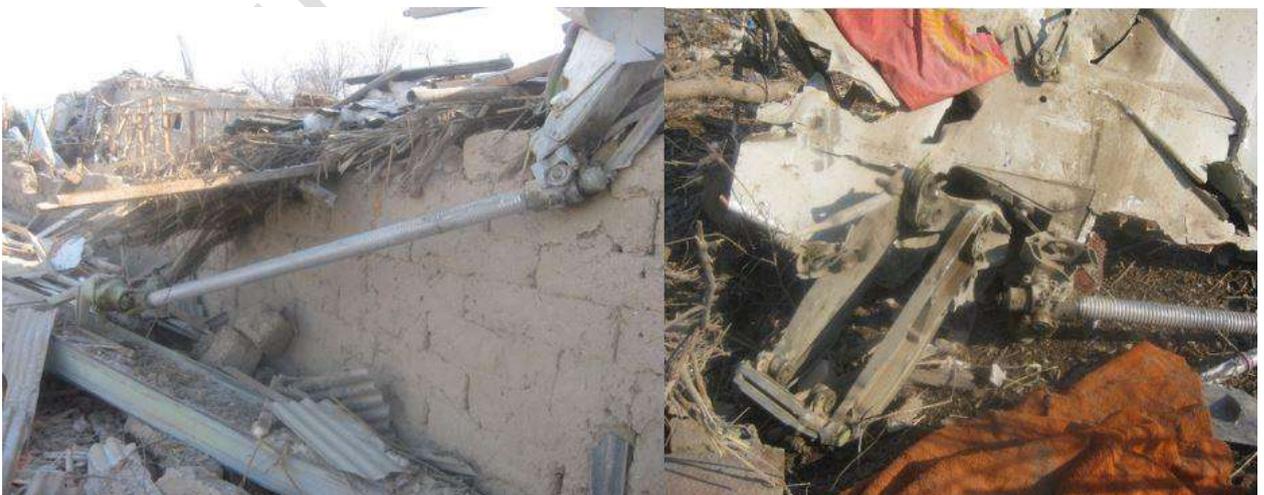
At the time of the accident, the wing flight control surfaces were in the landing configuration, which is confirmed by the positions of ball-screw assemblies of the leading and trailing edge flaps (the surfaces have been found in the fully extended positions (in the mechanical stop positions)) (Figure 8), as well as by the position of the flap control lever (Figure 9).

Figure 8. Ball-screw assemblies' positions

All the 8 ball-screw assemblies of the flap extension/retraction system (4 for each of the both outer wing sections) have been found. The shafts' positions in relation to the ball-screw nuts (thread turns) indicate that the flaps were at 30°.

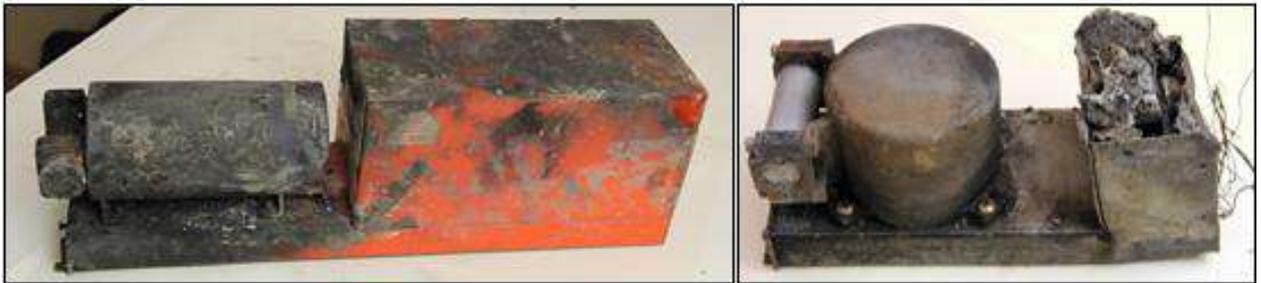
The Digital Flight Data recorder (FDR) and cockpit voice recorder (CVR) have been found at the accident site near the aircraft tail empennage fragment (Figure 12).

Figure 12. Inboard flight data monitoring and recording equipment

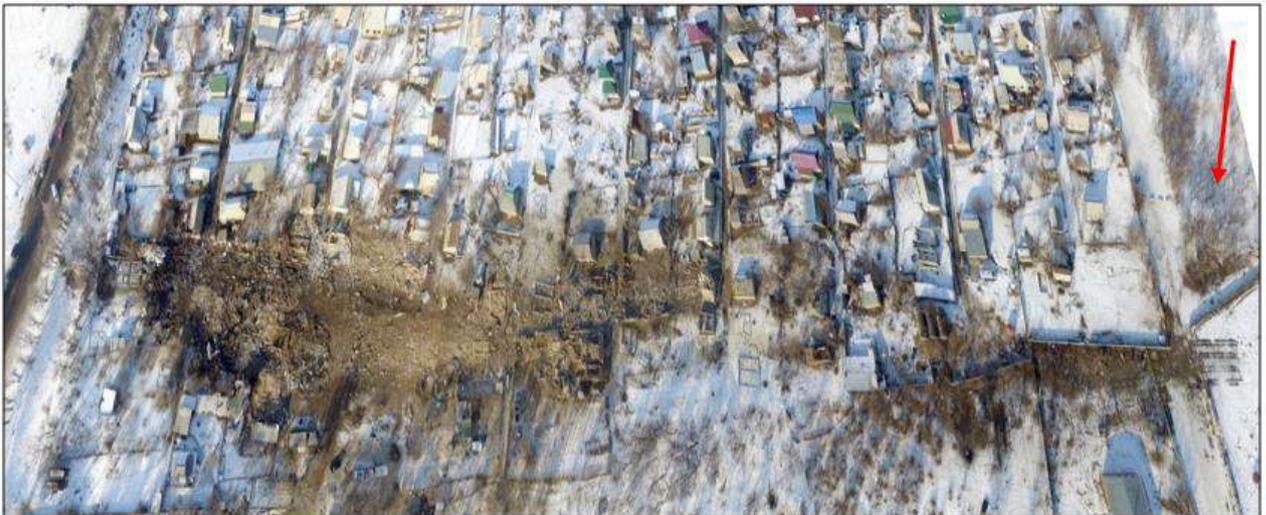
The accident site (Figure 25) is an area with the damaged or destroyed houses extending for the length of approximately 550 m and for the width of 40 – 60 m.

Figure 25. General accident site overview (photo made by drone, arrow indicates first touchdown point)

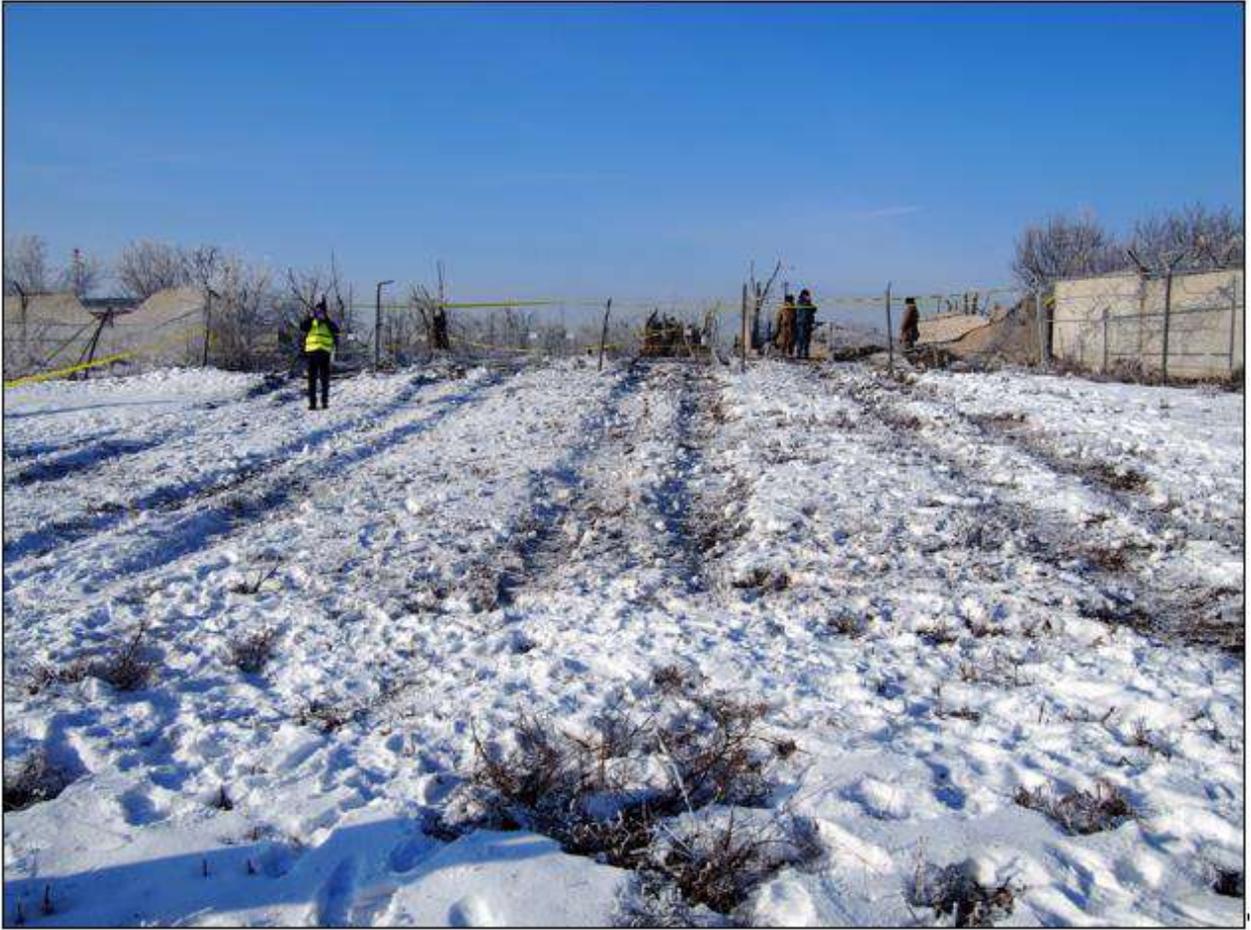
The character of the first touchdown traces indicates that the first aircraft terrain touchdown occurred at an insignificant vertical speed and almost without any bank angle. The aircraft heading at the beginning was very close to the landing heading of 255° . At the area where the aircraft was moving on the ground surface, no marks of the nose landing gear wheels have been found, which indicates that the aircraft was having a positive pitch angle at the touchdown. The aircraft movement after the first touchdown was straightforward (Figure 27).

Figure 27. Main landing gear wheel traces at first touchdown place

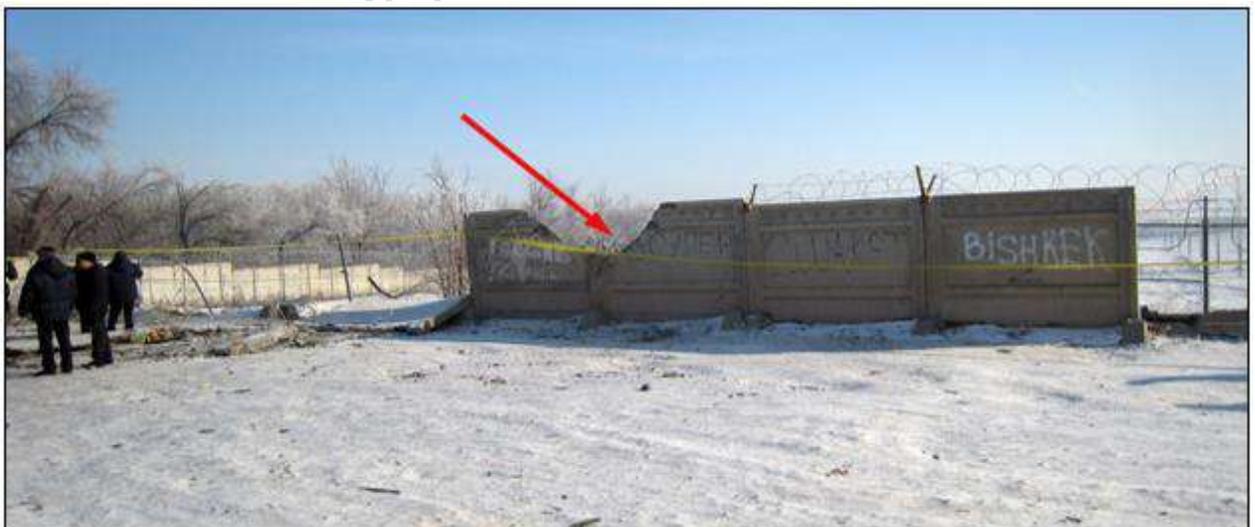
After 20 m of movement along the ground surface, the aircraft impacted the concrete aerodrome barrier and destroyed it (Figure 28). Judging by the marks on the area, after the impact with the concrete barrier, the aircraft lifted off the ground surface for a short period of time.

Figure 28. Trace of LH wing engine impact with aerodrome barriers (indicated by arrow), view taken in direction opposite aircraft movement

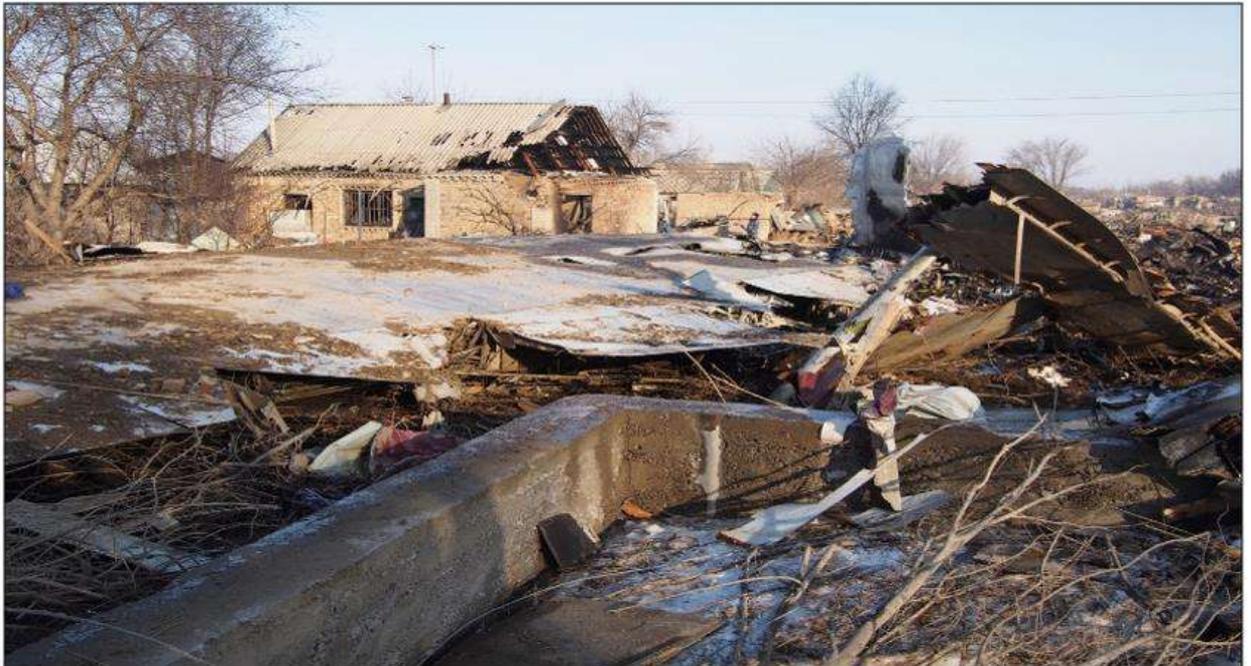
The aircraft movement stopped completely ≈ 60 m away from the cockpit separation place. The tail section of the aircraft (Figure 32) and a big fragment of the LH wing with the traces of fire (Figure 33) have been found ≈ 470 m away from the place of the first terrain touchdown.

Figure 33. LH wing at accident site
