Erratic airspeed indications, Boeing 787-8, VH-VKE

450 km north of Darwin, Northern Territory | 21 December 2015

ATSB Transport Safety Report
Aviation Occurrence Investigation
AO-2015-149
Final – 14 June 2017

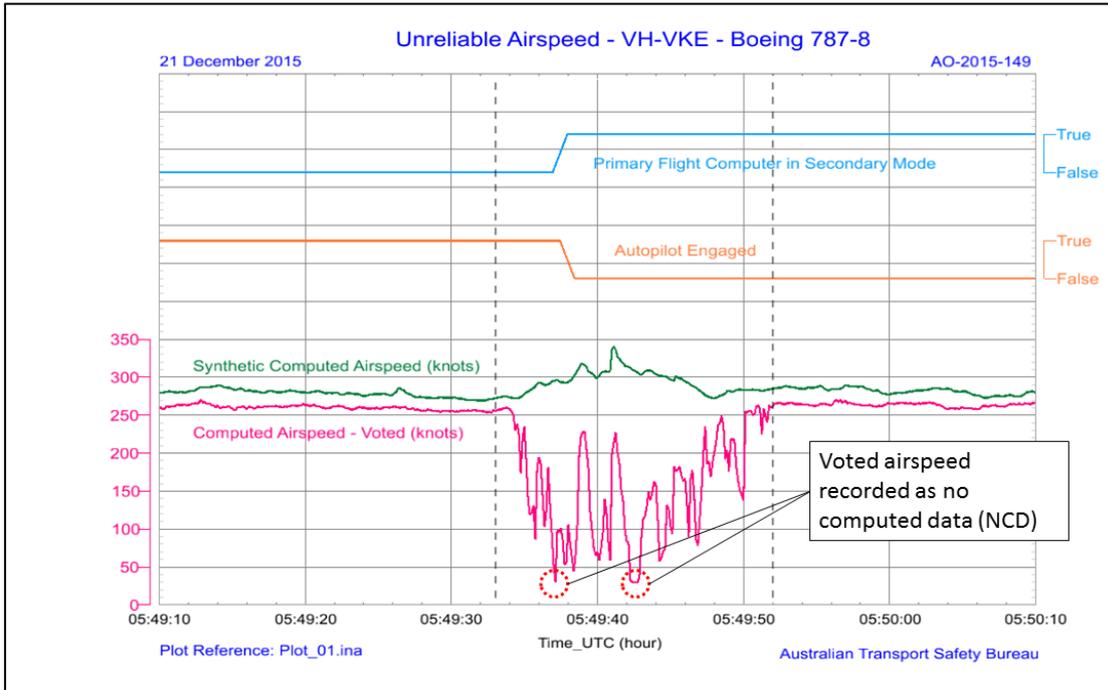
Figure 1: Graphical representation of flight data

Flight data from the occurrence shows that the voted airspeed value became erratic for approximately 17 seconds. The voted airspeed values deviated significantly below the independent AOA speed calculated by the aircraft flight computer. As indicated in Figure 1, the voted airspeed was NCD for more than 0.1 seconds twice throughout the event.

This figure illustrates the discrepancy between the recorded values of voted airspeed and synthetic AOA speed. Within 5 seconds of the diverging values the autopilot and flight computer mode reversion had occurred. The airspeed disagreement lasted for a total of around 17 seconds.

A drop in recorded airspeed to, or below, a threshold level is referred to as a No Computed Data (NCD) state. Throughout the recorded airspeed fluctuations, there were two occasions where the value of voted airspeed went NCD for a sufficient time to revert the flight control system to secondary mode.

Boeing has taken action to revise the software in the flight control computer related to the secondary mode reversion. This revision has increased the time required in an NCD state to revert to secondary mode.
