Near collision involving Pilatus BN2, VH-IOA, and Bombardier DHC-8, VH-ZZJ

Horn Island Airport, Queensland, 12 October 2016

ATSB Transport Safety Report
Aviation Occurrence Investigation
AO-2016-137
Final – 9 February 2017

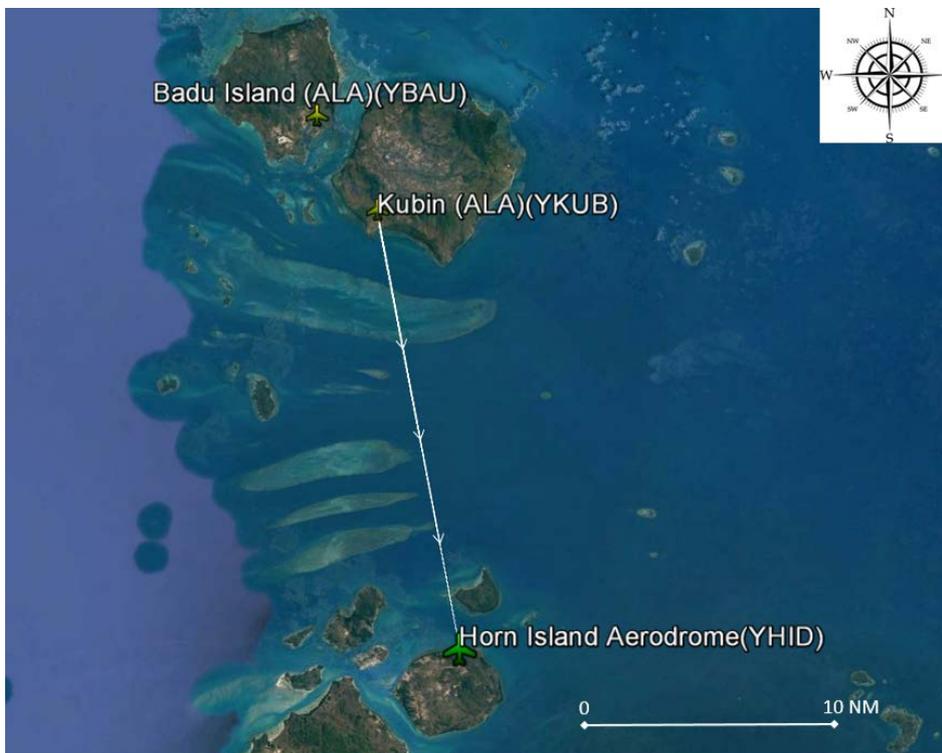
Figure 1: IOA track from Kubin to Horn Island

On 12 October 2016, at about 1330 Eastern Standard Time (EST), a Pilatus BN2A-20, registered VH-IOA (IOA), departed from Kubin on a charter flight to Horn Island, Queensland (Figure 1). On board IOA were one pilot and two passengers. At about the same time, a Bombardier DHC-8-202, registered VH-ZZJ (ZZJ), conducting surveillance operations, was preparing for departure from Horn Island. On board ZZJ were two pilots and three crewmembers.

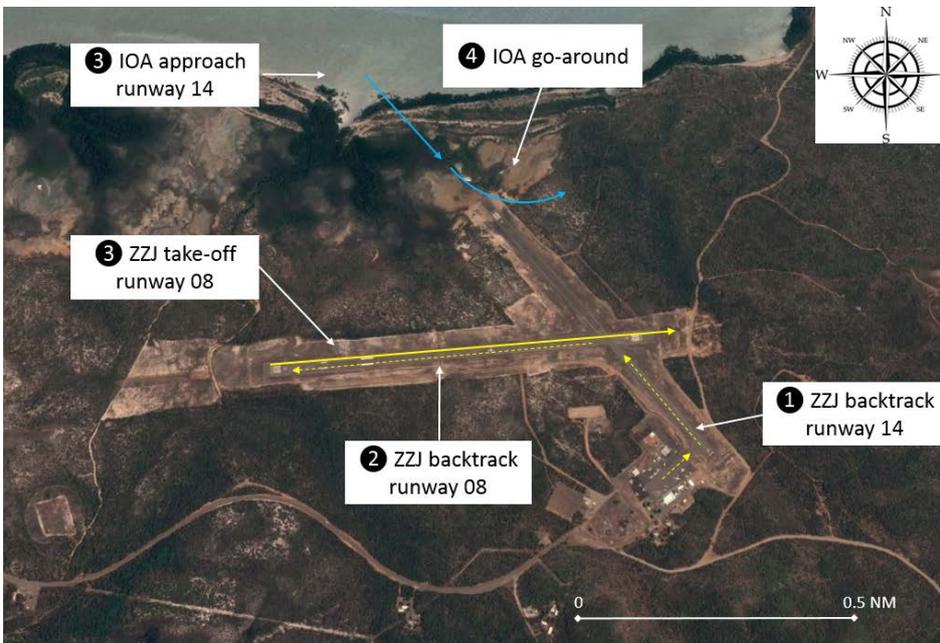
Figure 2: Sequence of movements

The first officer on board ZZJ made a broadcast they were entering and backtracking runway 14 at Horn Island for a departure from runway 08 (position 1 on Figure 2). Just prior to the intersection of the two runways, ZZJ held short of runway 08 to allow the training aircraft to complete a touch-and-go landing on runway 08. The first officer then broadcast ZZJ was entering and backtracking runway 08. While backtracking runway 08 (position 2 on Figure 2), ZZJ's flight crew heard a broadcast that WOT was joining the circuit as number 2 to the training aircraft and then observed a third aircraft appear on their traffic collision avoidance system (TCAS) display. The captain of ZZJ asked the first officer to contact the third unknown aircraft.

By the time the pilot flying IOA heard ZZJ broadcast 'rolling for departure from runway 08', IOA was at about 400 ft on final approach for runway 14. The pilot of IOA reported that at about 300 ft, they broadcast 'hold short' to ZZJ. However, the captain of ZZJ reported they heard the pilot of IOA say 'land and hold short of runway 08'.² Consequently, ZZJ continued their take-off. As IOA approached 100–150 ft on final approach, ZZJ had not crossed the runway intersection and the pilot flying IOA conducted a left climbing turn away from the runways to join the downwind circuit leg for runway 08. The captain of ZZJ looked out their left window when they were in the initial climb overhead the threshold of runway 26 and saw IOA turning through east at about the same level (position 4 on Figure 2). IOA then joined the circuit for runway 08 and landed after WOT without further incident.
