**AIRCRAFT SERIOUS INCIDENT
INVESTIGATION REPORT**

**JAPAN AIRLINES CO., LTD.
J A 8 3 6 4
NEW JAPAN AVIATION CO., LTD.
J A 8 0 C T**

AIR PROXIMITY

ON FINAL APPROACH COURSE ABOUT 0.8NM FROM
THE THRESHOLD OF RUNWAY 34 AT KAGOSHIMA AIRPORT
AT AROUND 16:54 JST, OCTOBER 10, 2015

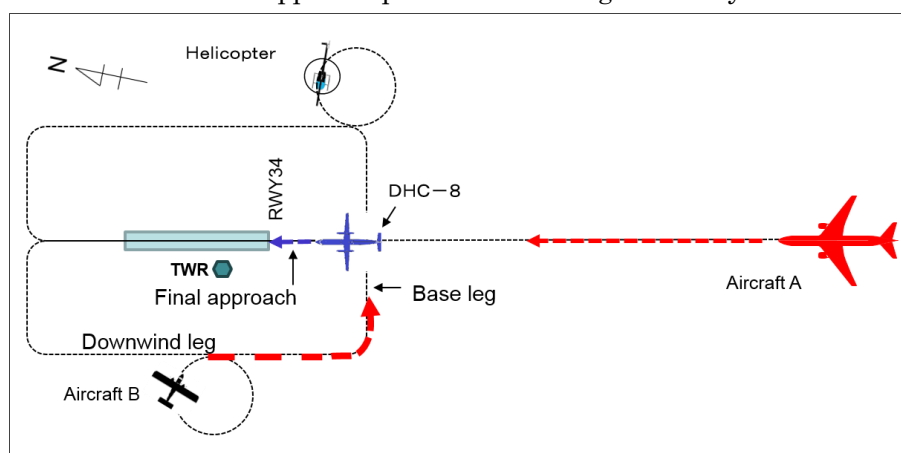
Hereafter, Aircraft A was permitted by the Tower to land on Runway 34, and was also informed at the same time that it was in second position in the landing sequence. At 16:50:52, Controller A instructed Aircraft B, which was holding on the downwind leg, as “Previous traffic 9 nm on final. Report traffic in sight.” At 16:51:34, the PIC of Aircraft B sighted a DHC-8 flying on the final approach path about 1 nm from the threshold of Runway 34, assumed it to be the relevant preceding aircraft, and reported “Final traffic in sight.” Hearing this, Controller A judged that Aircraft B had sighted Aircraft A, and instructed it to “Follow the traffic.” The PIC of Aircraft B repeated this instruction and headed to the final approach path without being noticed by Aircraft A.

Image of positional relationship when Aircraft B reported “Final Traffic Insight” to the Tower

At around this time, another Controller who was in the control tower (hereinafter referred to as “Controller B”) noticed Aircraft B flying on the base leg just before entering the final approach path, and asked, “Will it enter in front (of Aircraft A)?” On hearing this, Controller A turned his attention to a helicopter (Robinson R22) to which he was planning to give the instruction for approach after Aircraft B, since Aircraft A appeared to be ahead of Aircraft B and he naturally thought that Aircraft B was following Aircraft A. When Controller A again turned his attention to Aircraft B, he noticed that Aircraft B had entered the final approach, and intended to give Aircraft B the instruction to go around. At this time, he received a report from Aircraft A that there was traffic ahead. The Tower then instructed Aircraft B to break to the west and to maintain the altitude.
