FINAL INVESTIGATION REPORT ON
ACCIDENT TO SPICEJET BOEING B737-800
AIRCRAFT VT-SGK AT SURAT ON
06.11.2014

AIRCRAFT ACCIDENT INVESTIGATION BUREAU
MINISTRY OF CIVIL AVIATION
NEW DELHI

FINAL INVESTIGATION REPORT ON ACCIDENT TO SPICEJET BOEING B737-800
AIRCRAFT VT-SGK AT SURAT ON 06.11.2014

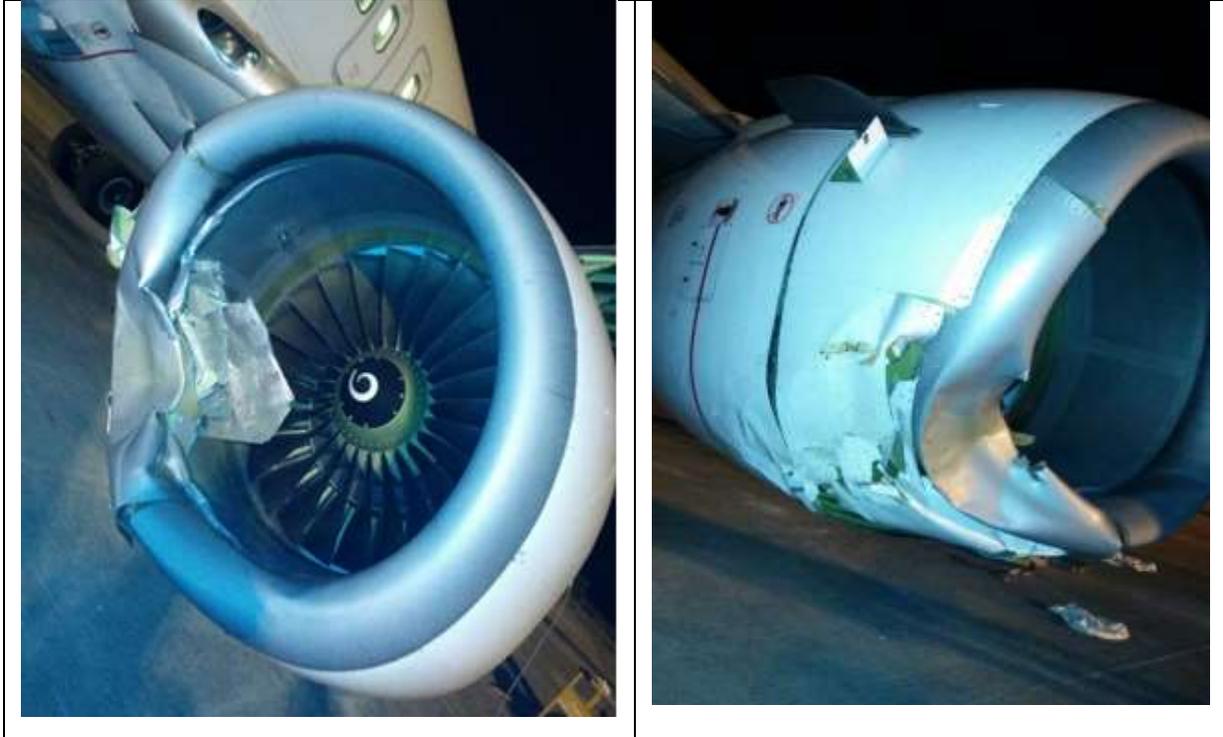
Damage to LH Engine Nose Inlet Cowl near 7 O' Clock Location

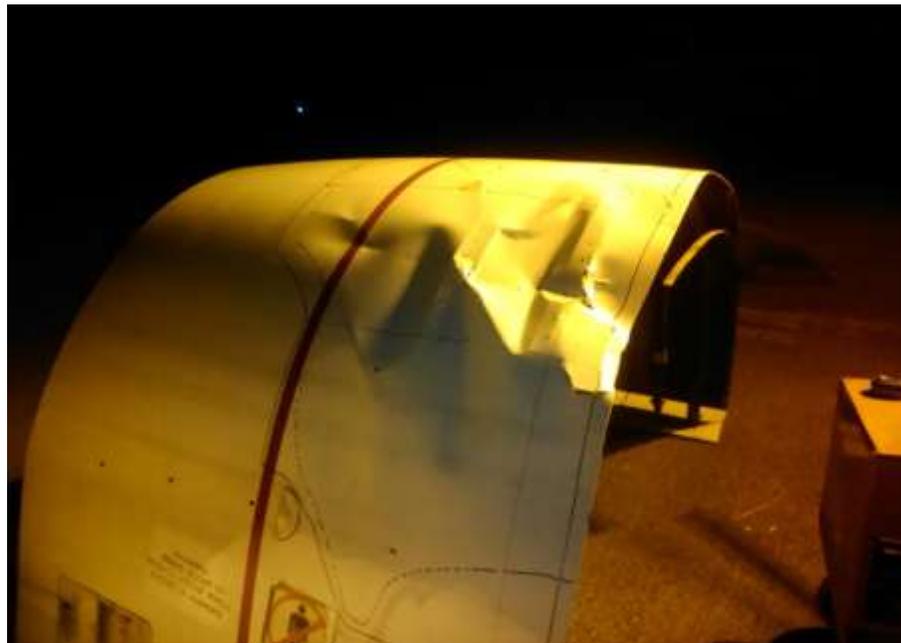
Dents on Fan cowl at around 9 O' Clock position

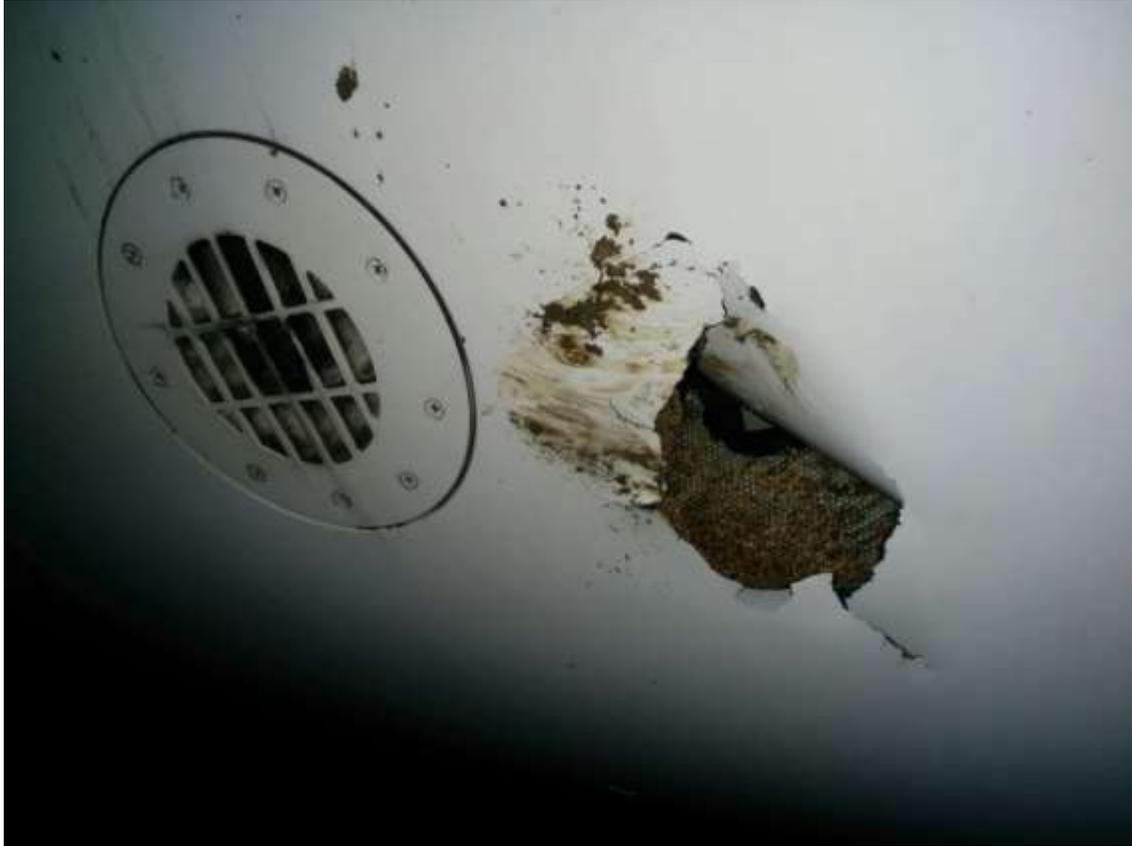
Big Puncture on Inboard Thrust Reverser Sleeve of LH Engine

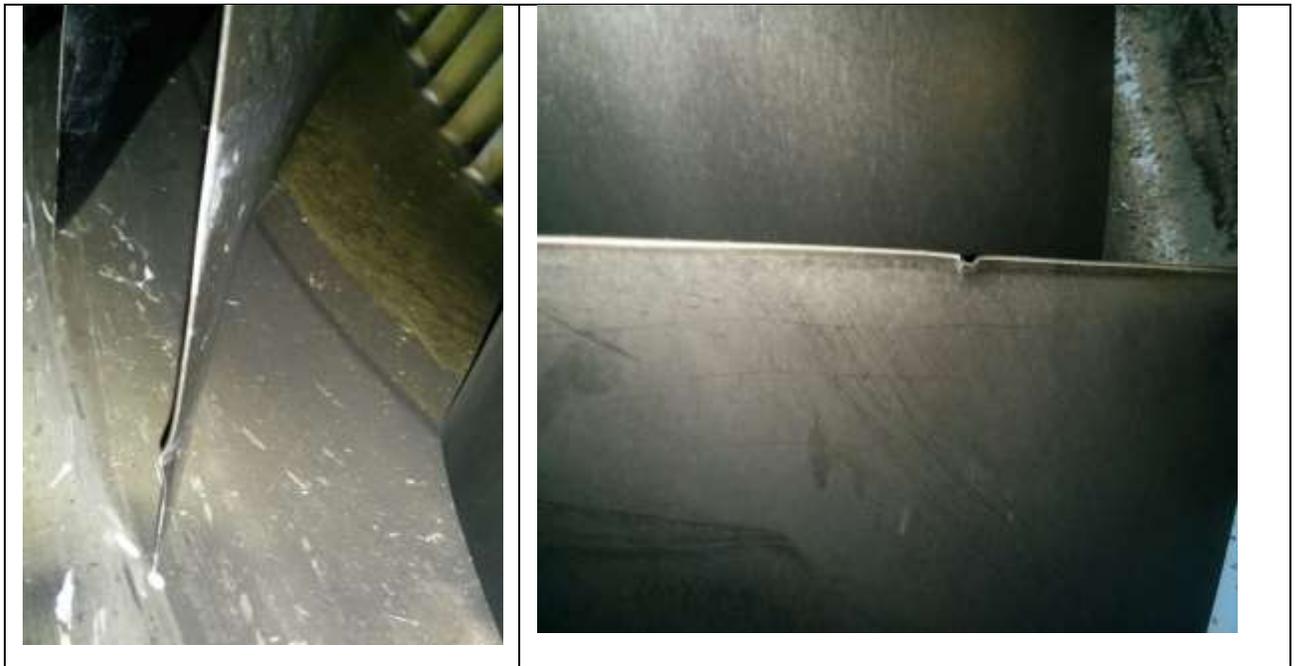
Fan Blades (9) had nicks, slight bends, chipping and FOD damage

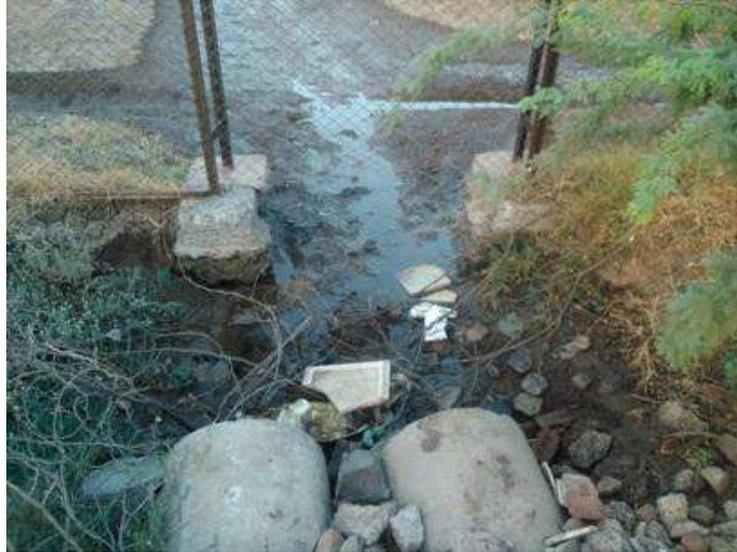
- a) In west of runway towards Dumas side, 05 Chain Links of the fencing were found damaged, (Each Being 2M X 2.5 M) leading to big gaps.

Gap between Chain Link fencing and Ground

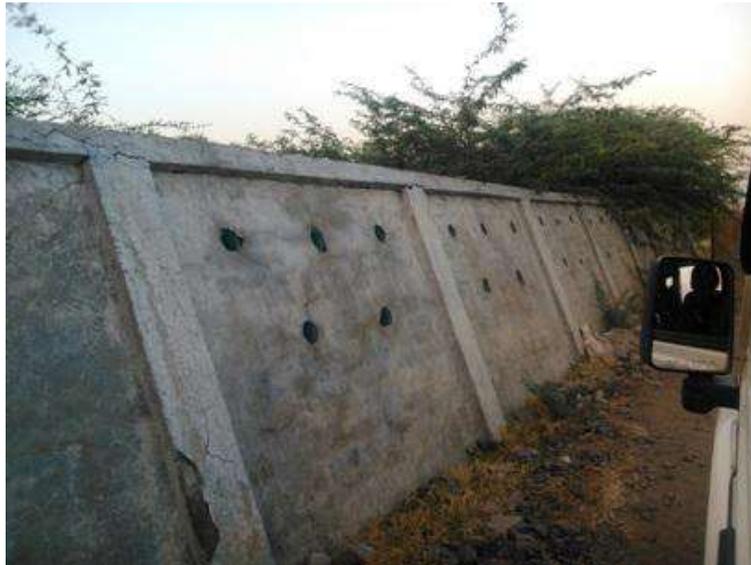
- b) Columns of 110 meters brick wall in SW end of runway were found tilted. Some of these were found in much depleted condition.

Tilted and damaged Wall

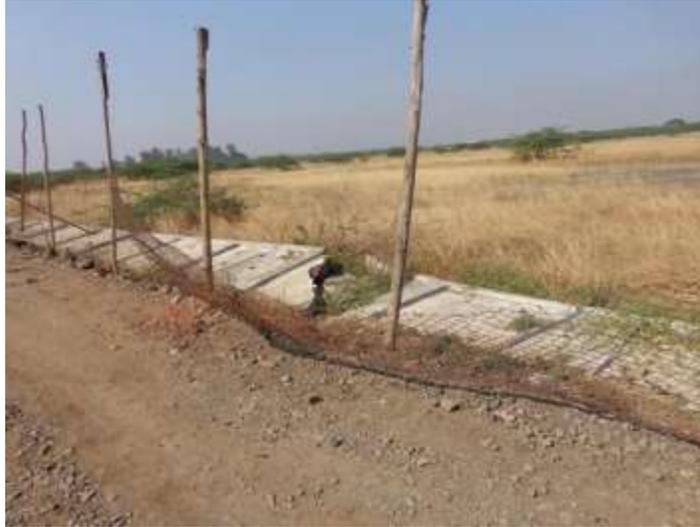
- c) Towards Southwest of the runway, chain link fence supported by wooden ballies were observed for a distance of approx. 172 M. Approx. 36 of these were found either damaged or with big gaps from Ground.

Chain Link fencing with wooden ballies without solid base

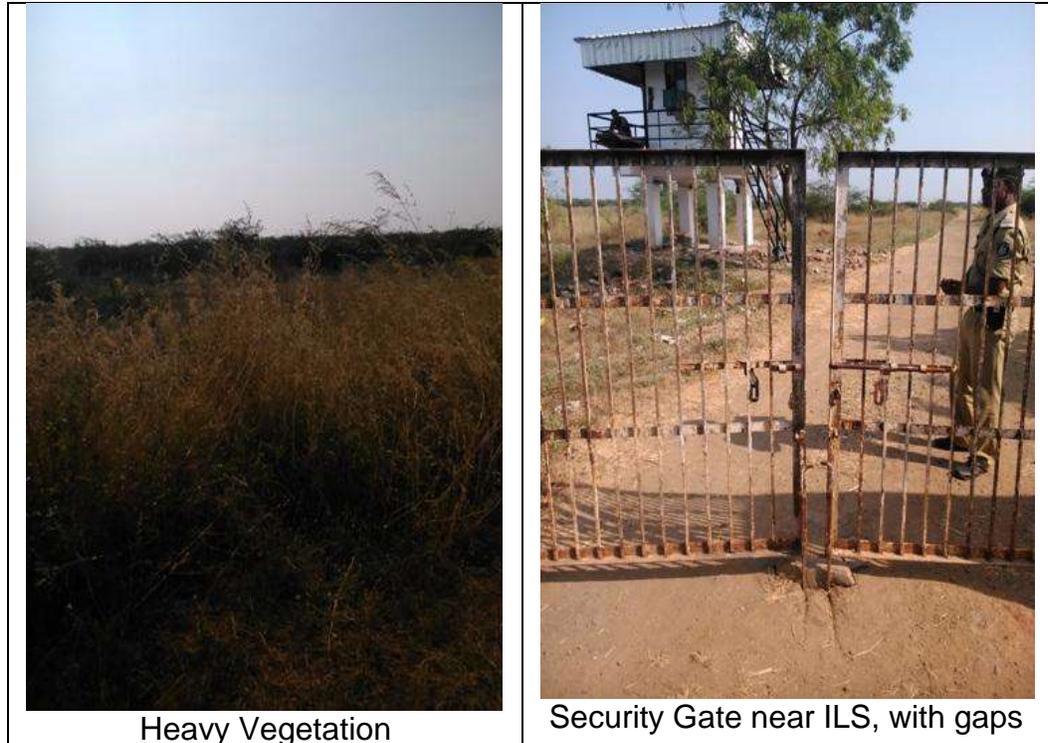
- a) At the time of inspection heavy vegetation throughout the operational area was found approx of 3 - 4 Ft height. This acted as a camouflage / shelter for wild animals and birds. Second Buffalo which was reported by CNS Jeep after the accident was again spotted near the runway on 07.11.2014 a day after the accident.
- b) Beyond Localizer Antenna towards the West of runway low lying area with standing water bodies. Also towards South of runway water bodies patches found which is an attractant for Bird Hazard.
- c) Total six number of security Gates are there. During inspection Security Gate near Localizer was observed with gaps from Ground large enough for Dogs and small Wildlife to enter the Operational area.
- d) On 08.11.2014, the Aerodrome Operator started with the process of getting the vegetation mowed.
