Transportation Safety Board
of Canada

AVIATION OCCURRENCE REPORT

A98H0002

LOSS OF SEPARATION

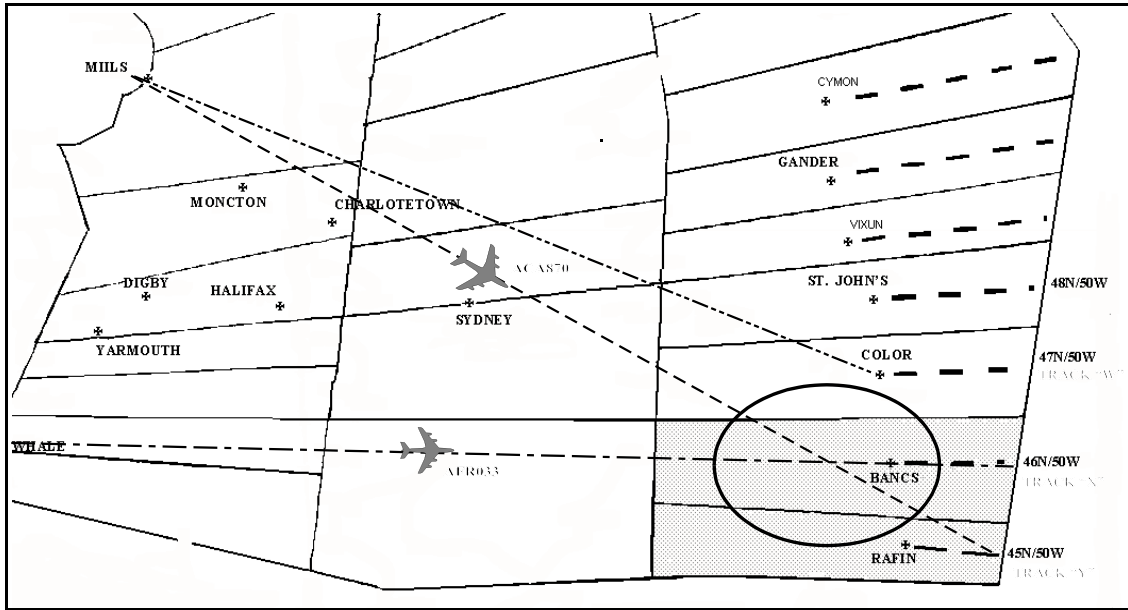
The two aircraft were being controlled by the Gander Area Control Centre (ACC) high domestic controllers responsible for the combined sector BANCS and south, the two south-easternmost sectors of the Gander domestic airspace, in which the coast-out points BANCS and RAFIN are located (see Appendix A, Figure 1). ACA870, with 265 passengers and a crew of 14, had been issued an amended oceanic clearance by clearance delivery prior to handoff to the BANCS radar controller. ACA870 contacted the radar controller at 0151:15², outside the geographic boundaries of the BANCS sector, and crossed the sector boundary at 0207. Position estimate information was provided by ACA870 to the radar controller indicating that the aircraft was level at FL 370 and estimating latitude 45°N longitude 50°W at 0227.

The original flight planned routing for ACA870 was from North American route N49A to MIILS direct to COLOR and then to latitude 47°N longitude 50°W (Oceanic Track "W") (see Appendix A, Figure 1). The original flight progress strip, designated D1 for ACA870, was posted under the COLOR header in the flight progress board of the appropriate sector. When the oceanic clearance was changed necessitating a reroute, the D1 strip was amended by the data controller in the COLOR sector by stroking out the fix identifier COL (COLOR) and writing in the new fix identifier, RFN (RAFIN), which is the fix associated with latitude 45°N longitude 50°W. In accordance with the Gander ACC Operations Manual, article 4.1.6.2, the strip was then passed to the affected sector, BANCS. Subsequently, a new oceanic clearance strip was printed at 0138 together with an amended sector strip designated D2 and passed to the BANCS sector for posting under the RAFIN header. There was no traffic on the route from RAFIN to latitude 45°N longitude 50°W at FL 370 which conflicted with ACA870.

Figure 1 - Routes of ACA870 and AFR033. BANCS and south sector shaded.

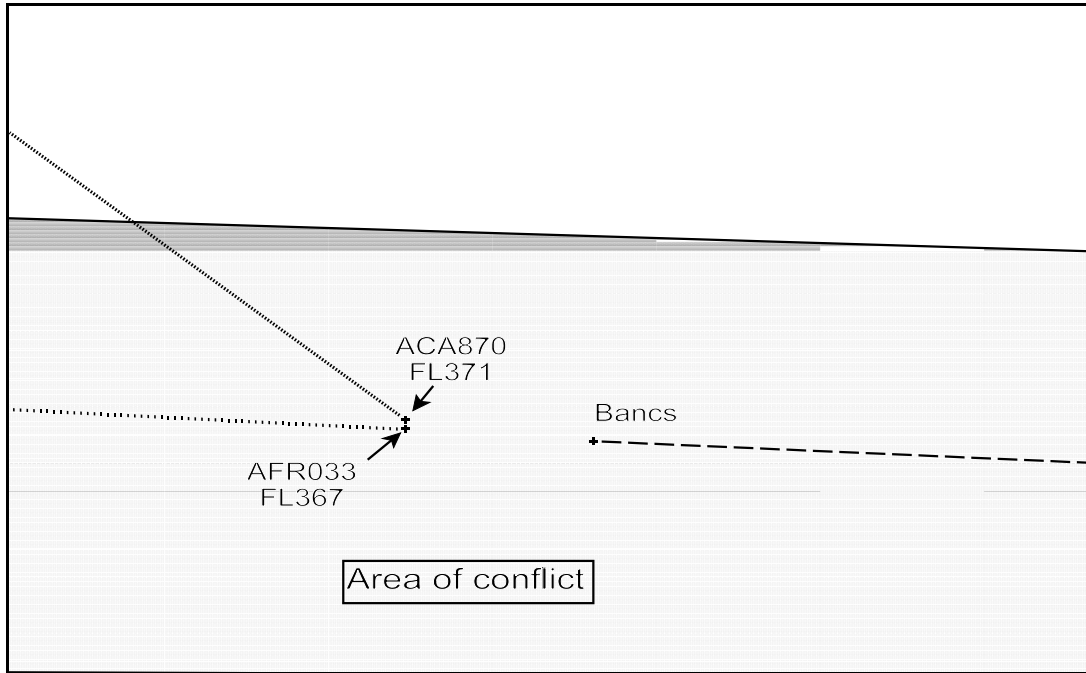
Immediately thereafter, AFR033 declared Pan, Pan, Pan and advised the controller that the aircraft was descending as a result of a TCAS RA (see Appendix A, Figure 2). AFR033 received an initial TCAS traffic advisory (TA) at 0211:34 and an RA to descend at 0212:47. Recorded radar data of the occurrence shows AFR033's altitude to have been 36,900 feet at 0212:49, 36,700 feet at 0212:54, 36,700 feet at 0212:59, and 36,400 feet at 0213:03. (Valid recorded radar data may differ from aircraft-reported altitude by plus or minus 200 feet.) Aircraft data provided by Air France show the altitude of AFR033 as 36,788 feet at 0212:59 with a downward velocity of 1,790 feet per minute, and 36,384 feet at 0213:30. The time between the onset of the RA and initiation of descent with the autopilot off was two seconds.

Figure 2 - Aircraft positions at 0212:54. Horizontal distance 1.9 nm, vertical distance 400 feet
