Incident Final Report

State File Number: I139201299MXAC
Type of Occurrence: Incident (RWY Excursion)
Date of Occurrence: April 18th 2013
Place of Occurrence: I.R.IRAN
Aircraft Type: A340-300
Registration: 9M-XAC
Operator: Air Asia

State File Number: I139201299MXAC
Type of occurrence: Incident (Runway Excursion)
Date of occurrence: April 18th 2013
Place of occurrence: on RWY 30L, Tabriz INTL Airport (OITT) Islamic republic of Iran
Aircraft Model: A340-300
Registration: 9M-XAC
Operator: Air Asia
Lessor: Saudi Arabian Airlines

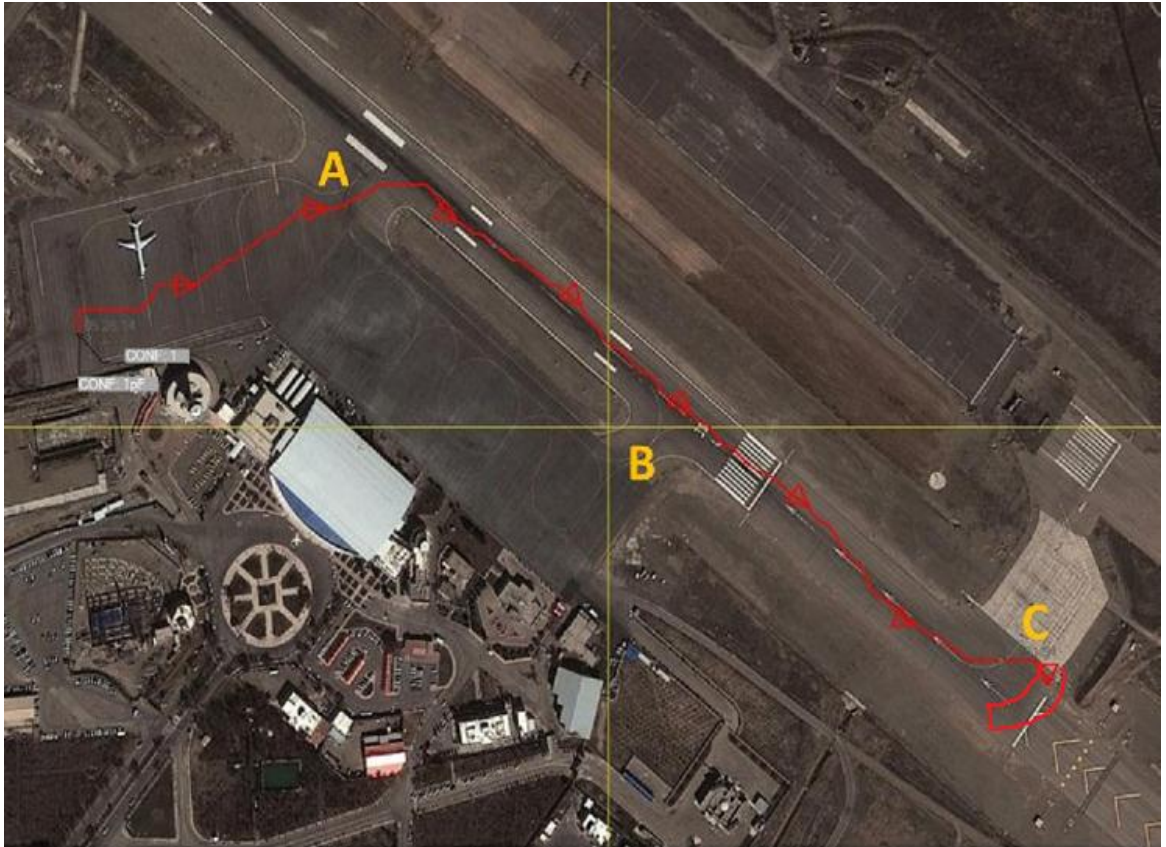
- e) DFDR approximate position plotting confirms accurate information from both pilots.

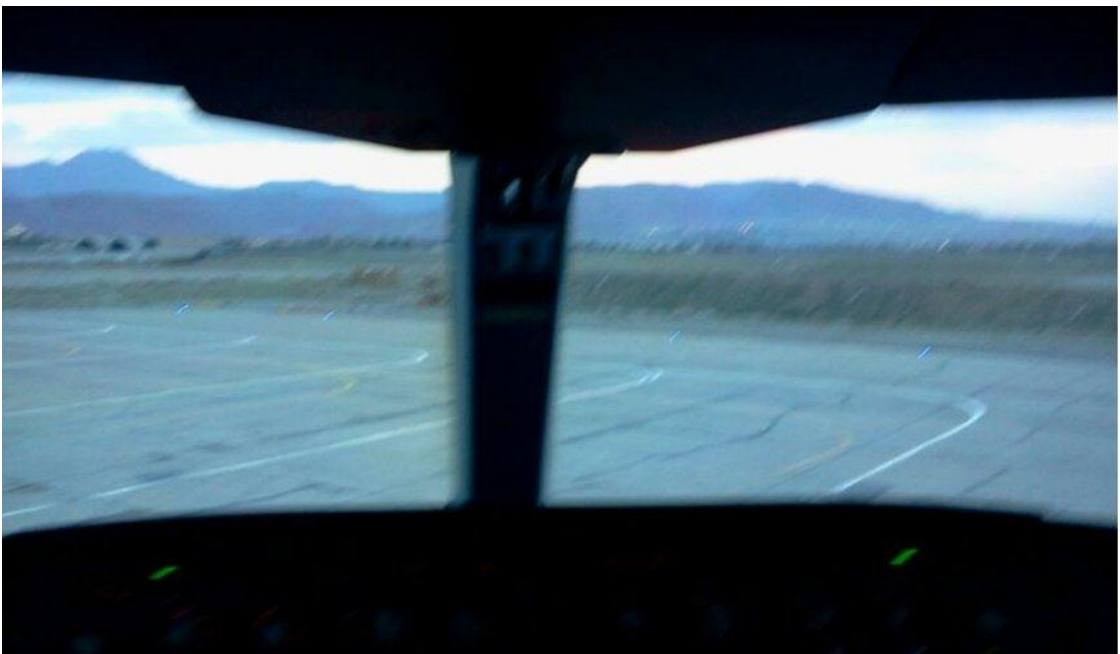
- f) Captain did not make much use of the additional space of taxiway “C”.

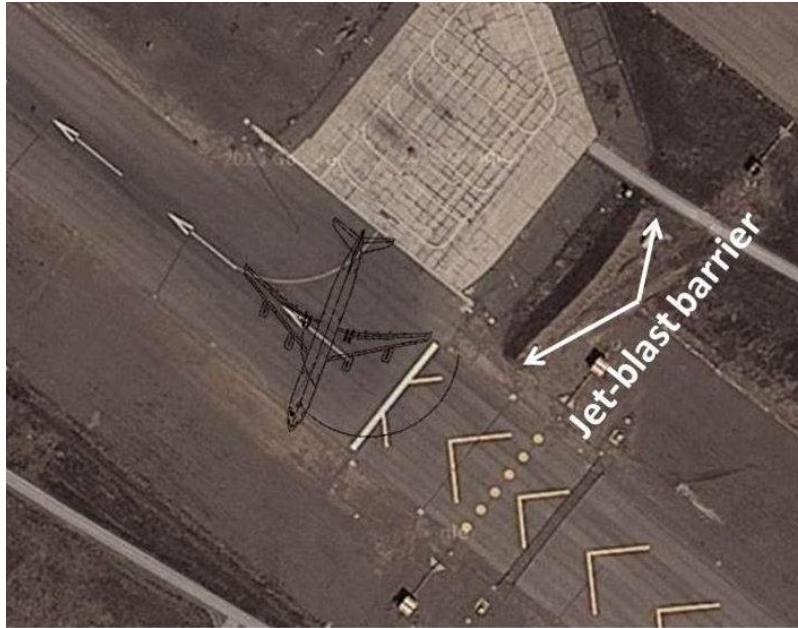
- i) Captain requested Marshaller aid to move Nose wheel of A/C to RWY margin to have enough width for the anti-clockwise turn
- j) During the anti-clockwise turn, the captain came to realize that the outer left engine (number 4) might not have sufficient clearance over the “Jet-blast barrier” at the south-east corner of the runway end.

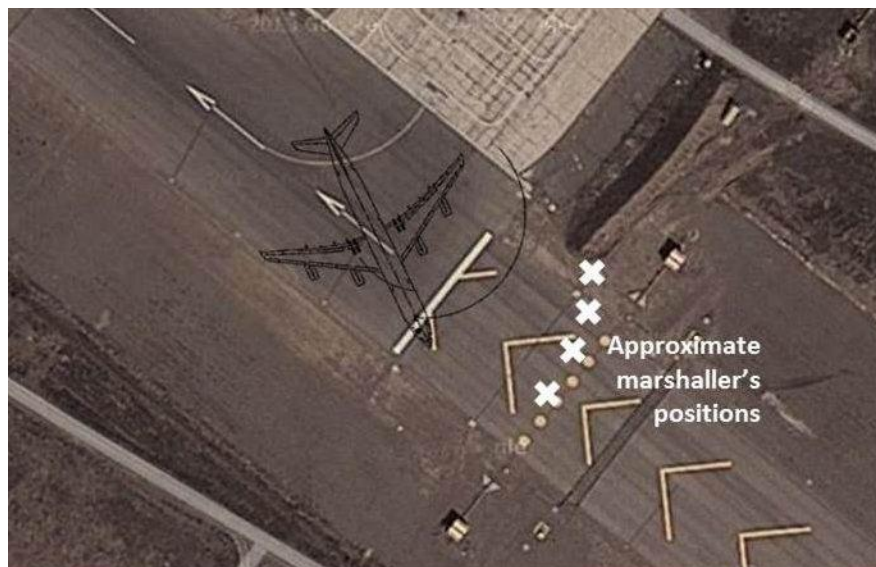
- k) Aircraft entered into “Pre-Threshold” Area (Chevron Marking).
- l) DFDR data divulges that the aircraft was skidding during the anti-clockwise turn. Substantial Left brake pedal input with high engine power settings (up to 55% N1) recorded at the speed of less than 3 knots.
- m) The captain had to make a slow turn to allow the Marshaller to “run along” so that they could keep visual contact with each other.

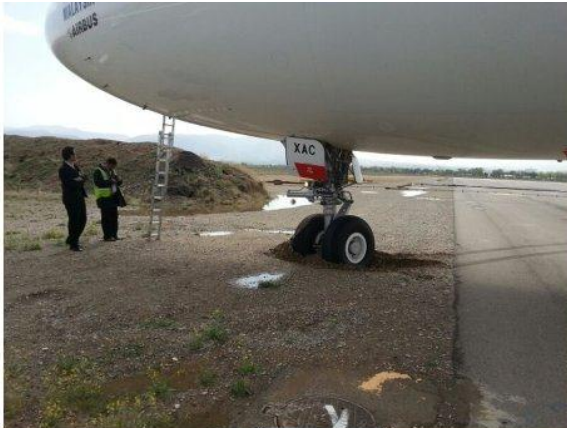
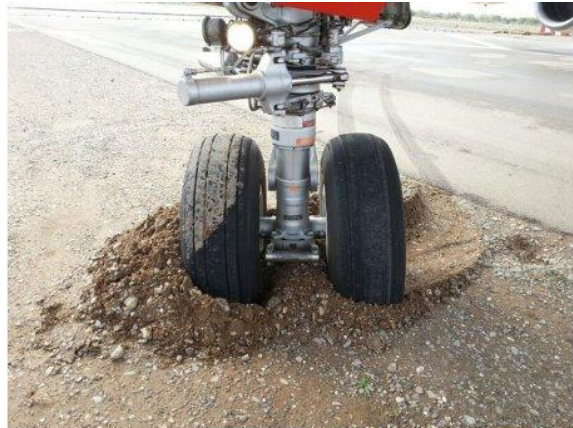
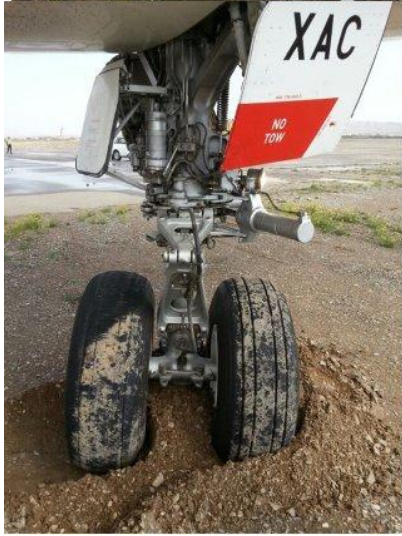
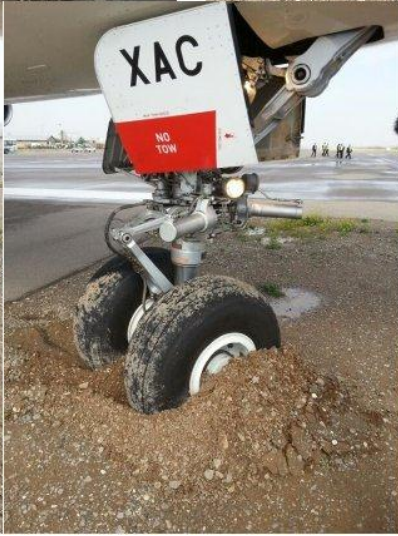
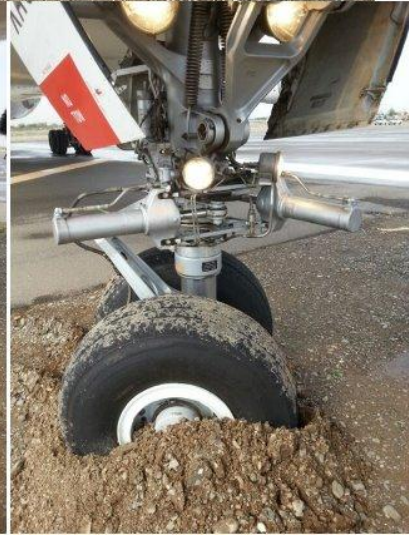
- o) The aircraft nose wheel was out of the hard surface and then landed on the soft ground.
- p) No tow bar was available for the A340 aircraft in this airfield for use. After ATC coordinated, a pull operation towing system was available.
