Incident Final Report

State File Number: I1394022EPMNI
Type of Occurrence: Incident
Date of Occurrence: 17 May 2015
Place of Occurrence: Republic of Armenia
Aircraft Type: A300B4-600
Registration: EP-MNI
Operator: MahanAir
Date of Issue: 15 July 2016

State File Number: I13940227EPMNI
Type of occurrence: Incident
Date of occurrence: 17 May 2015
Place of occurrence: "Zvartnots" International Airport (UDYZ) .Republic of Armenia
Aircraft Model: A-300B4-603
Registration: EP-MNI
Operator: Mahan Air

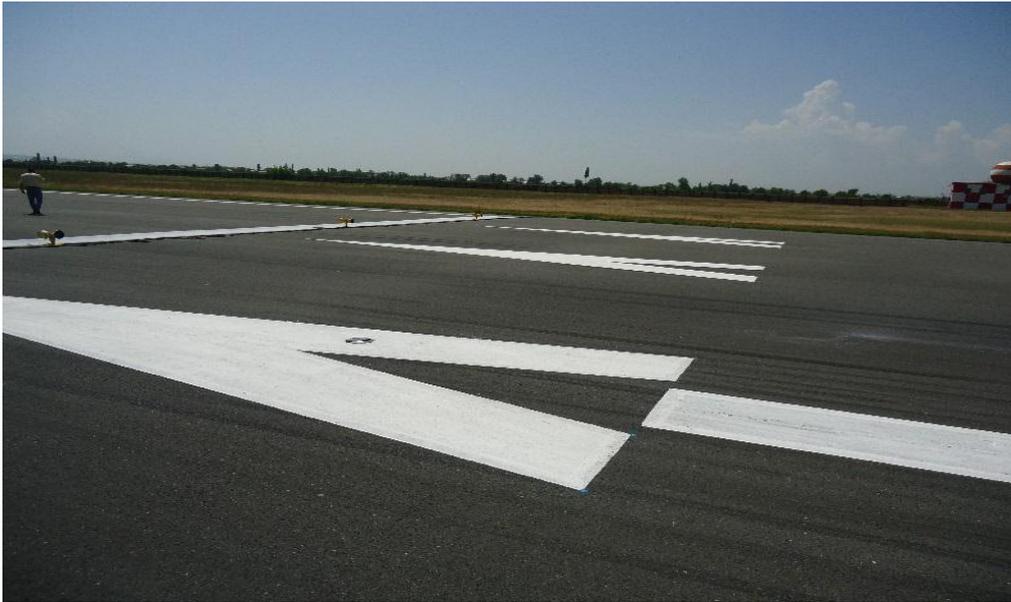
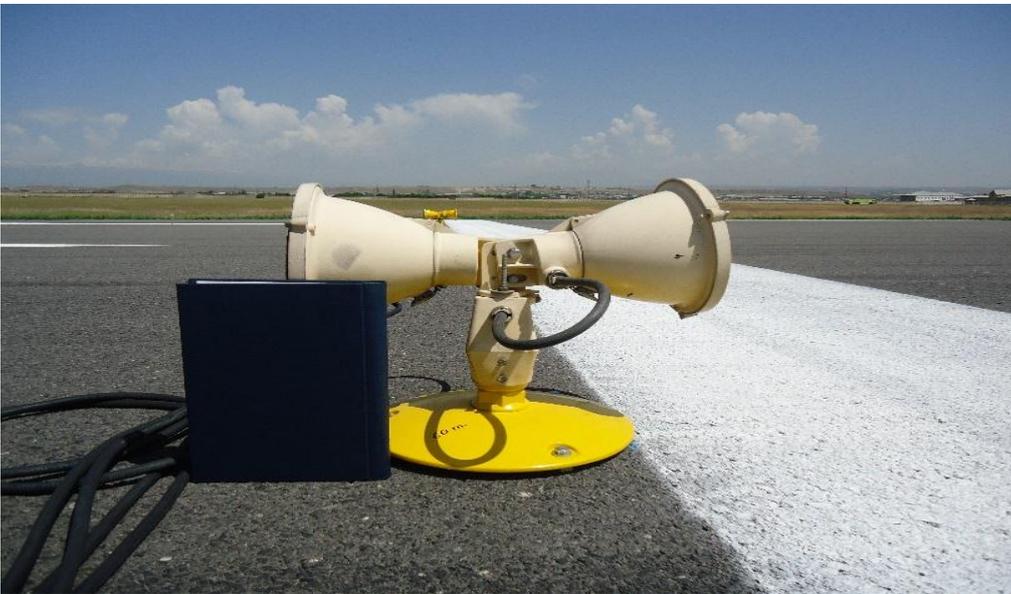
There was a lined threshold sign marking with elevated lights on the displaced threshold with ended white chevrons on beginning of RWY 09.

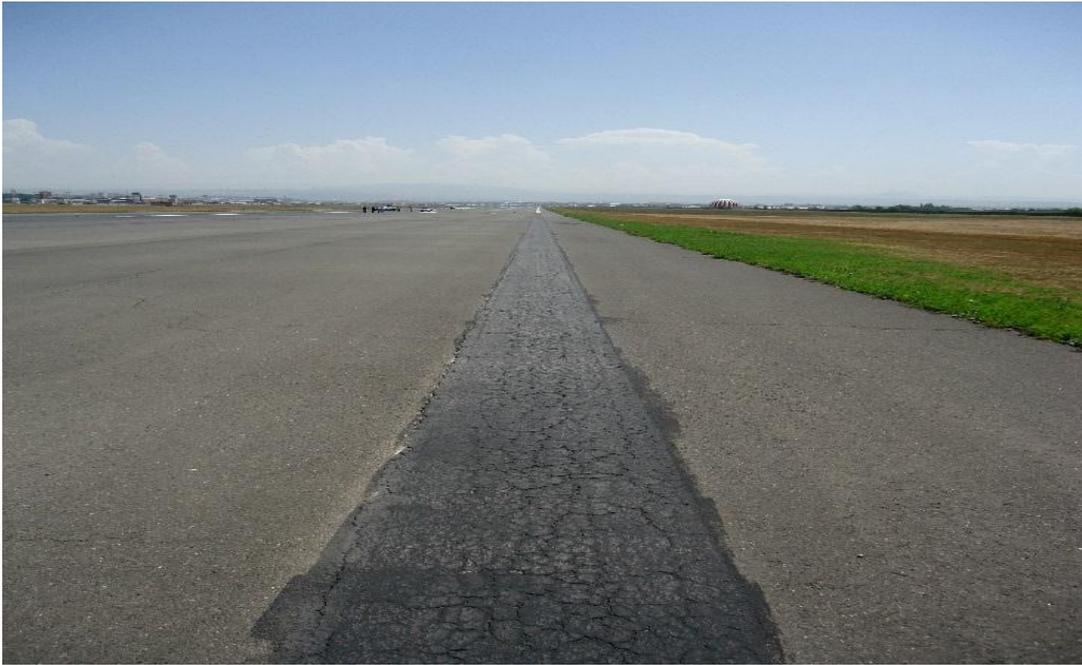
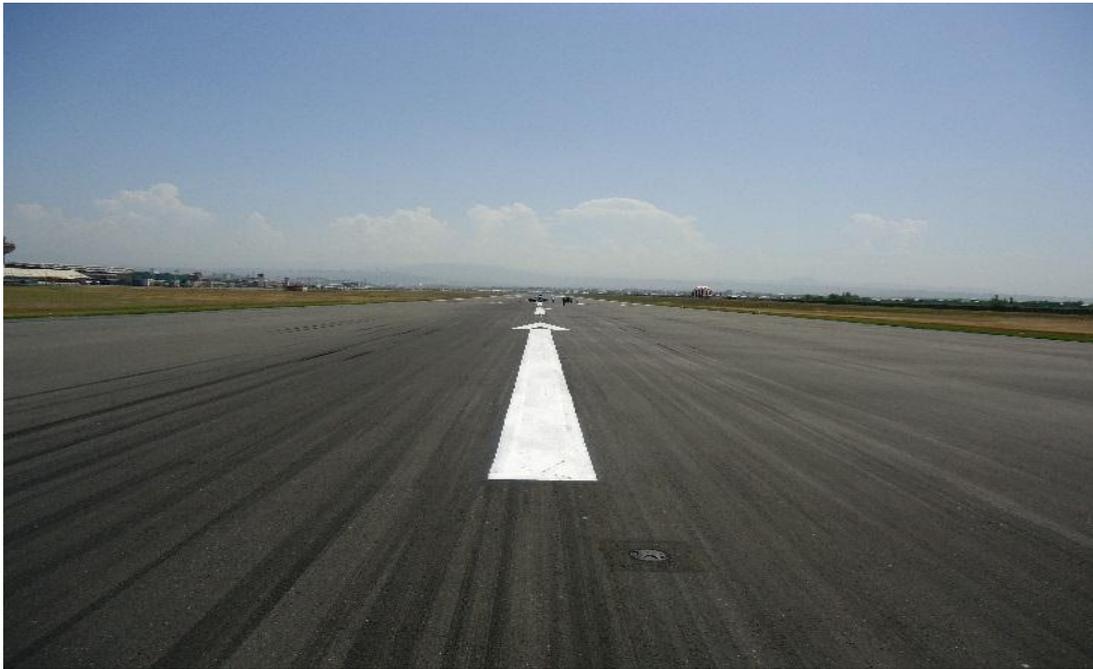
On the beginning of the displaced area, there was a row of elevated lights which used as approach lights. In this area, the edge line of RWY before displaced threshold was covered by black color. While displacing of this runway, closed marking signs in displaced area could help pilot to distinguish more about displaced area.

Although considering those mentioned matters for the real root cause of the incident; there were not enough closed marking signs before threshold lights to prevent landing in this unauthorized displaced area according standard criteria in Annex14. It was recommended in annex 14 that:

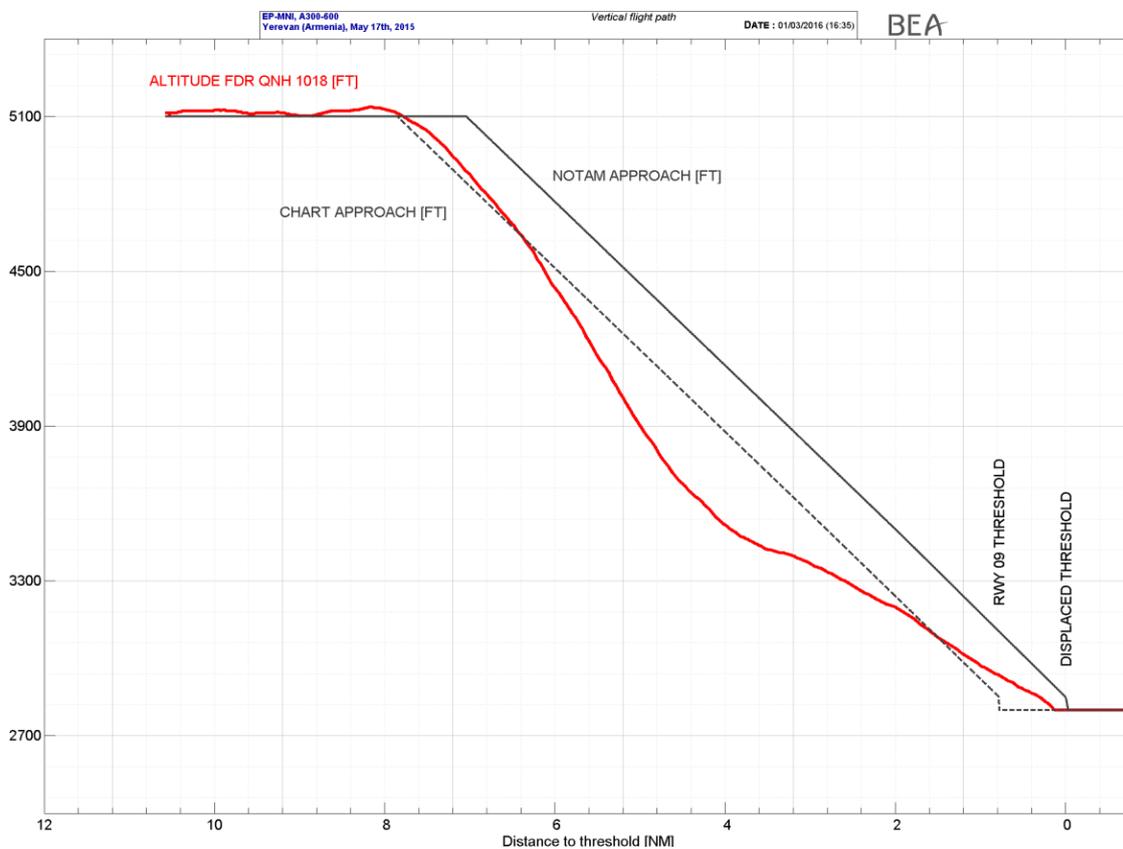
Distance to the displaced threshold was computed from positions recorded in the FDR.

Positions were corrected so that the aircraft Main L/G position at the time of touch down is before displaced threshold.

A vertical flight path was computed from recorded pressure altitude and distance to the displaced threshold. On the following plot, FDR altitude values were corrected with QNH 1018 and levelled to 2800 ft when recorded below 2800 ft.

The flight path is compared to the approach path described in the NOTAM and the approach path of the approach chart (dashed line).

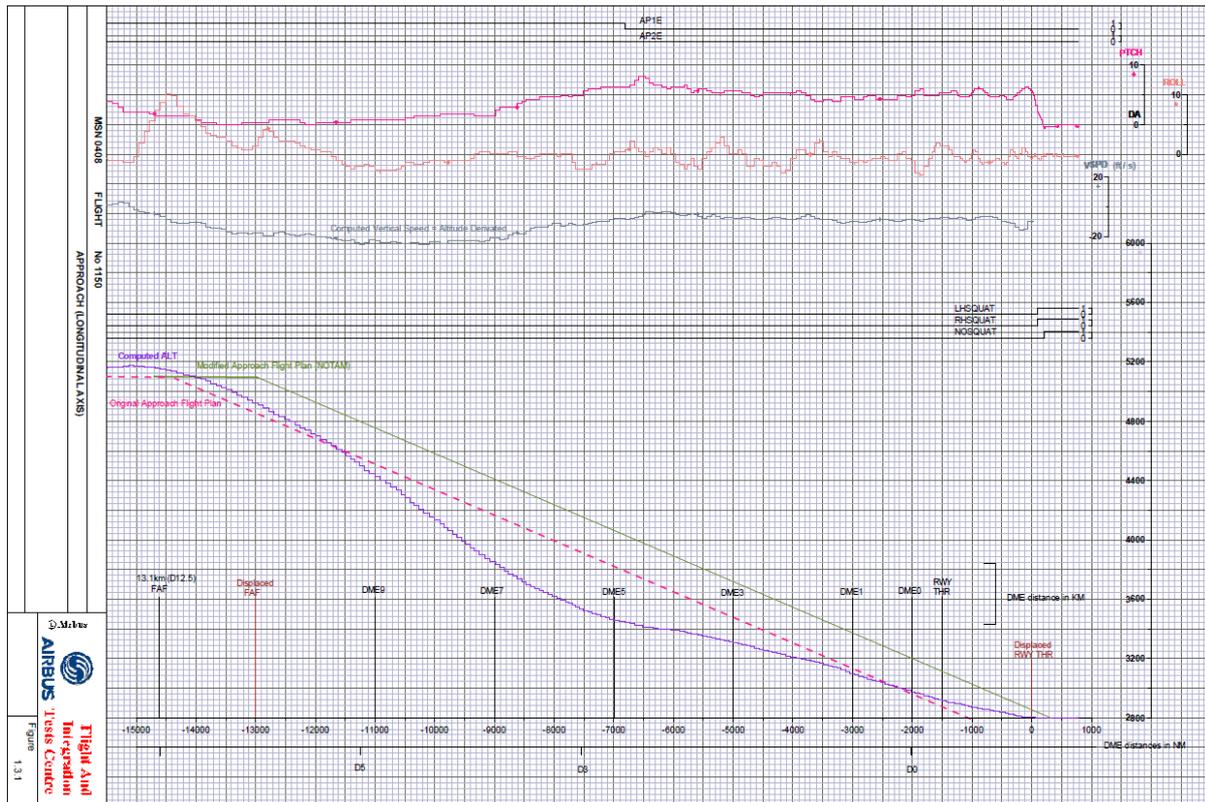
The flight safety office of the Airbus Co. also performed a vertical flight path computation which has similar results.
