Accident Investigation Final Report

State File Number: A13940723EPMNE
Type of Occurrence: Accident
Date of Occurrence: Oct. 15th 2015
Place of Occurrence: Near Mehrabad Airport
Aircraft Type: B747-300
Registration: EP-MNE
Operator: Mahan Air

Final Report

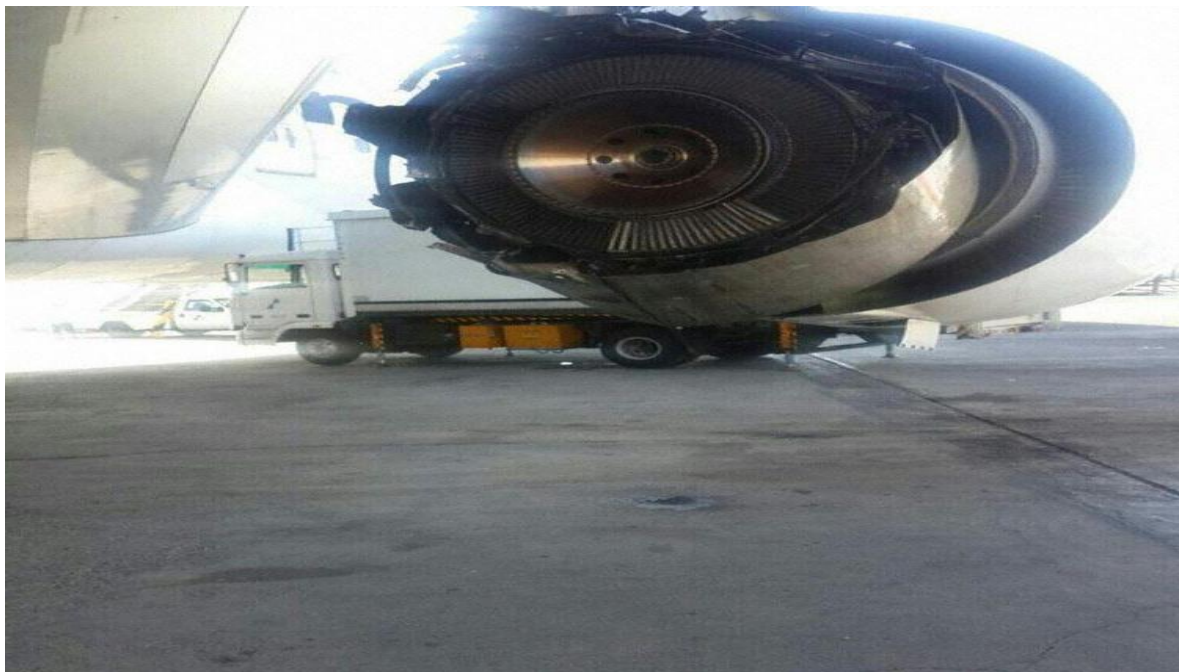
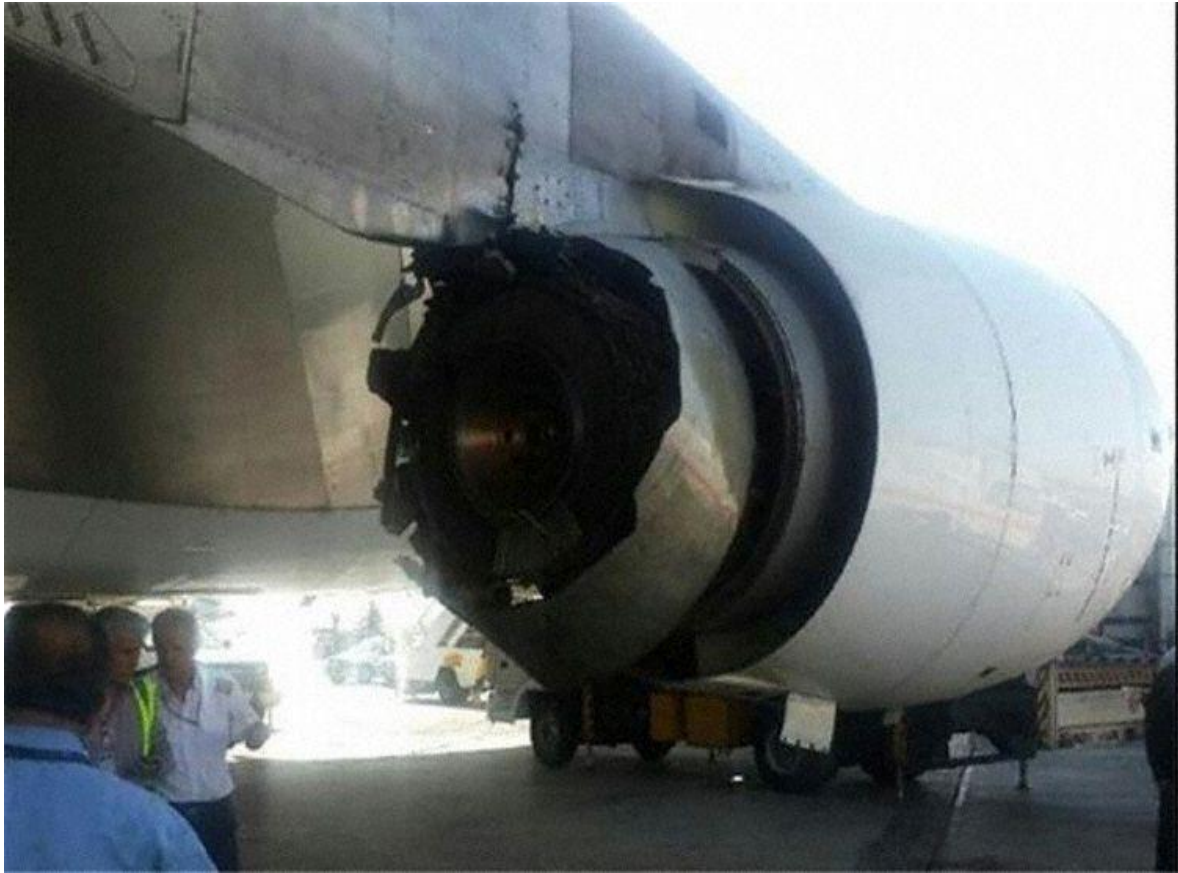
Inboard Damaged Engine

The main damage on ENG#3 " REAR ,LOW PRESSURE TURBINE " was completely detached and as a result the engine exhaust section was detached

Some of ENG#3 detached parts hitting ENG#4 and related fan blades and cowling of the engine were damaged.

Some of ENG#3 detached parts hitting the aircraft fuselage and caused some significant damage and some hydraulic lines were damaged.

The outer skin of right hand wing inboard fuel tank was damaged /raptured by thrown rotary parts of ENG#3 and consequently caused the leakage of the most fuel.

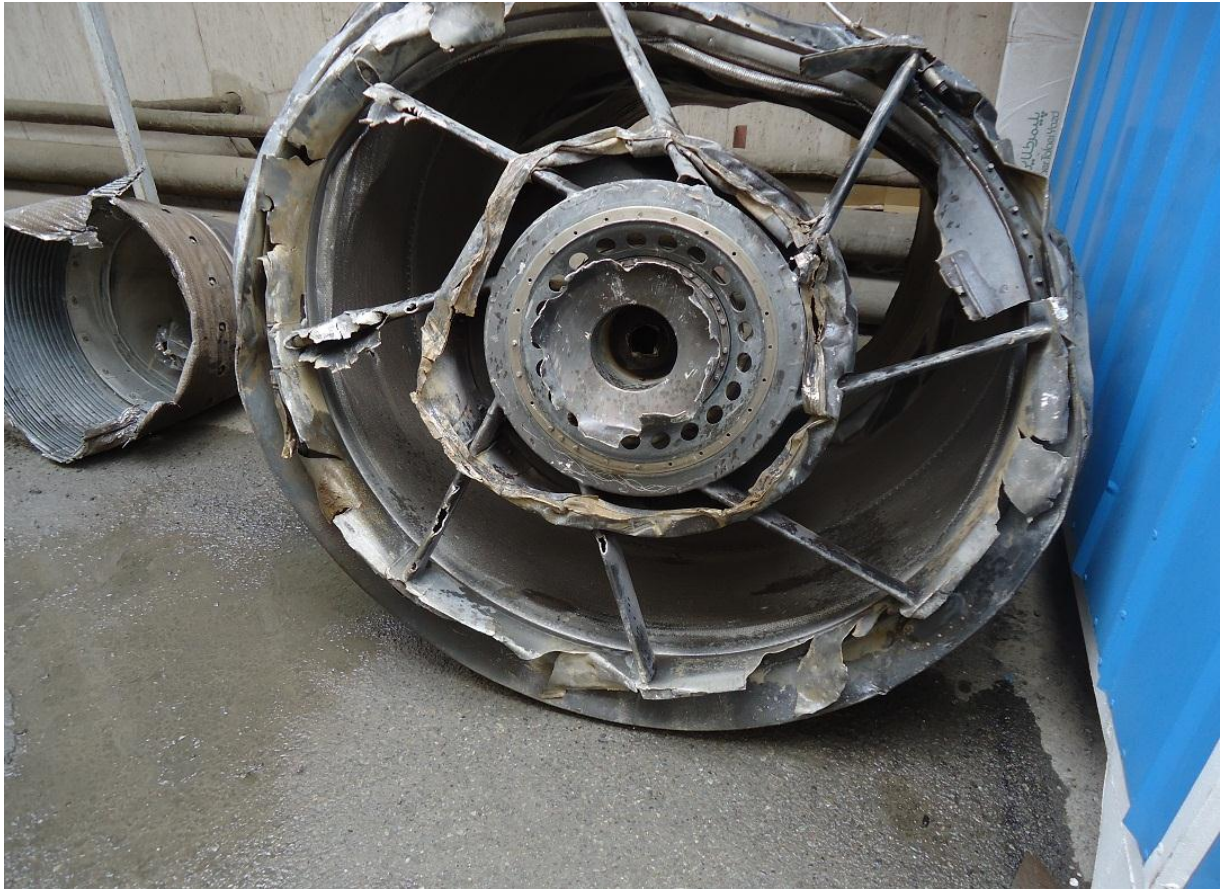
Detached Engine Part on Ground

The ENG #3 "Rear, Low Pressure Turbine" parts damaged livestock located at the Tehran (Mehrabad International Airport) south west suburb.

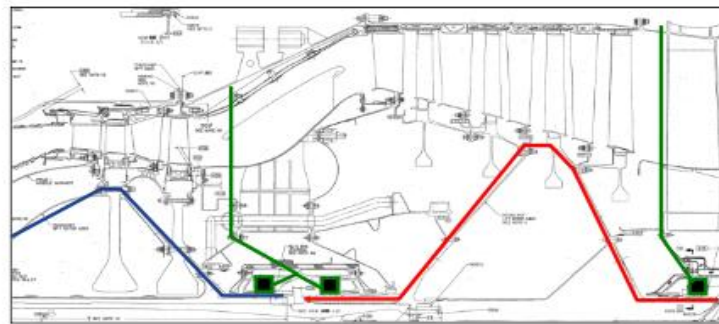
Root Cause

High HPTR imbalance causes secondary vibratory damage in the LPTR

Loads are transmitted between the HP and LP systems through a common sump (#5R & 6R bearing sump)

HCF crack initiates/propagates in LPT S3 disk forward spacer arm

Continued engine operations can lead to 360° crack and separation of LPT

The main related AD is 2012-02-07 which consists of following procedures to detect failures and preventative actions:

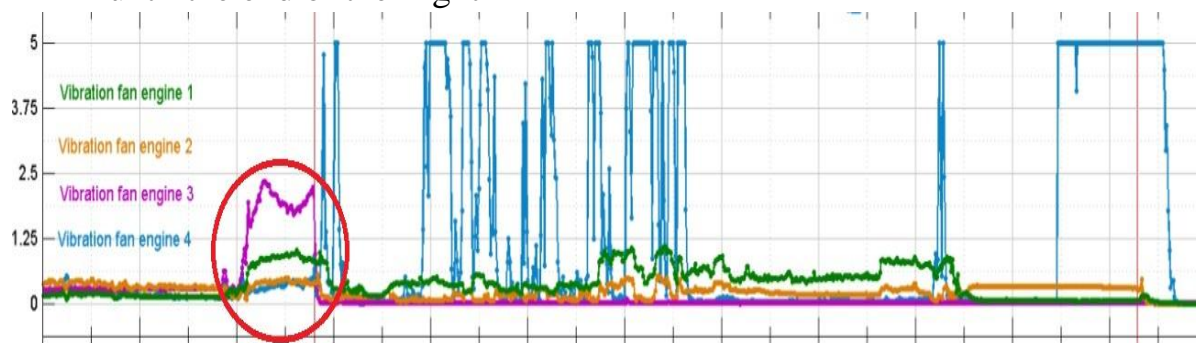
- From this time, engine #3 parameters N1 ENG#3, Engine 3 Fuel Flow, Vibration fan engine #3 and Vibration N1 ENG#3 are recorded to zero until the end of the flight

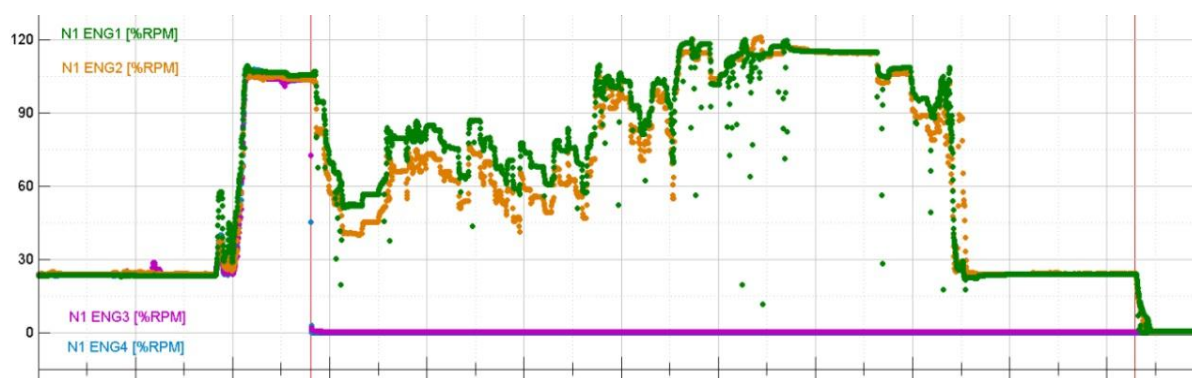
All engines N1 variation (loss of N1 in Eng#3&4 is obvious)

- Simultaneously, the parameters Engine 4 Fuel Flow and N1 ENG4 are also recorded to zero until the end of the flight. The other engine #4 parameters seem to be valid.
- The parameter Landing gear (Air/Gnd) is not consistent from about 20 minutes after take-off. This could be due to damage on landing gear position sensor / harness

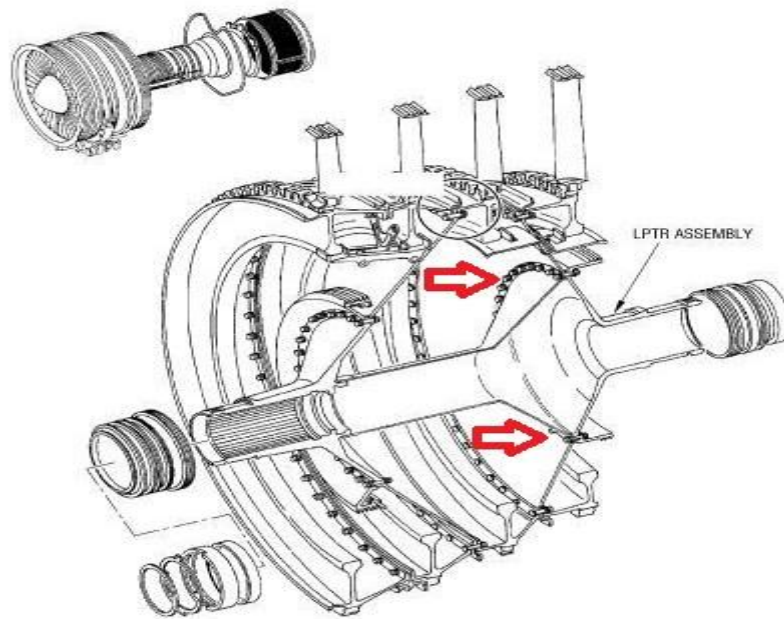
Cut away illustration of CF6-50 LPT disk#3 Location

Because the LPT rotor spins rapidly, detachment of Disk#3 from its axis by centrifugal force resulted in radial propagation of defragments with high velocity. Therefore, LPT stage#3 is completely detached from the engine. Figure illustrates the LPT stage 3 with red arrows.

This damage led in complete loss of thrust in engine#3.

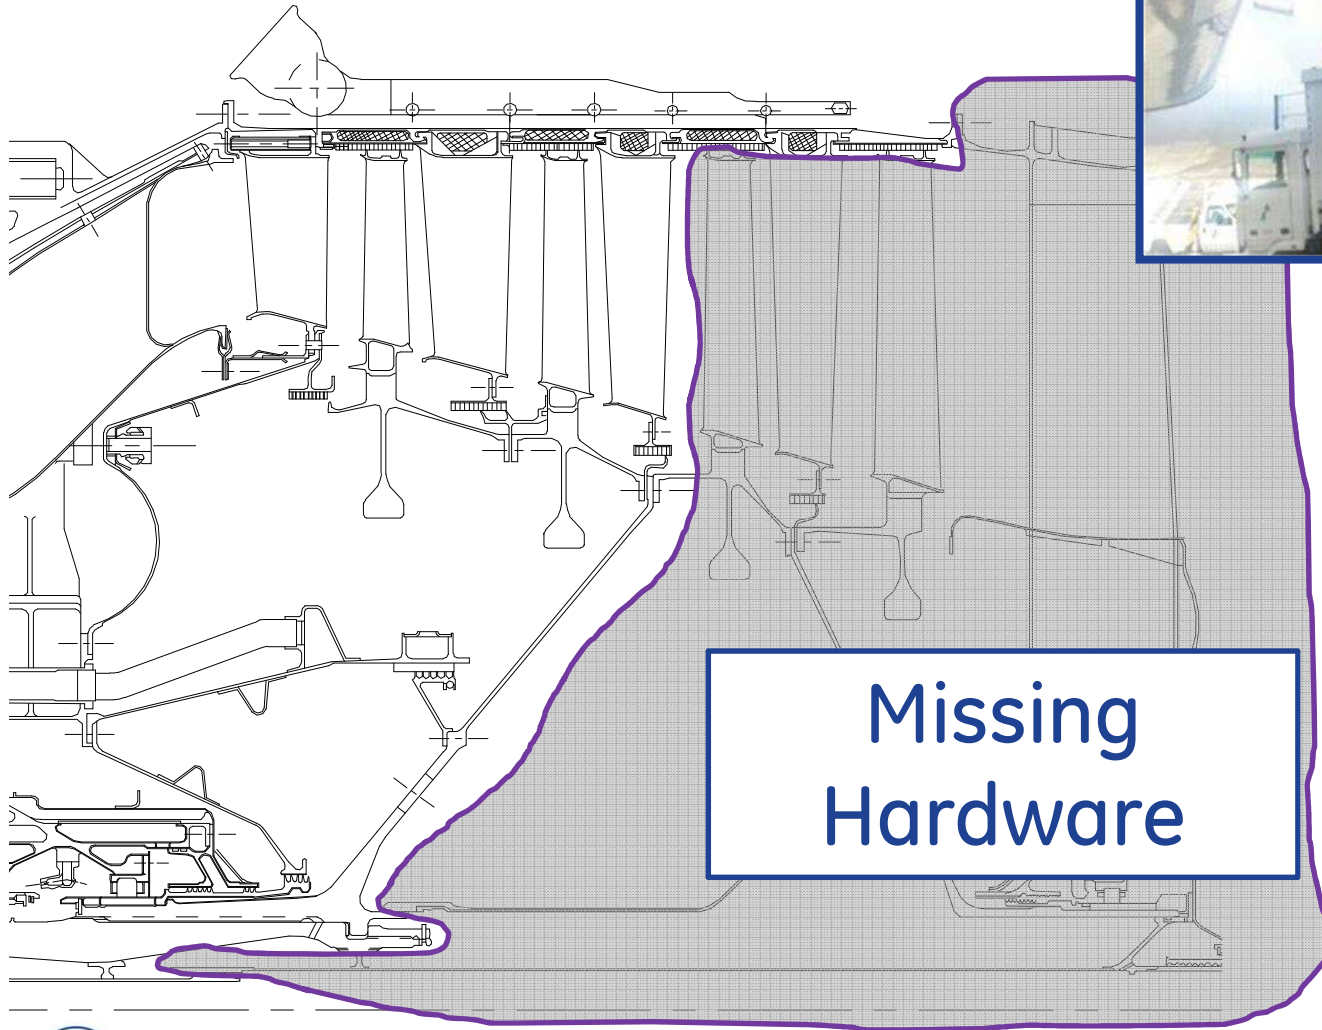
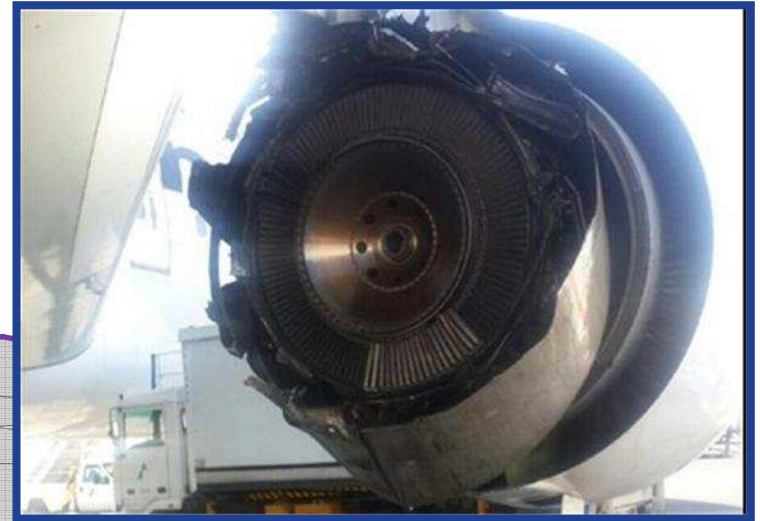
Event # 9 – Mahan Air

The main problem which led to engine failure was vibration as a result of unbalance engine HPT module ,which caused crack propagation in ENG.#3 LPT.
