SERIOUS INCIDENT

Aircraft Type and Registration:	Airbus A330-323, N276AY	
No & Type of Engines:	2 Pratt & Whitney PW400 turbofan engines	
Year of Manufacture:	2001 (Serial no: 0375)	
Date & Time (UTC):	26 June 2016 at 1115 hrs	
Location:	London Heathrow Airport	
Type of Flight:	Commercial Air Transport (Passenger)	
Persons on Board:	Crew - 12	Passengers - 277 Ground staff - 2
Injuries:	Crew - None	Passengers - 1 (Minor)
Nature of Damage:	APU failure	
Commander's Licence:	Airline Transport Pilot's Licence	
Commander's Age:	61 years	
Commander's Flying Experience:	31,635 hours (of which 1,912 were on type) Last 90 days - 200 hours Last 28 days - 28 hours	
Information Source:	AAIB Field Investigation

Synopsis

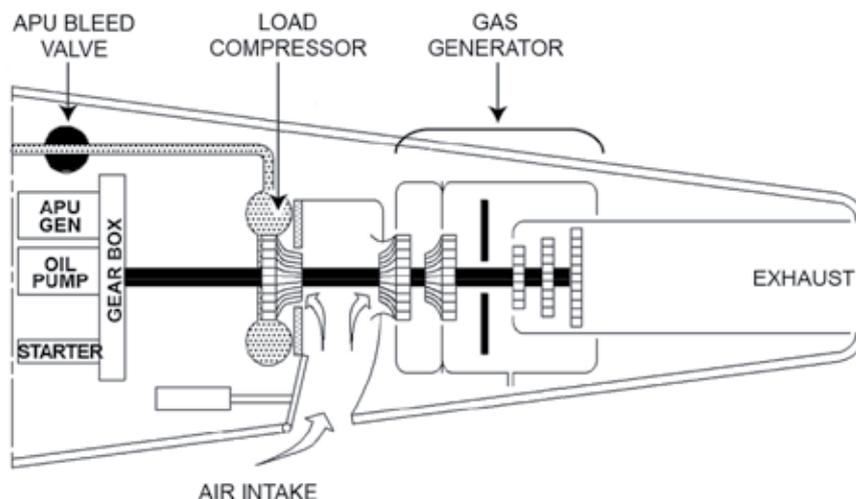
Figure 3

The source of the smoke was traced to a failure of the Auxiliary Power Unit (APU) load compressor carbon seal that allowed hot oil to enter and pyrolyse in the bleed air supply.

Metallic debris in the shared oil system compromised the load compressor bearing, leading to the failure of the load compressor carbon seal.

Schematic diagram of APU

The examination of the APU revealed considerable metallic debris in the shared oil system. The quantity of debris overwhelmed the filtering capacity of the system, causing the bypass to operate and allow debris to move into other areas of the oil system such as other bearings and seals. This debris eventually caused a failure of the load compressor carbon seal, allowing hot oil to enter the bleed air supply to the cabin and causing smoke in the cabin. The initiating source of the debris could not be identified positively due to the distribution of debris throughout the whole oil system.

Examination of the APU after the event revealed considerable metallic debris in the shared oil system. This debris eventually caused the load compressor carbon seal to fail, allowing hot oil to enter the bleed air supply to the cabin and causing smoke in the cabin. The initiating source of the debris could not be identified positively due to the distribution of debris throughout the oil system.

It is recommended that the Federal Aviation Administration mandate Service Bulletin GTCP331-49-7936 to add a system that shuts down the APU automatically if there is contamination of the lubricating oil.

It is recommended that the European Aviation Safety Agency mandate Service Bulletin GTCP331-49-7936 to add a system that shuts down the APU automatically if there is contamination of the lubricating oil.

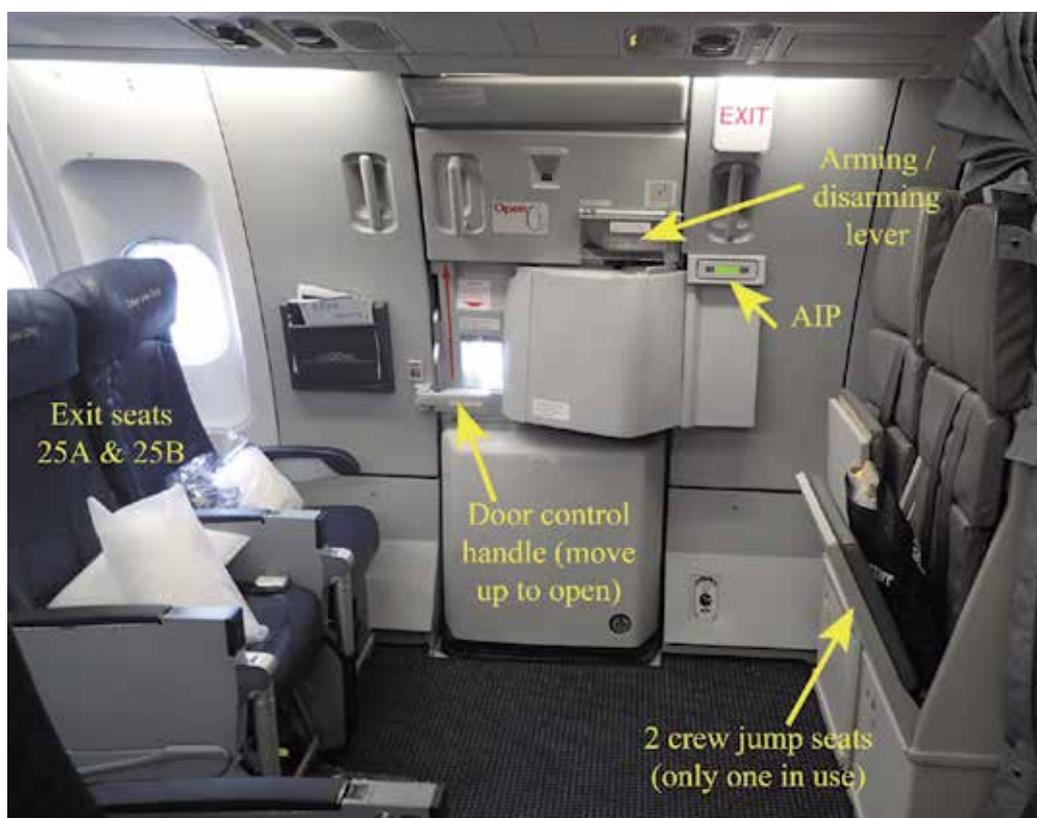
Figure 5

Photograph of Exit 3L and surrounds; the Attendant Indication Panel (AIP) is described in *Crew stations*

The door at exit 3L was apparently opened in accordance with the safety information card, without the slide being armed. However, the guidance on the card which then shows the manual slide deployment handle being pulled, was not followed and the slide did not deploy. The fall of 5.2m metres from the sill of this door to the ramp below represented a significant hazard to anyone using it.
