Aircraft Accident Investigation Bureau of Myanmar

**DRAFT FINAL REPORT OF HARD LANDING INCIDENT OF AIR MANDALAY
AIRLINES EMBRAER-145EP IN SITTWE AIRPORT ON 18th SEPTEMBER, 2017**

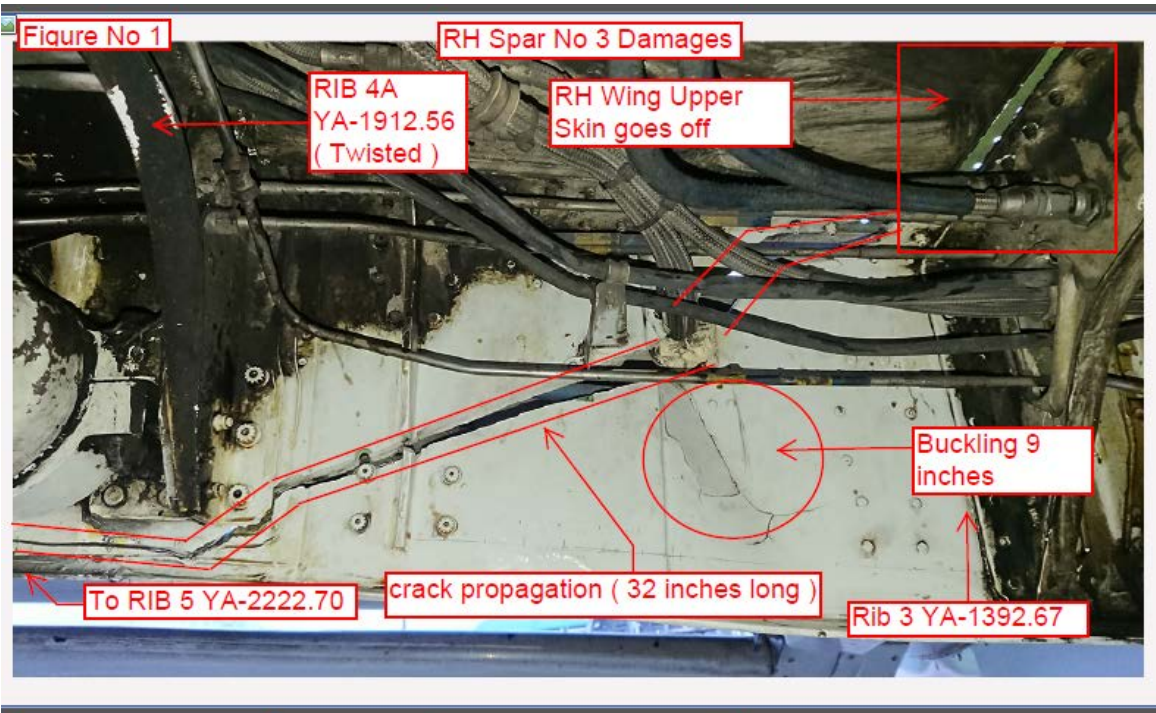
1.3.1 Right Hand Wing, Spar No 3 broken

- (a) Crack propagation from (RIB 3A YA-1392.67 up to RIB 5 YA-2222.70)
- (b) Length of crack is 32 inches.
- (c) Nature of crack is diagonal across the SPAR No 3
- (d) Refer to Figure no.1

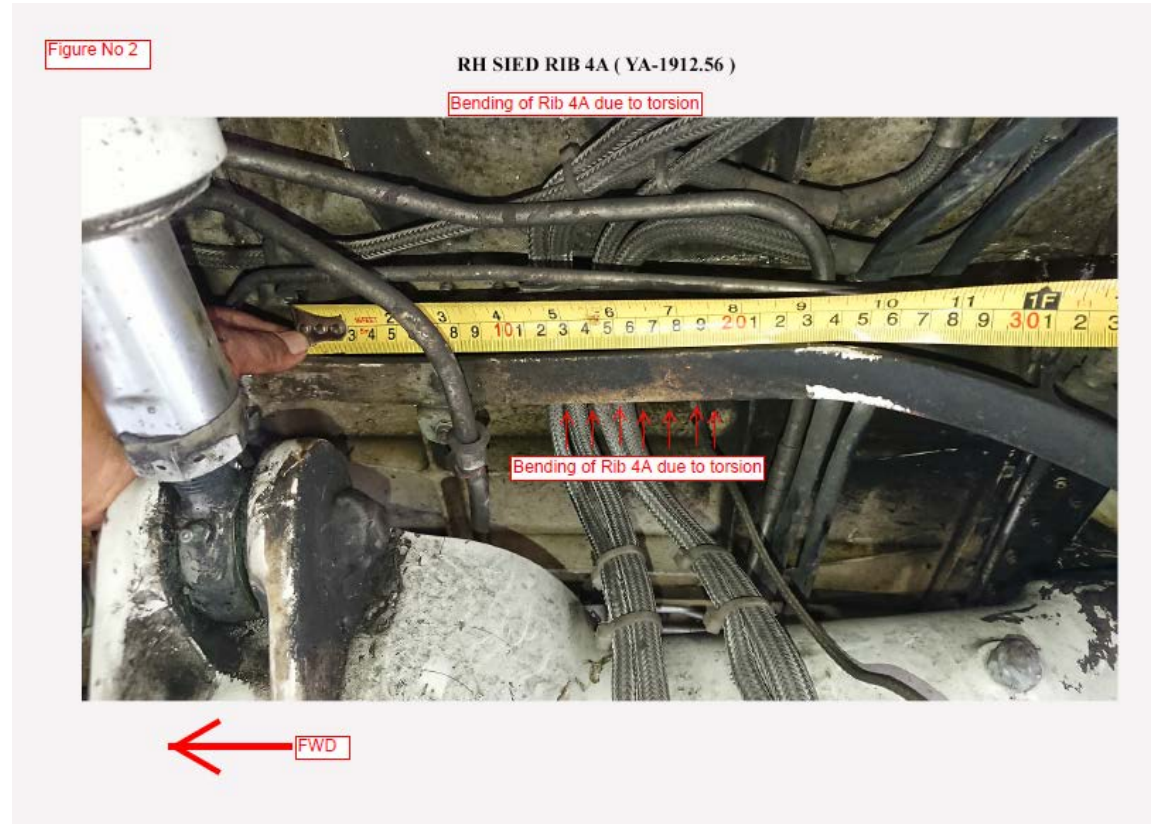
1.3.2 RIB 4A twisted or deformed

- (a) The length twist is about 9 cm
- (b) Refer to Figure no.2

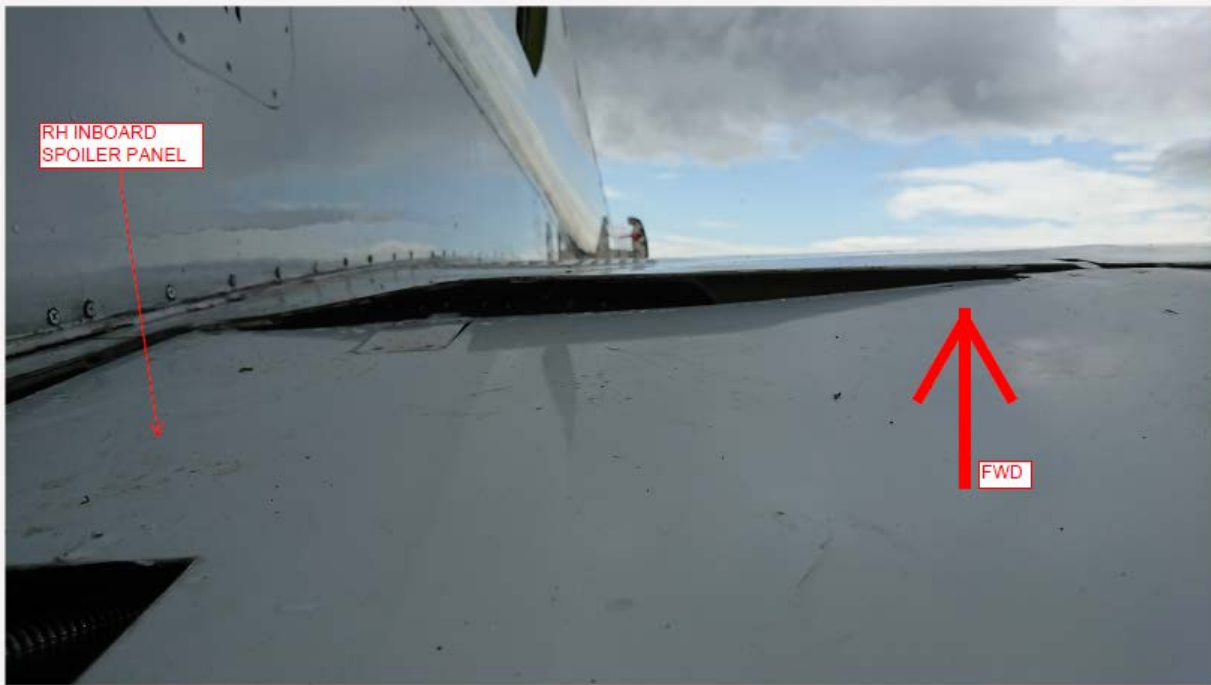
FIGURE NO 3

1.3.3 Right Hand Wing Skin at Trailing Edge Separation

- (a) Location is between Y-1085.00 to RIB 4A YA-1912.56
- (b) Fasteners to RIB 3 and Spar No 3 went off
- (c) Length of Skin Separation (61 cm long).
- (d) Peak of buckle is about 3 cm high.
- (e) Refer to Figure no.3

RH Wing, Trailing Edge Skin Buckling (From Y - 1085.50 + 61 cm)

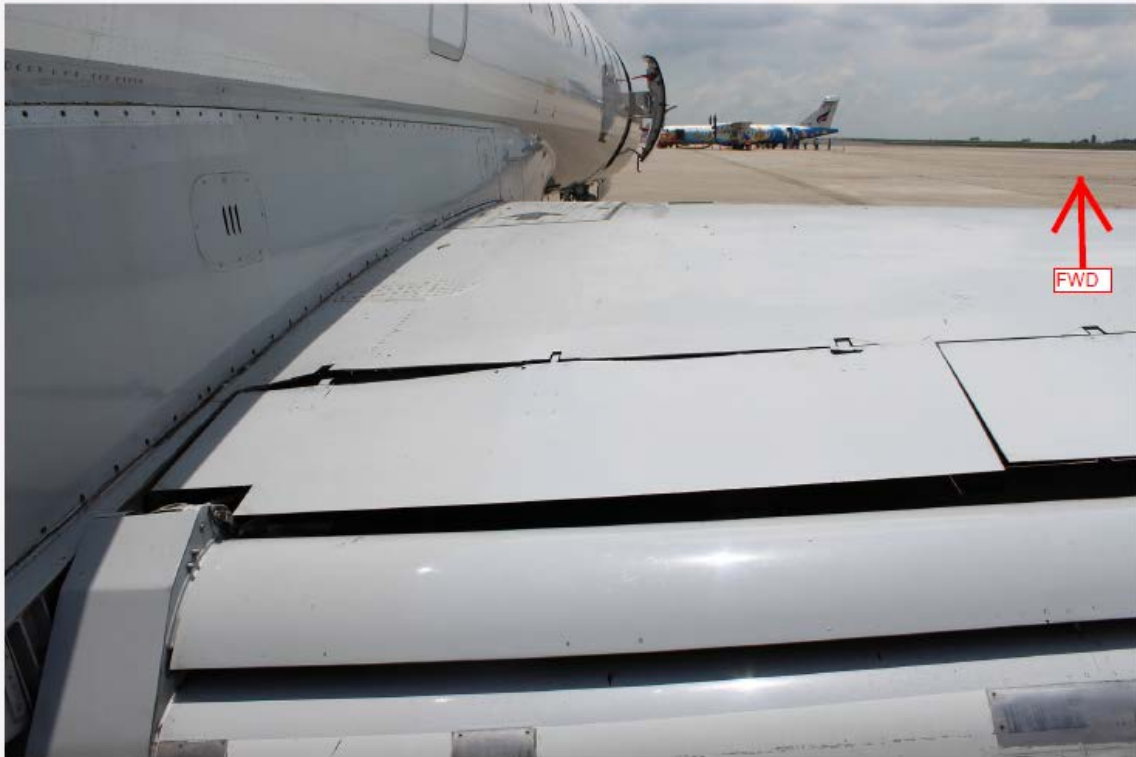
Figure No 4

1.3.4 Buckling of Right Hand Wing Inboard Spoiler

- (a) Spoiler Panel buckling (Length is about 128 cm in wave form)
- (b) Refer to figure no.4

Damages and skin Buckling of RH Inboard Spoiler Panel

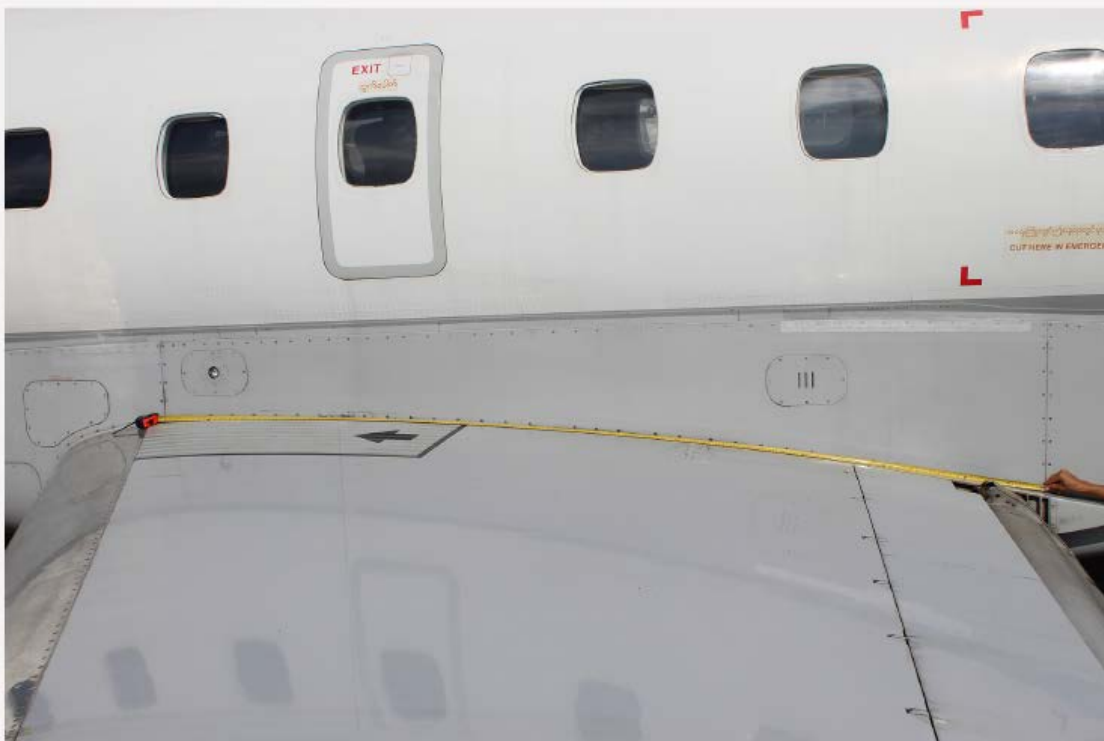
Figure No 5

1.3.5 Deformation of LH Side lateral fairing, (Location: Central Fuselage)

- (a) Fiber glass panel buckled (Length 180 cm)
- (b) Refer to Figure no.5

Buckle of LH Lateral Fairing
