# AVIATION INVESTIGATION REPORT

## A17F0052

### **Risk of collision with terrain**

Boeing 737-800, C-GWSV

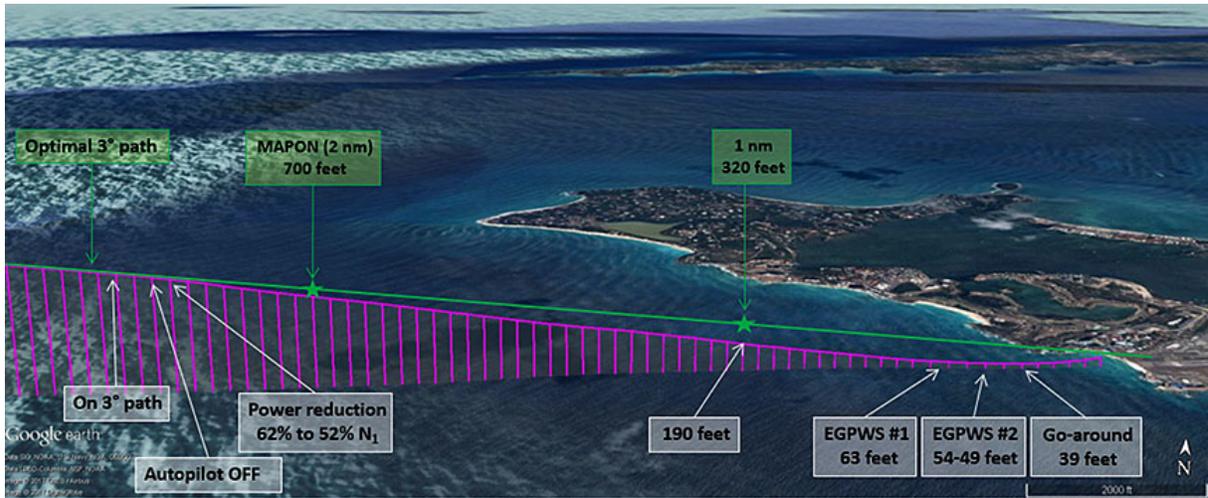
Figure 2. Standard 3° angle of descent versus the aircraft vertical approach path

An increase in visual workload led to inadequate altitude monitoring, which reduced the crew's situational awareness. As a result, the crew did not notice that the aircraft had descended below the normal 3° angle of descent to the runway threshold. The lack of visual texture and other visual cues available over water contributed to the crew's inability to detect the aircraft's reduced height above the water.

7. An increase in visual workload led to inadequate altitude monitoring, which reduced the crew's situational awareness. As a result, the crew did not notice that the aircraft had descended below the normal 3° angle of descent to the runway threshold.

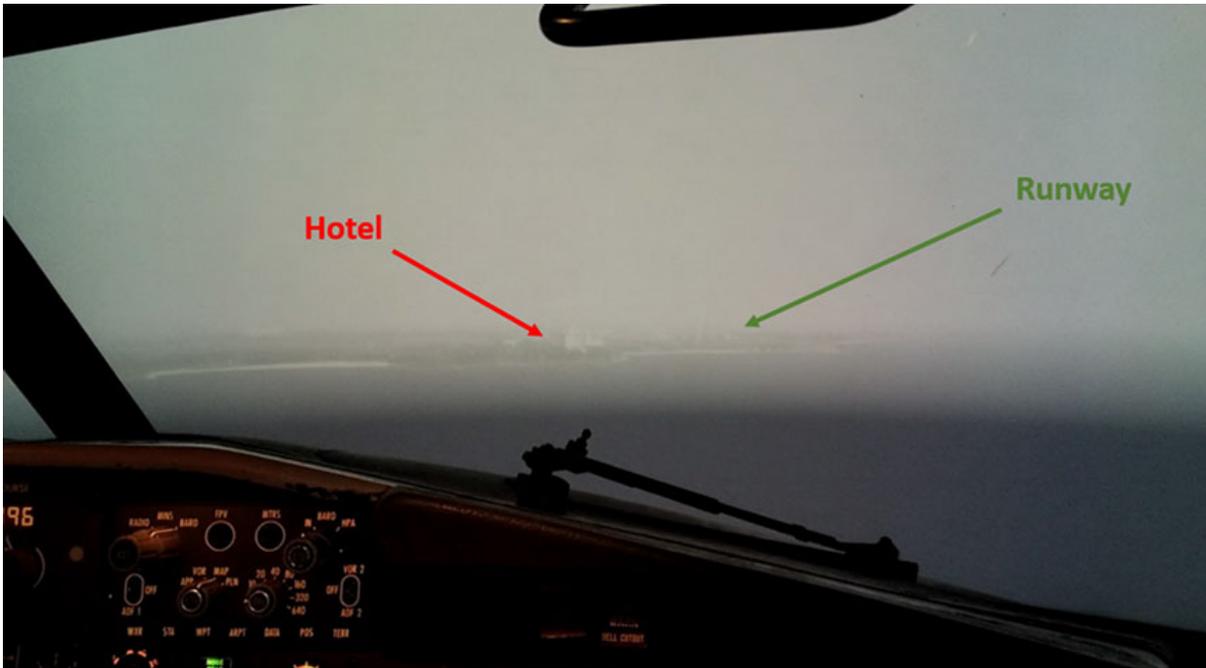
The simulator did not allow for an exact replication of all of the visual conditions at the time of the occurrence, such as the effect of the rain on the windshield. However, the exercise demonstrated a significant reduction in the visual discernibility of the runway environment when visibility diminished to 2000 m. It also highlighted the necessity for runway and PAPI lights to be illuminated at high intensity to clearly demarcate the runway edges under conditions of low visibility.

Figure 3. Visual references as seen in a flight simulator at approximately 500 feet AGL in poor visibility
