Birdstrike and engine failure involving Airbus A330, 9M-XXT

Gold Coast Airport, Queensland, 3 July 2017

ATSB Transport Safety Report
Aviation Occurrence Investigation
AO-2017-070
Final – 2 May 2018

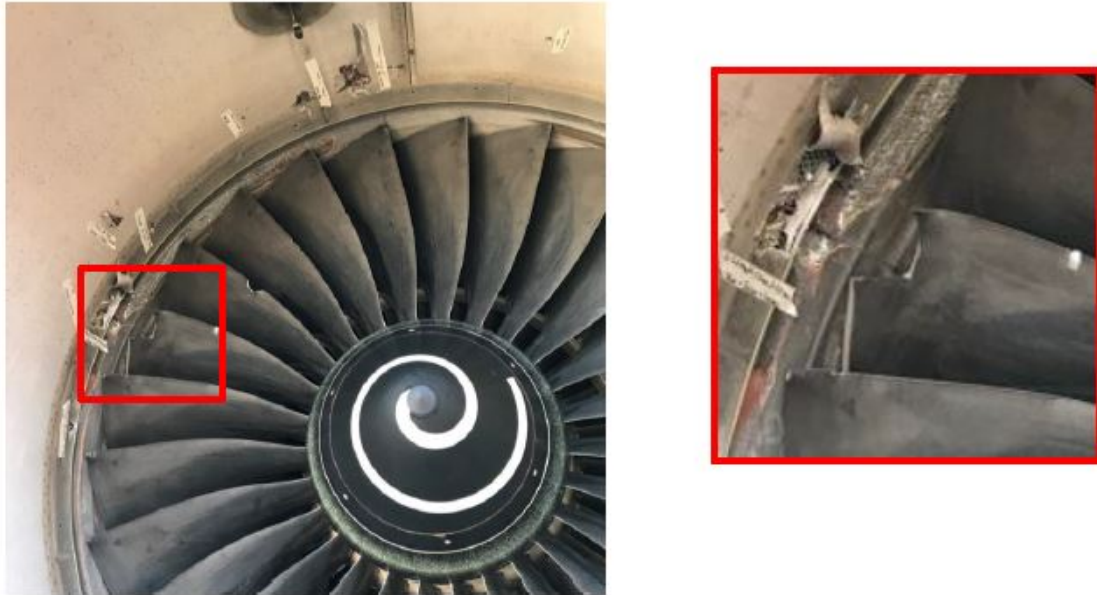
After the occurrence, an engineering examination at Brisbane Airport found a single fan blade-tip section, approximately 140 mm x 125 mm, had fractured from one fan blade and the fan rear seal

was found broken into pieces and scattered throughout the bypass areas of the engine (Figure 1). There was also evidence of fire within the engine.

Figure 1: Damage to Rolls Royce Trent 700 engine fan blades

- Blade 1 exhibited cupping damage consistent with soft body impact close to the point of material release. The radial height of the fracture on the blade was in a leading edge impact cup at approximately 84 per cent blade-height (Figure 1 and Figure 2).

- There was blade damage on a blade adjacent to blade 1 (see to the right of the red square in Figure 1). This damage to the adjacent blade was consistent with impact from a hard body, and laboratory analysis did not identify that any foreign object had impacted that blade.

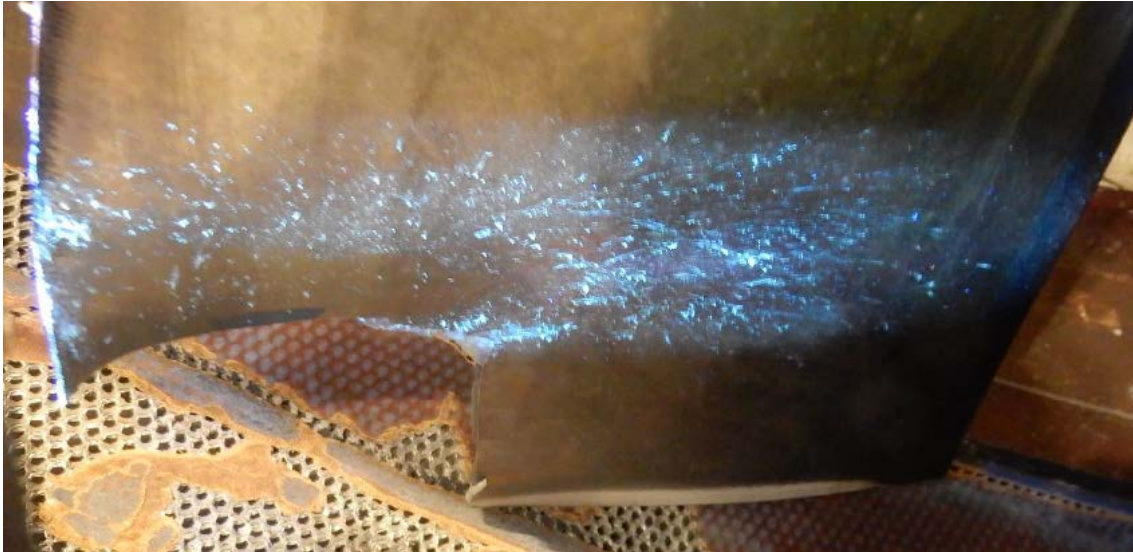
- UV light inspection identified that blade 1 (the blade with the released tip) had organic debris in the area near the blade-tip release (Figure 2), and there was also organic debris on the blade-tip that was recovered at Brisbane Airport. DNA analysis confirmed the debris from the blade and the blade-tip was from a masked lapwing.

Figure 2: Ultraviolet light showing bird remains on damaged fan blade
