Incident Final Report

INCID 02/05 - QTR8505

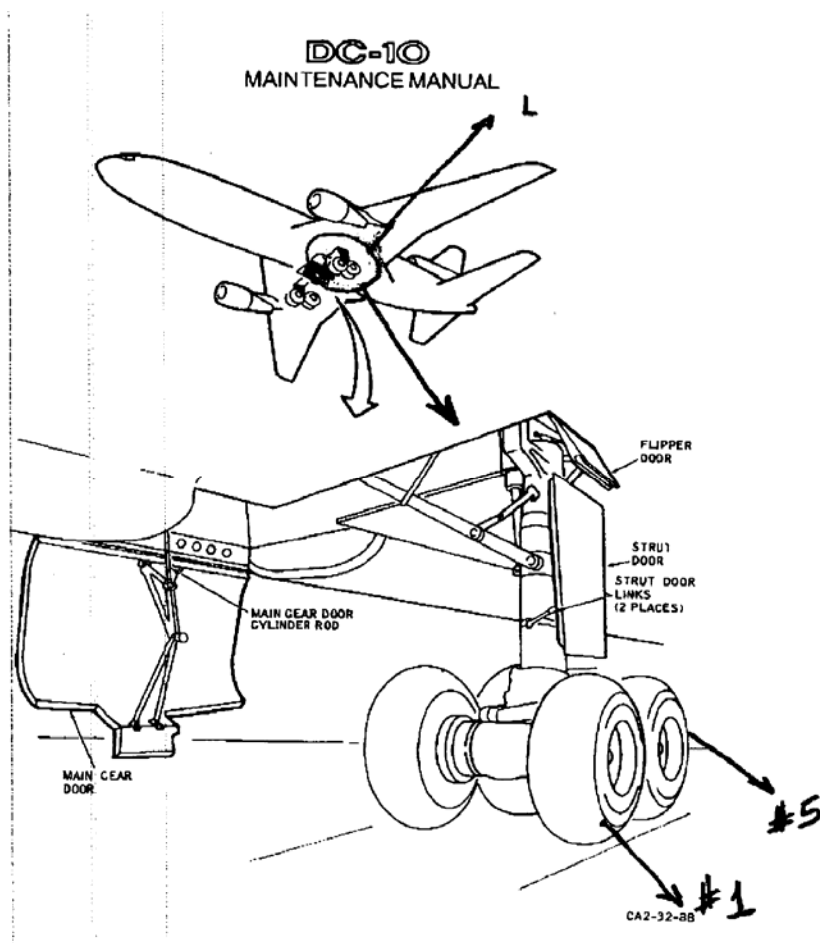
Picture 1.3-1

According to information provided by Cielos Airlines, the DC 10-30F aircraft, after aircraft arrival in Karachi, Pakistan, were found with cuts in two tyres, forward left (#1) and rear left (#5). The #1 tyre (Picture 1.3-1) showed a cut on the inner side wall and the #5 tyre showed a cut on the tread, neither compromising the pressure holding capabilities. No other damage to the aircraft was identified. The aircraft backed to service after respective wheel change.

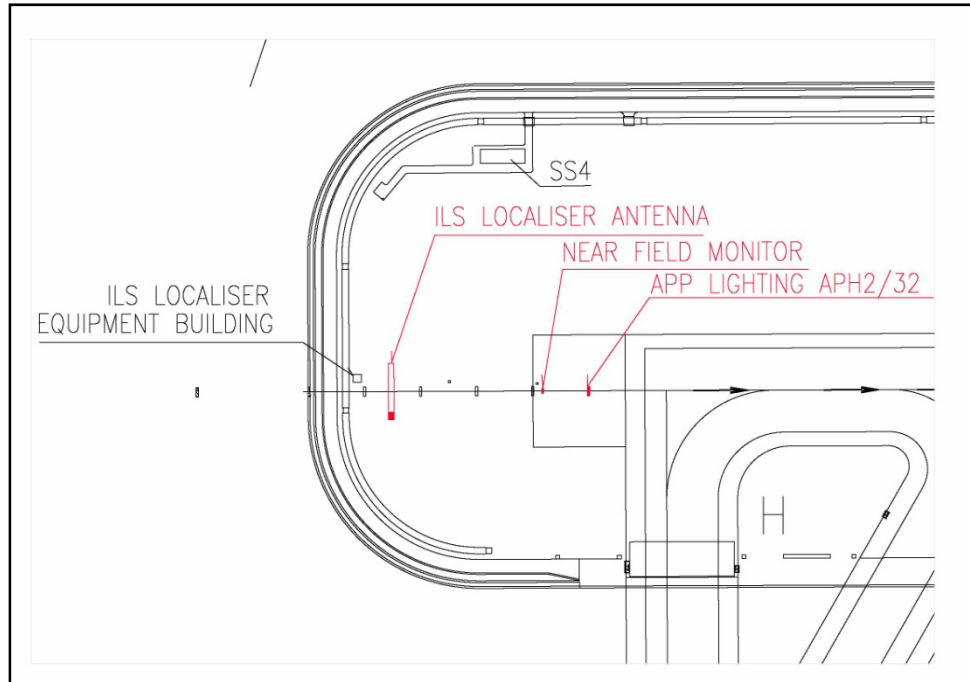
At the end the RWY 34, one of the elevated approach lights (APH2/32), near field monitor antenna of ILS Localizer and one of the antenna elements of the ILS Localizer (together with the associated red obstacle lighting) are damaged and the wreckages are spread towards the end of Runway 34 and the service road.

Picture 1.4-1 Location of Damage ILS equipment and runway lighting

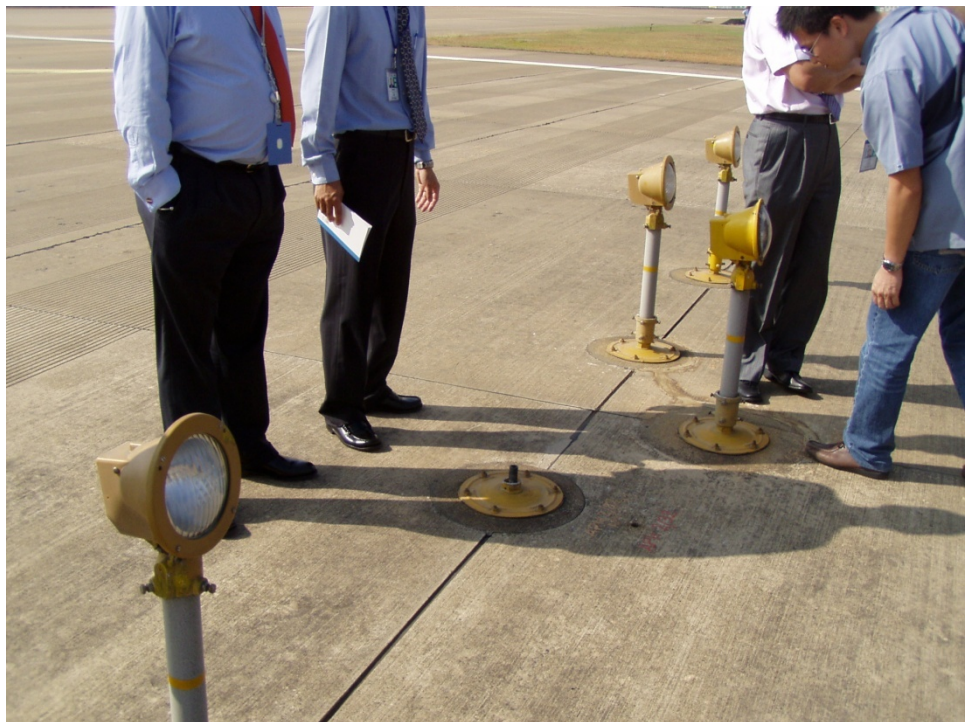
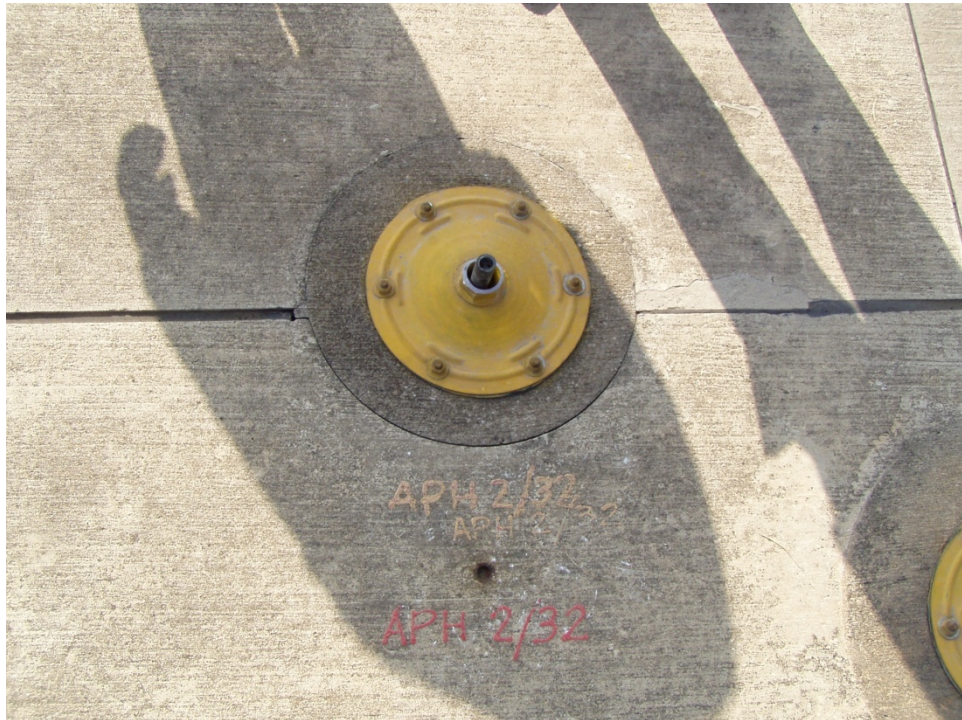
Picture 1.4-2 APP Lighting APH2/32

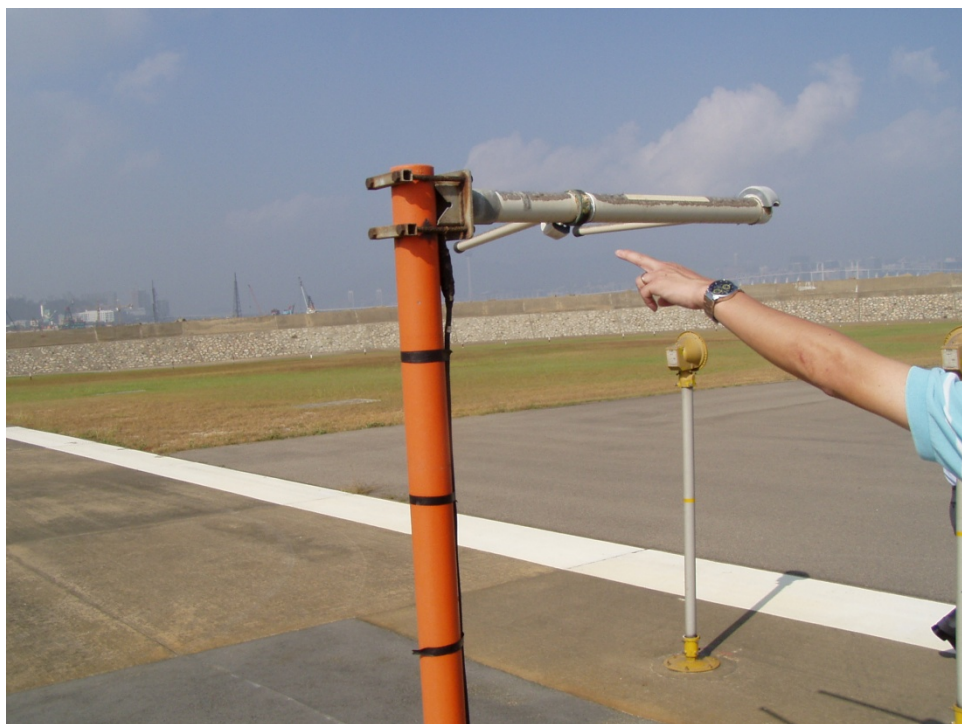
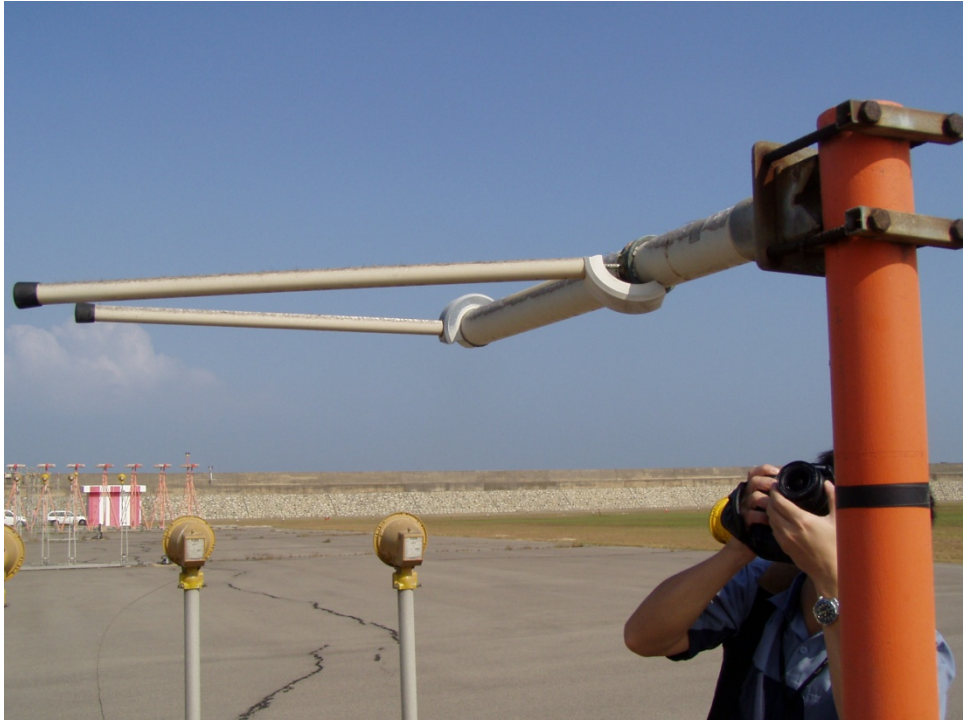
Picture 1.4-4 Near Field Monitor

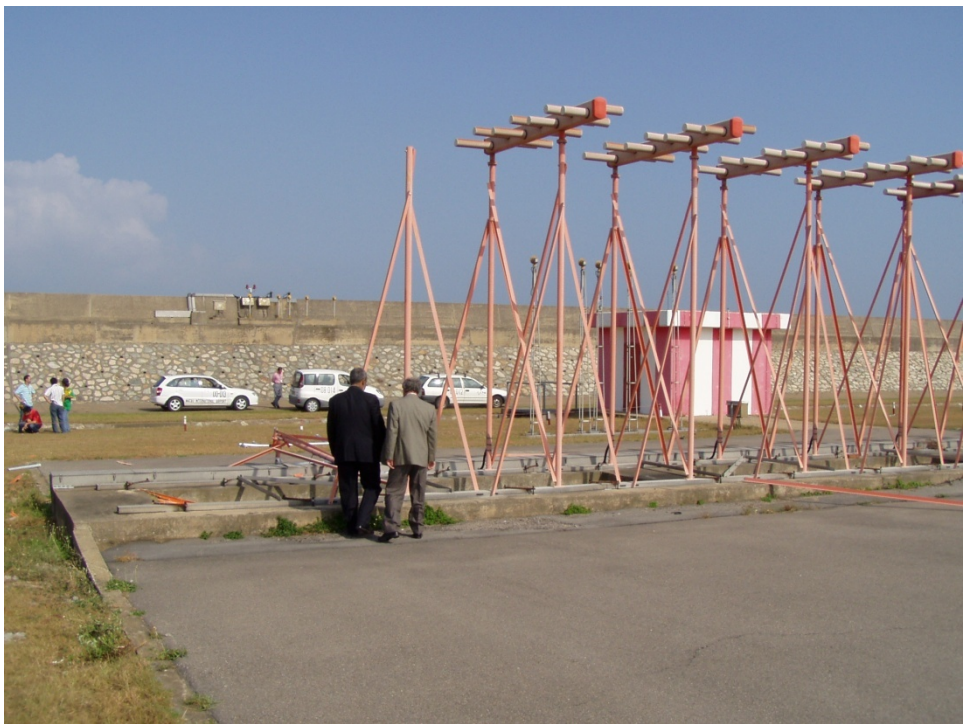
Picture 1.4-6 ILS Antenna element

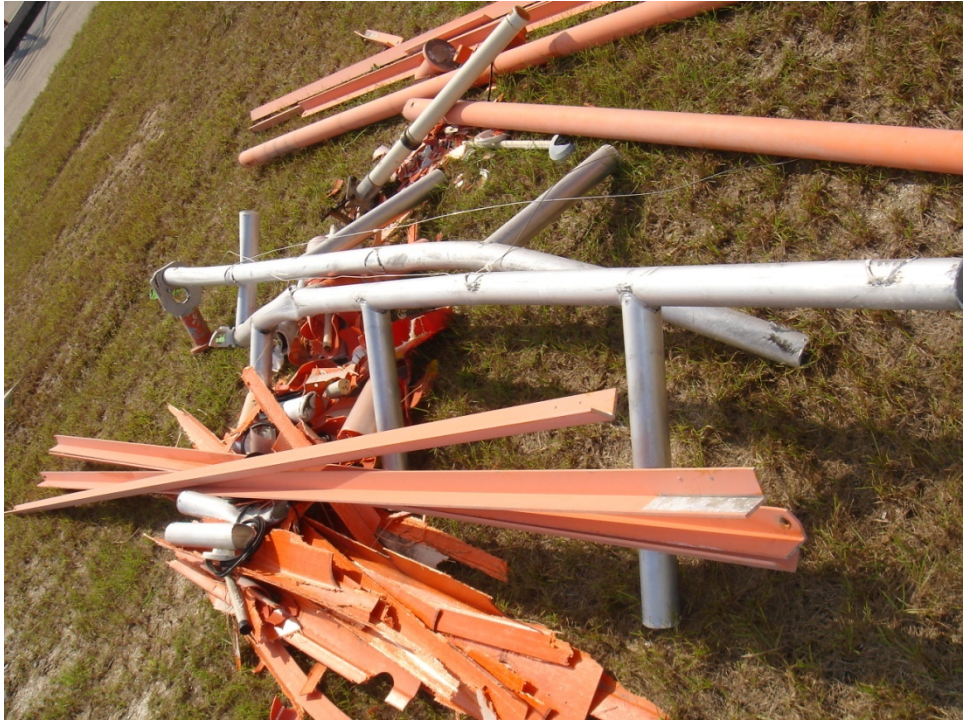
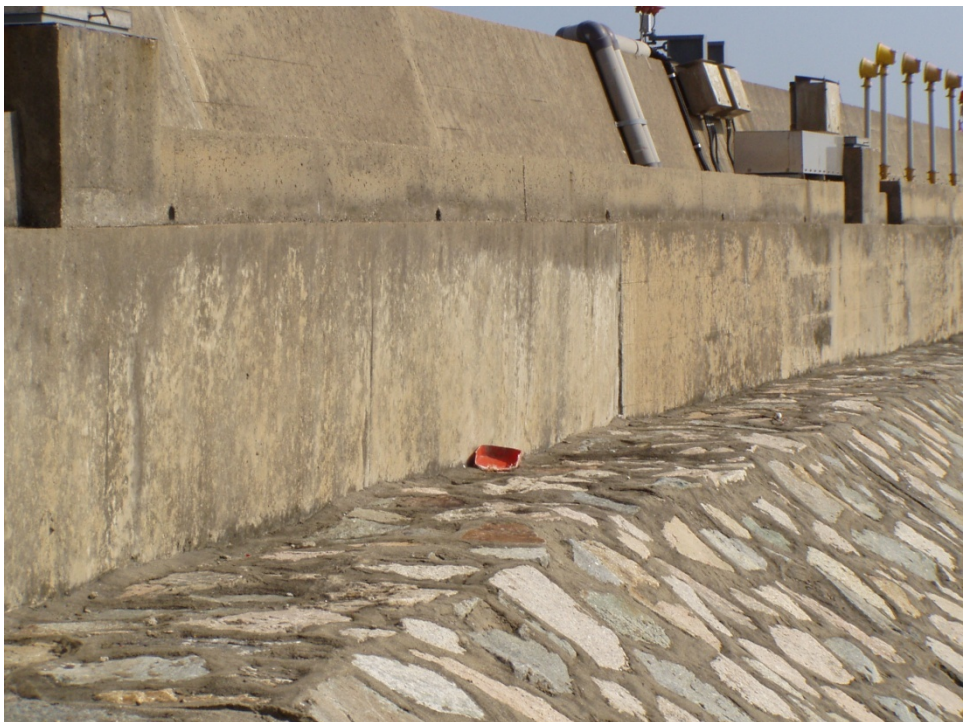
Picture 1.4-7 wreckages of ILS elements

1. No wreckage or parts liberated from the subject aircraft was identified on the runway.
2. The wreckages of the ILS antenna elements and runway lightings are spread towards the end of Runway 34 and the service road.

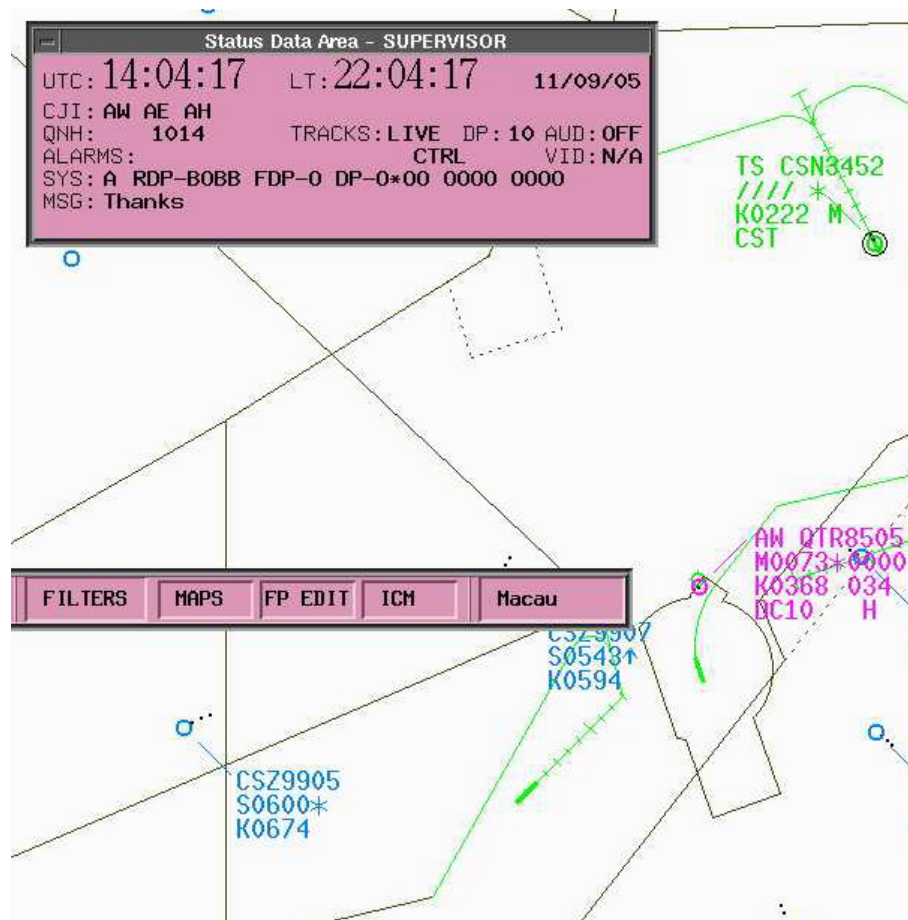
Picture 1.18-1 Extraction of radar replay

As shown by the radar play back at 140417 (UTC), QTR8505 appeared in the radar display with deviated flight path to the SID for Runway 16.
