SERIOUS INCIDENT

Aircraft Type and Registration:	Airbus A340-313, G-VAIR
No & Type of Engines:	4 CFM56-5C4 turbofan engines
Year of Manufacture:	1997
Date & Time (UTC):	27 April 2008 at 0218 hrs
Location:	Nairobi Airport, Kenya
Type of Flight:	Commercial Air Transport (Passenger)
Persons on Board:	Crew - 14 Passengers - 108
Injuries:	Crew - None Passengers - None
Nature of Damage:	Minor scratches to left aft lower fuselage
Commander's Licence:	Airline Transport Pilot's Licence
Commander's Age:	49 years
Commander's Flying Experience:	14,250 hours (of which 9,667 were on type) Last 90 days - 108 hours Last 28 days - 41 hours
Information Source:	AAIB Field Investigation

Synopsis

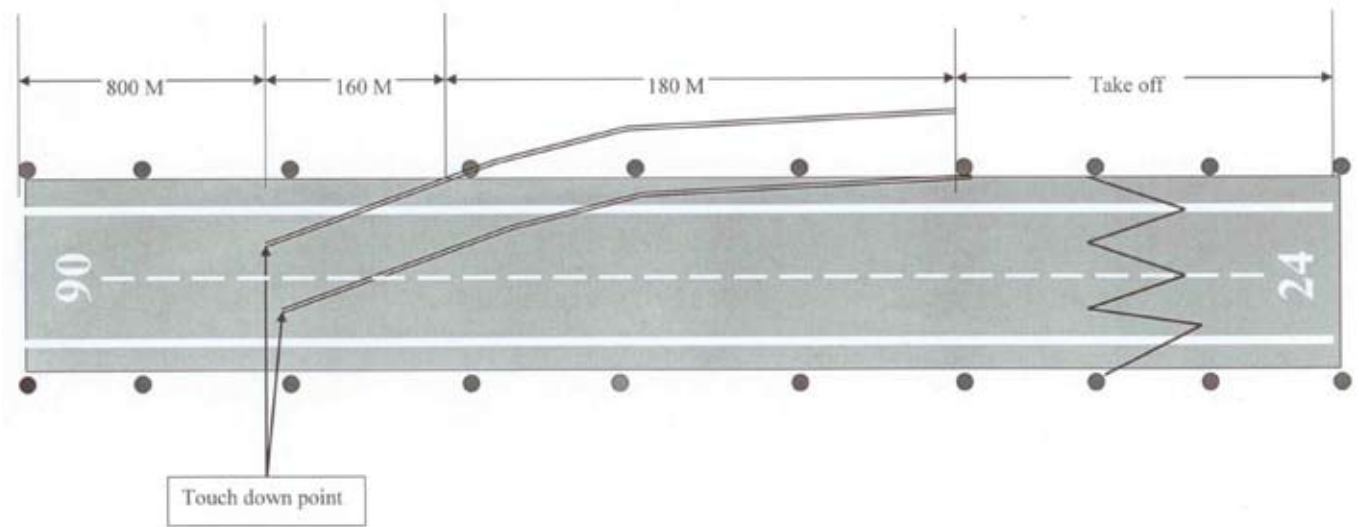
Figure 1

Having been advised of the possibility that the aircraft had run off the runway an inspection by Nairobi Airport staff confirmed the presence of a set of landing gear tracks running off to the left of the paved surface. They believed these had been made by the main gear of G-VAIR. The marks started 800 m from the threshold of Runway 06 and continued towards the edge of the runway for 160 m. From that point the marks from the left main gear passed over a runway light (which had been destroyed) before continuing off the paved surface and then curving right to run approximately parallel with the runway for 180 m. The set of marks from the right main gear did not quite leave the paved surface (stopping 5 cm from the edge of the paved shoulder) although they were off the declared runway surface. The airport staff provided a diagram depicting the ground marks and this is shown in Figure 1. Photographs of the ground marks were also taken at six hours and 14 days after the event. These are shown in Figures 2 and 3 respectively.

Diagram depicting ground marks

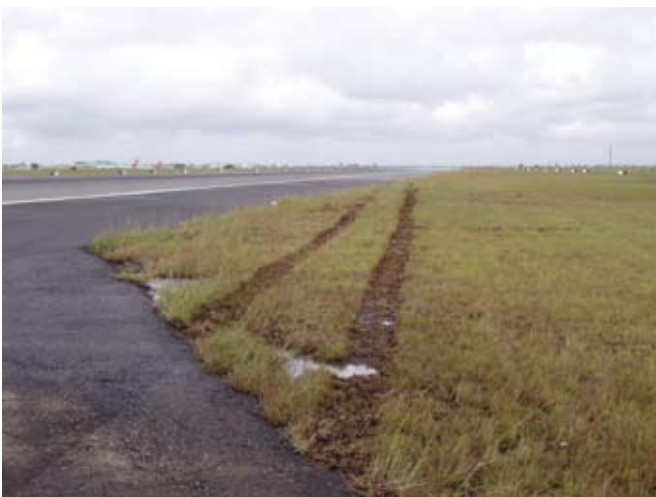
Figure 2

View towards the touchdown point

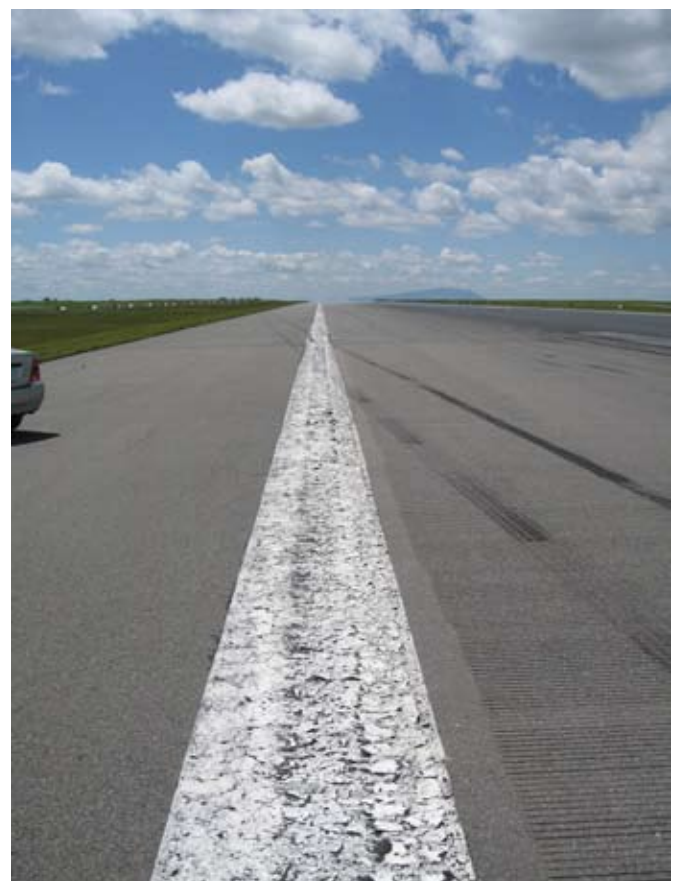
Figure 3

Left hand runway edge markings for Runway 06 with G-VAIR left main gear tyre tracks visible

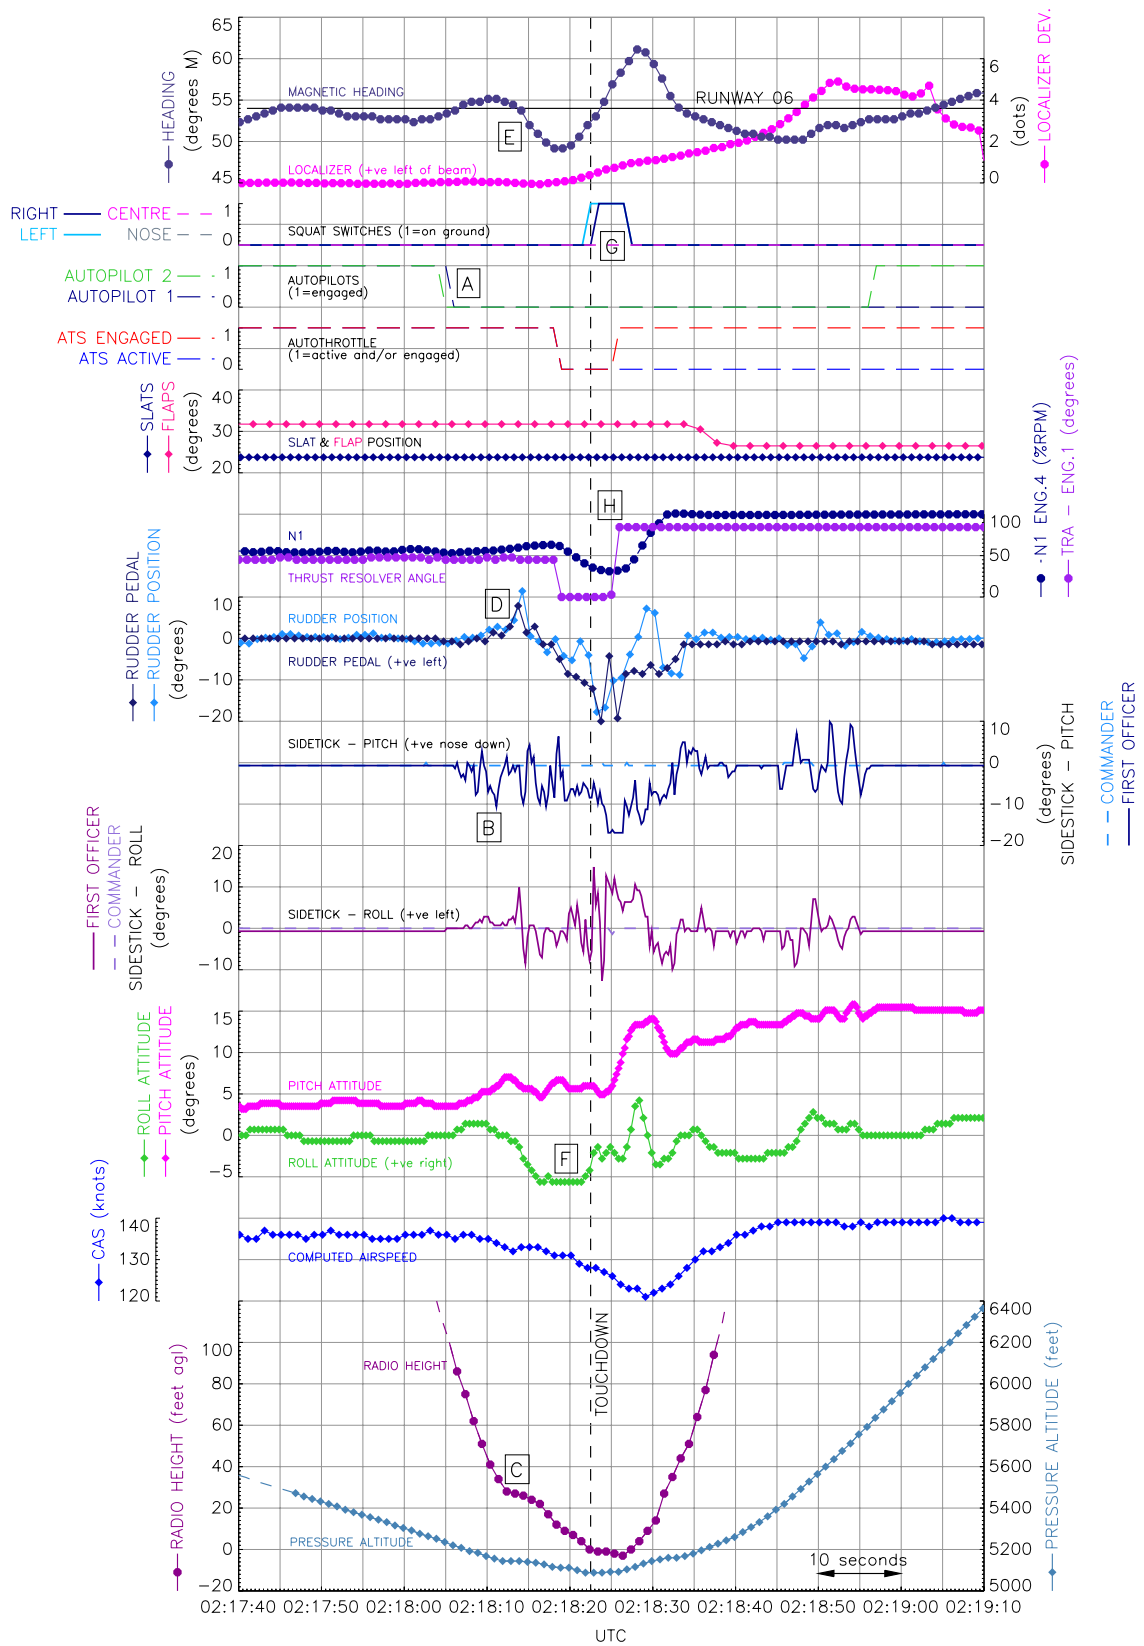
The aircraft continued descending on the ILS with minor variations in heading of $\pm 2^\circ$ to the runway heading. At approximately 90 ft agl, wings level and 4° nose-up pitch attitude, both autopilots were disengaged (Point A) with multiple FO sidestick inputs and some left rudder following. The ATS remained engaged and active.

Between 40 and 50 ft agl, the PF initiated the flare by briefly pulling back on the side stick (see Point B).

Figure 4
 Salient FDR Parameters
 (Serious Incident to G-VAIR on 27 April 2008)

This momentarily pitched the aircraft to 7° nose up, and reduced the rate of descent to about 60 feet/minute as the aircraft passed through 30 ft agl (Point C). The FO then put in a 10° left side-stick¹ input followed by an 8° right input, during which the FDR recorded an 8° left rudder pedal² input being made (Point D), causing G-VAIR to roll left and drift to the left of the runway centreline (Point E).

The PF continued to make further pitch and roll stick inputs and, as the aircraft passed through 17 ft agl, all engines were throttled back to idle, causing the ATS to drop out automatically. Right rudder inputs were also made that slowed the drift to the left; however, the aircraft remained left wing down till touchdown (Point F).

Touchdown occurred 10 seconds after the flare was initiated, still left of the runway centreline with only the main gear making contact with the ground and the left gear touching down first (Point G). The airspeed at touchdown was 128 kt, with a recorded vertical acceleration of 1.1g (not shown).

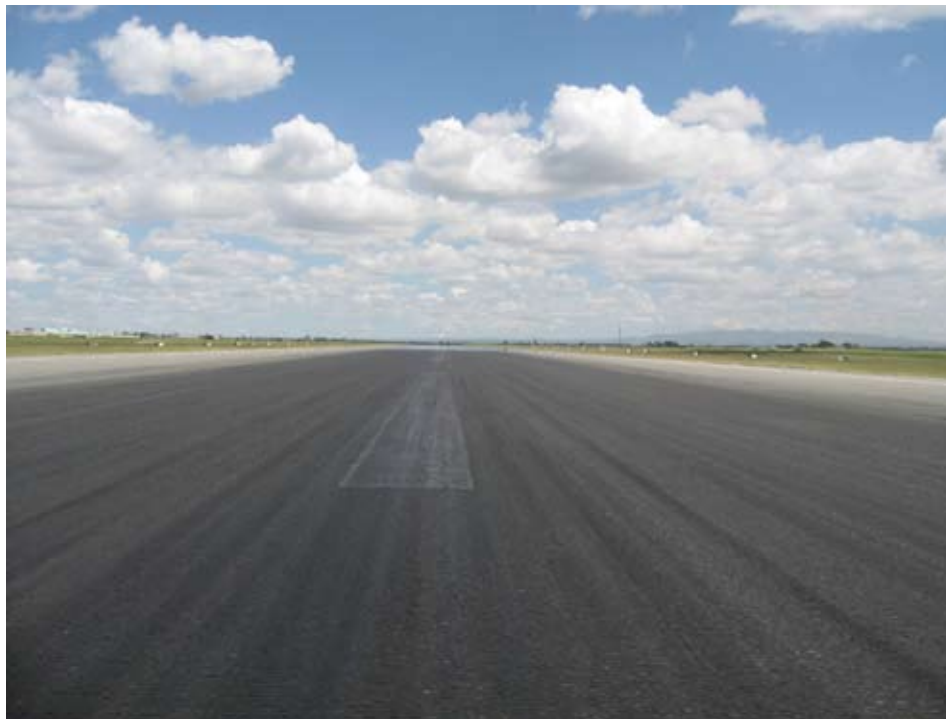
Figure 5

Runway 06 at Nairobi is declared as 4,117 m long by 45 m wide. It consists of a grooved asphalt surface with 7.5 m asphalt shoulders either side to give a total paved width of 60 m. Two weeks after the incident to G-VAIR, an AAIB Inspector, in conjunction with the Kenyan Accredited Representative, conducted a visual inspection of the runway condition. The touchdown zone area of Runway 06 appeared heavily contaminated with rubber deposits which partially obscured the runway centreline markings. A photograph of this area is shown in Figure 5.

Contamination in touchdown zone area of Runway 06

Of limited consequence to this investigation, the level of contamination seen on the surface of Runway 06 and the lack of any evidence that grip testing had been conducted was of concern. It was considered that the quantity of rubber deposition may reduce the available friction and braking action for landing aircraft on Runway 06, whilst aircraft conducting a rejected takeoff on the reciprocal runway (Runway 24) in wet conditions could suffer a significant loss of braking effectiveness. In the absence of routine grip testing it is unlikely that

Safety Recommendation 2009-073

It is recommended that the Kenya Airports Authority initiates routine testing to monitor runway friction levels at Nairobi International Airport in order to ensure compliance with the standards required by ICAO.

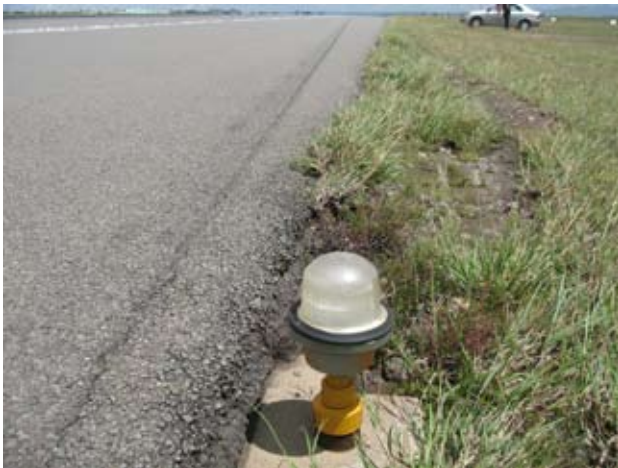
Photographs of the edge lighting were shown to an expert in runway lighting systems. He commented that, in the photograph shown in Figure 6 below, the glass on the lamp appeared "frosted" which would diffuse the light adversely affecting its output. He also commented that, in one photograph he was shown (Figure 7), the lamp appeared to be misaligned and also that he would have expected to see reference markings to the runway centre line and a unique identifier for each lamp neither of which was visible in the photographs.

Figure 6
“Frosted” edge light

Safety Recommendation 2009-070

It is recommended that the Kenya Airports Authority review their maintenance programme for runway lighting at Nairobi International Airport to ensure that runway lighting quality complies with ICAO Standards.

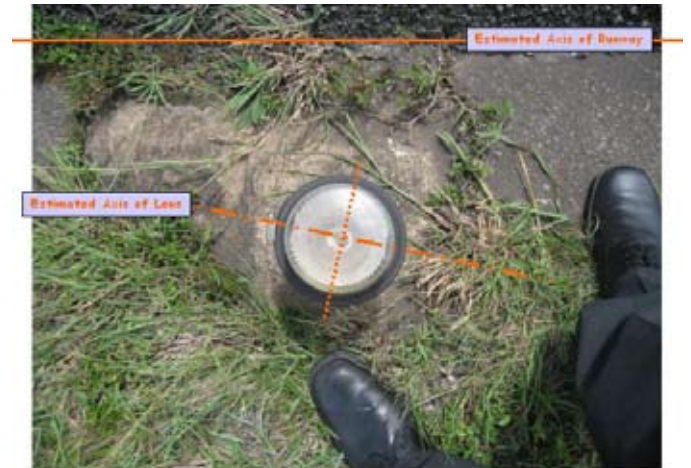
The runway lighting was observed by an AAIB inspector during a night arrival two weeks after the incident. During a good-visibility arrival, turning from base leg to final, the runway lighting had a ragged appearance. A UK CAA expert from Aerodrome Standards was of the opinion that this ragged appearance may have been caused by the rotational alignment of individual lights not being uniform.

Figure 7
Example of edge light misalignment

Safety Recommendation 2009-071

It is recommended that the Kenya Airports Authority take action to ensure that the positioning of the runway edge lights at Nairobi International Airport complies with ICAO Standards.

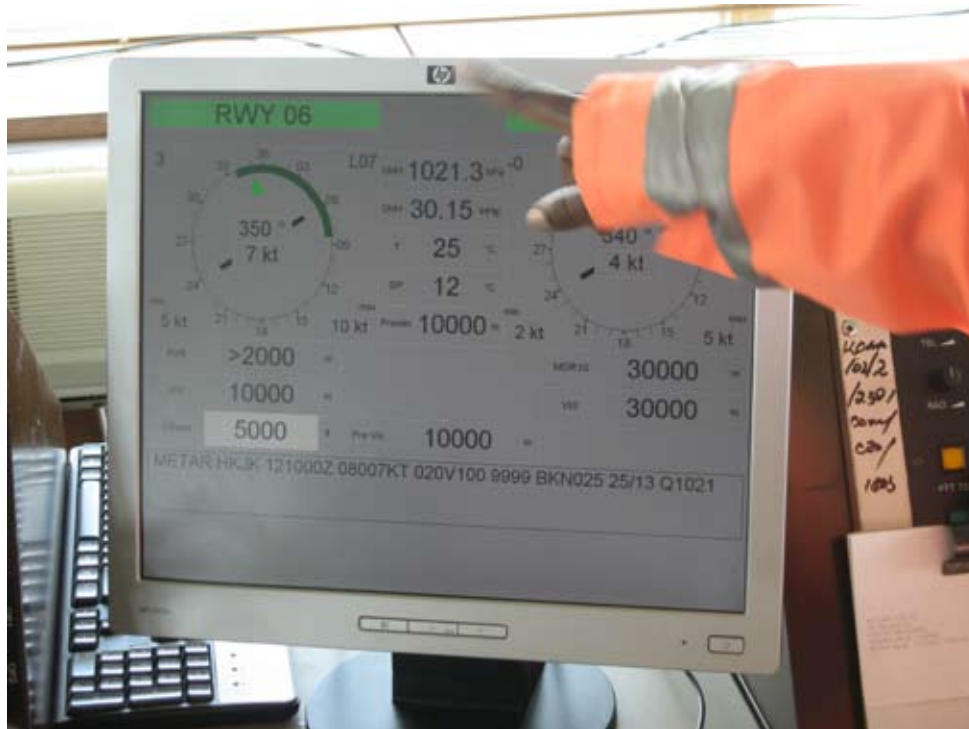
An Automated Weather Observation System (AWOS) was installed at Nairobi. This system was certified as operational by the manufacturer and accepted into service on 31 October 2006. In addition to sending data to the meteorological office on the airfield it had the capability to provide instantaneous Runway Visual Range (RVR) to the ATC tower as well as other weather information. The display for this system was positioned next to the tower controller's communications desk, as shown in Figure 8.

Figure 8
AWOS display in the tower

limited as, due to the absence of appropriate training on the AWOS, information from that system was not passed to flight crews and pilot-assessed visibility from several minutes earlier was routinely relayed instead. Therefore the following Safety Recommendation is made:

Safety Recommendation 2009-069

It is recommended that the Air Traffic Controllers at Nairobi International Airport are provided with appropriate training in the use of the Runway Visual Range measuring equipment which is a function of the Automated Weather Observation System installed at the airport.
