AA2019-8

**AIRCRAFT ACCIDENT
INVESTIGATION REPORT**

CABIN ATTENDANT INJURY
BY SHAKING OF AIRCRAFT
JAPAN AIRLINES CO., LTD.
BOEING 777-300, JA8944
AT FL300 OVER KURIHARA CITY,
MIYAGI PREFECTURE, JAPAN
AROUND 15:56 JST, JUNE 24, 2018

August 30, 2019

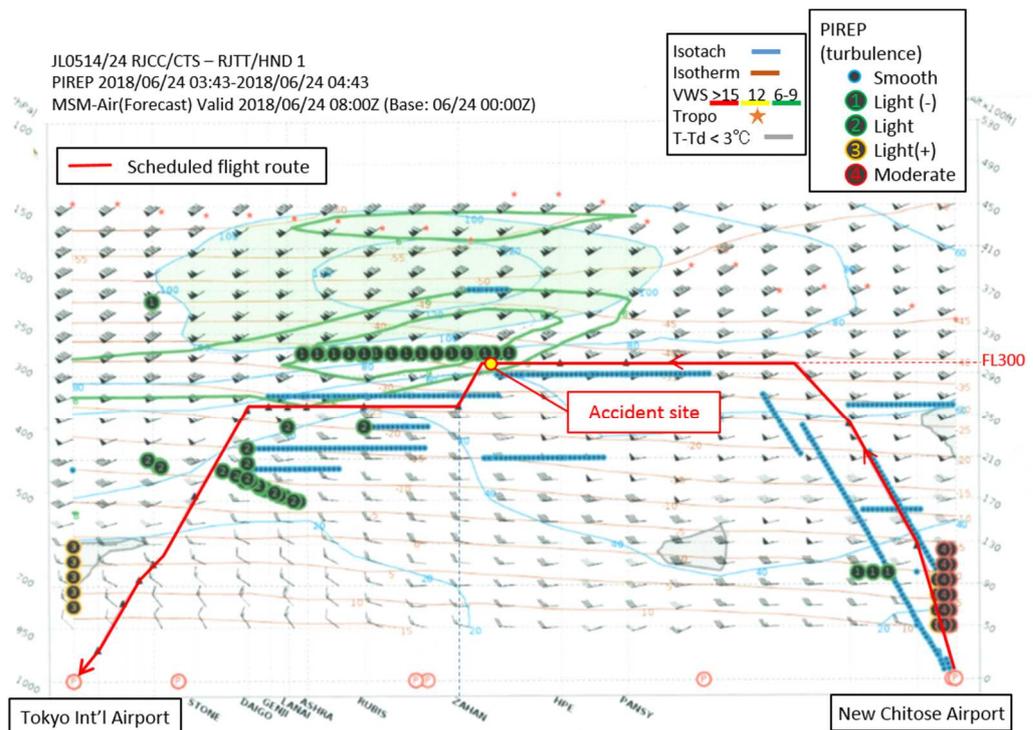
Figure 1: Predicted VWS in the pre-flight briefing

In the pre-flight briefing performed around 13:45, flight crew confirmed the flight plan, meteorological situation and forecast of the day and so on. The forecast indicated that there was vertical wind shearing (VWS) showing wind direction and wind velocity change of six to nine kt against altitude difference of 1,000 ft at the scheduled cruising altitude (FL*1300), and furthermore, there was jet stream with the maximum wind velocity of 150 kt centered at FL370 in the upper air that was moving southward as time went by. Because turbulence by PIREP (weather report from pilot) on the scheduled cruising route of the aircraft from 12:43 till 13:43 was weak (-) or nil, the flight crew presumed that shaking might occur when the aircraft approached VWS region but an initial shaking would be light, and they mutually confirmed that the aircraft avoided VWS region by lowering the cruising altitude if it felt a light shaking (see Figure 1). Besides, considering a probable occurrence of a shaking in cruising, the flight crew instructed cabin crew in the pre-flight briefing to guard themselves against such a shaking in cruising and let them aware of a possible occurrence of an abrupt shaking from 50 minutes after take-off.

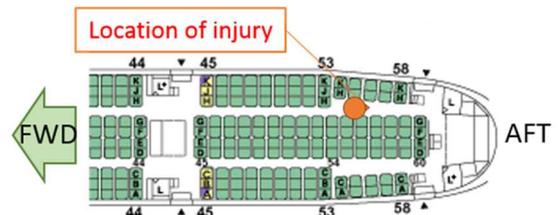
Figure 3: Location where cabin attendant was injured

attendant was unable to grasp the armrest, fell down and had her ankle injured after feeling that she was floating (see Figure 3).

In this accident, it is highly probable that the aircraft encountered clear air turbulence while it was passing through the side edge of the jet stream, and because of that the aircraft was so fiercely shaken that the cabin attendant who was on the aft aisle of the aircraft fell down and was injured.

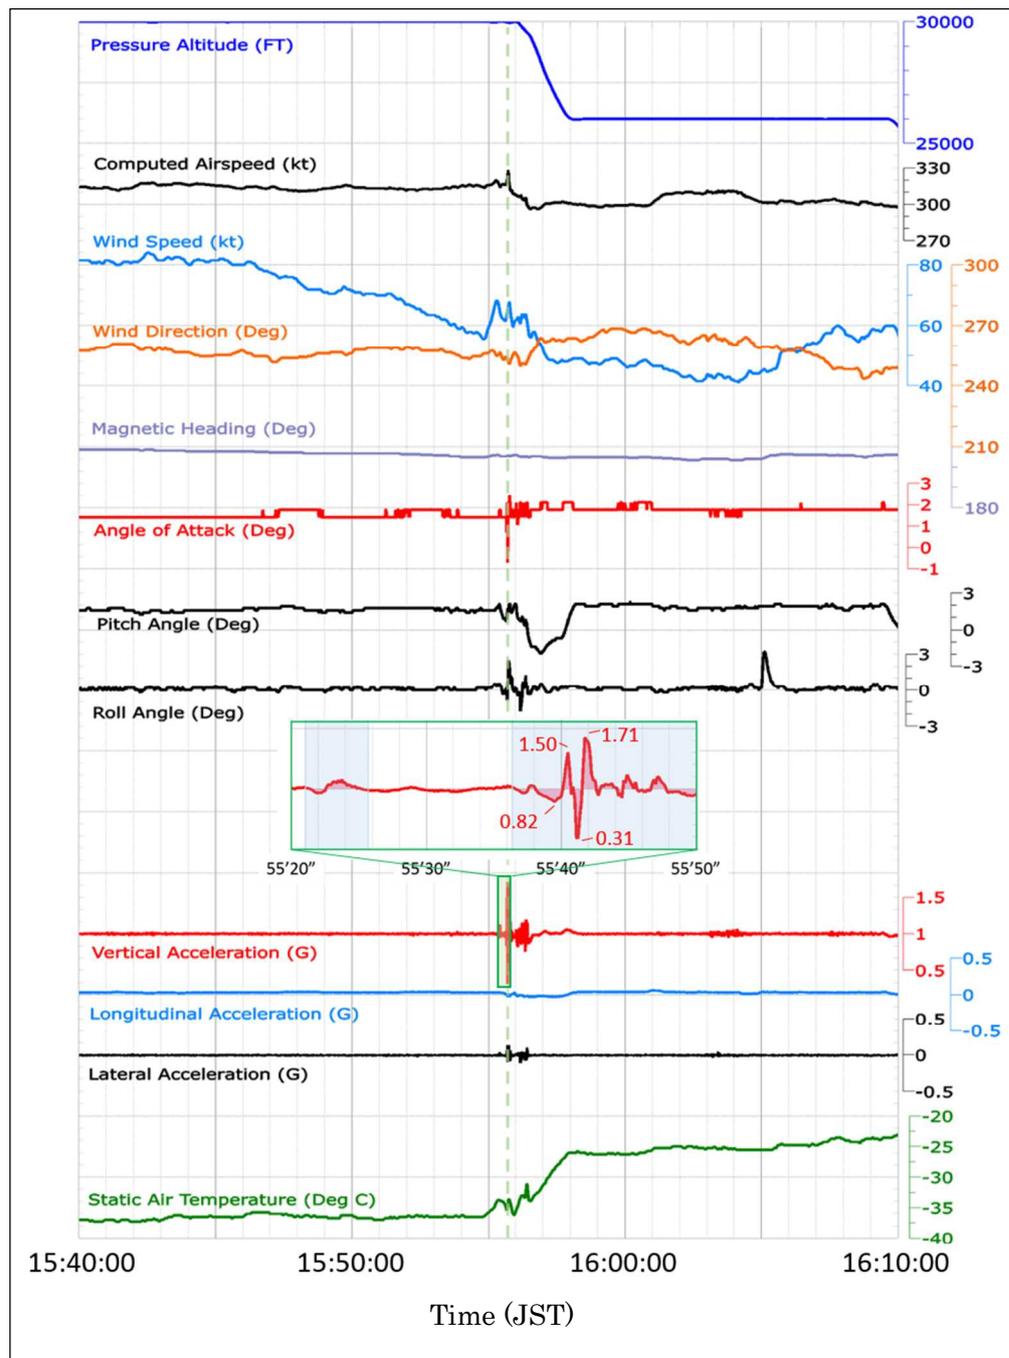
Figure 4: FDR Record

Vertical acceleration speed at the second shaking of the aircraft varied by increase from +0.82G to +1.50G followed by decrease to 0.31G and increase again to 1.71G (see Figure 4) in approximately three seconds. Besides, echo was not displayed on airborne weather radar of the aircraft. The seat belt sign was turned off because the aircraft kept stable cruising from take-off and climbing until the occurrence of the shaking. Immediately after the occurrence of the shaking, the FO illuminated the seat belt sign, and the aircraft descended to the altitude FL260 and continued the flight. The aircraft landed at Tokyo International Airport at 16:34.

| 3.4 Analysis of Findings | <p>(1) From the history of the flight, it is probable that the shaking of the aircraft corresponded to the abrupt change of vertical acceleration speed recorded in FDR. Due to the shaking, it is probable that there occurred the fierce change of the vertical acceleration speed near the aft cabin of the aircraft as well, and it is highly probable that the cabin attendant, who was on the aisle of the aft cabin, was unable to hold a passenger seat or structures of the aircraft, fell down and had her ankle fractured after feeling that she was floating.</p> <p>(2) It is highly probable that the shaking of the aircraft occurred while it was passing through the side edge of the jet stream. Besides, from angle of attack, wind direction, wind velocity and abrupt change of outside temperature, all of which were recorded in FDR, and VWS region shown in the hourly atmosphere analysis chart as well as echo that was not displayed on airborne weather radar, it is highly probable that the aircraft encountered clear air turbulence that generated on the side edge of the jet stream.</p> <p>(3) It is probable that the jet stream that generated clear air turbulence the aircraft encountered accompanied VWS region in the accident airspace, which had an increased strength at the time of the accident compared to the strength of weather forecast in the pre-flight briefing.</p> <p>(4) From weather information flight crew confirmed prior to the flight and PIREP as well as display of airborne weather radar in-flight, information regarding such a strong turbulence on the flight route as the one that adversely affected the flight operation was not confirmed, and it is probable that they did not predict to suddenly encounter the strong turbulence. However, due to the existence of VWS region on the flight route that became stronger than forecasted at the time when the aircraft was flying, it is probable that it encountered clear air turbulence.</p> <p>(5) In the pre-flight briefing, flight crew instructed cabin attendants to use caution against a possible abrupt shaking from 50 minutes after take-off. On the other hand, flight crew presumed that the shaking that would occur when the aircraft approached VWS region would be light at the beginning and</p> |

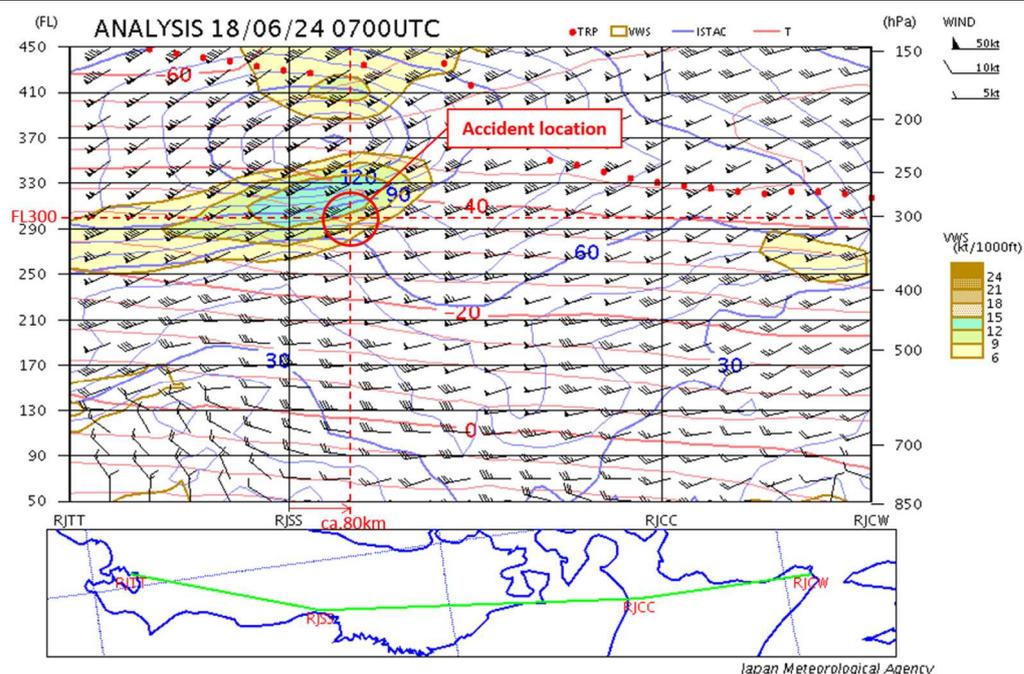
Figure 6: Hourly atmosphere analysis chart
(vertical cross-sectional chart of air route)

| 2.6 Meteorological Information | <p>(1) General Weather Conditions</p> <p>According to Asia Pacific Surface Analysis Chart (excerpt) (see Figure 5) as of 15:00, June 24, 2018, a cold front line extending from a low pressure centered in the Sea of Okhotsk was passing over northern part of Japan and a seasonal rain front was stationary on the sea of southern part of Japan.</p> <p>(2) Hourly Atmosphere Analysis</p> <p>Hourly atmosphere analysis chart (see Figure 6) as of 16:00, June 24, 2018 in the vertical cross-sectional chart of air route indicated that there were jet stream with the maximum wind velocity of about 150 kt centering at FL370 and VWS region of 9 – 12 kt/1,000 ft near the accident site.</p> |

With regard to the encountering of the aircraft with clear air turbulence, it is probable that the existence of VWS region on the flight route of the aircraft, which was stronger than the forecast confirmed prior to the flight, was attributable to the encountering.
