# Aircraft preparation event involving A320, VH-FNP

Perth Airport, Western Australia on 14 August 2018

**ATSB Transport Safety Report**  
Aviation Occurrence Investigation  
AO-2018-063  
Final – 11 September 2019

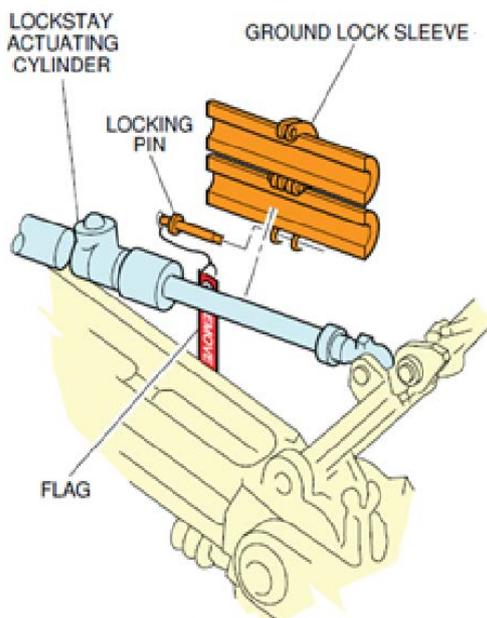
**Figure 1: Schematics showing design of LGGL strut locks**

As shown in Figure 1 and Figure 2, the LGGL have several design features to make them conspicuous. The LGGL sleeves are painted red and the pins have high-visibility flags attached.

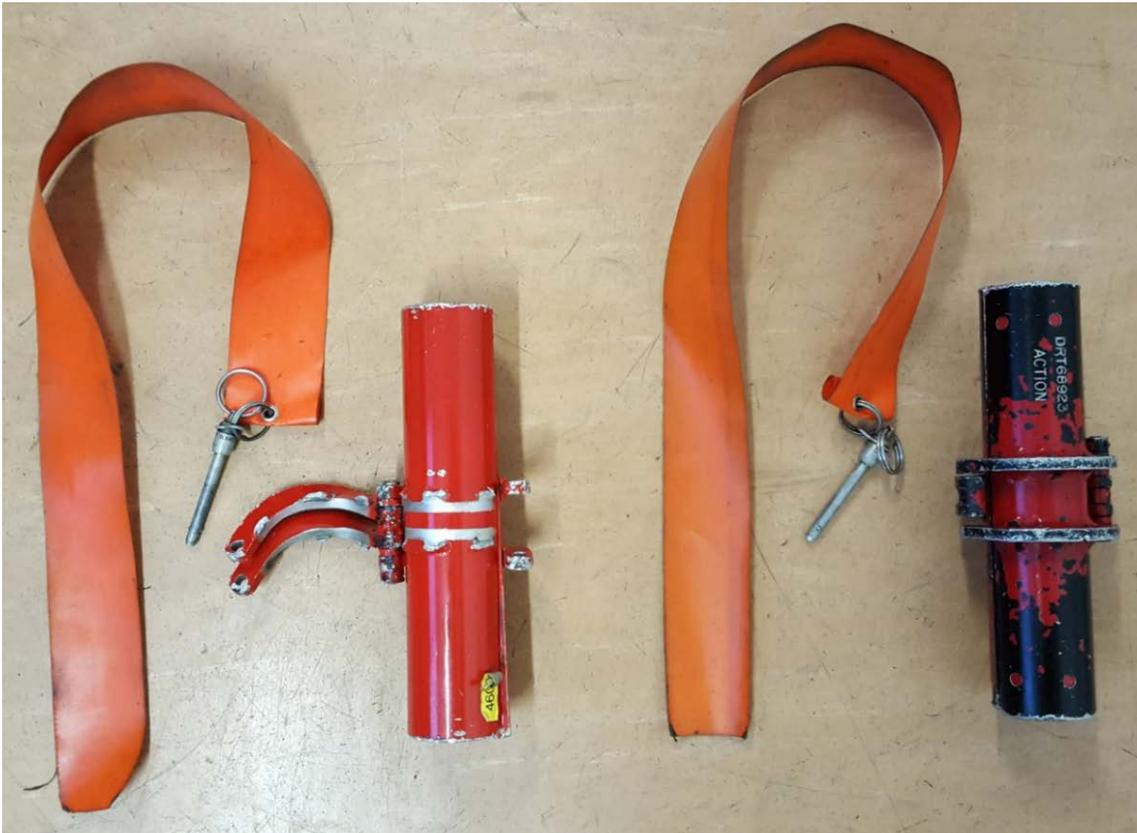
**Figure 2: LGGL pins, flags and sleeves installed on VH-FNP**

Under normal conditions, a wire lanyard secures the LGGL sleeves to the pins, preventing separation of the two components. The lanyards were missing for both sets of LGGL on VH-FNP (FNP), a condition that had not been reported prior to the occurrence. The operator conducted a check across their fleet and missing lanyards were also found on two other aircraft.

As the wire lanyard was missing for both sets of LGGL, there was no physical defence to ensure the sleeves could not be left on the aircraft without the locking pins in place. While a last line of defence, such a simple mechanism would have been an effective protection against an occurrence such as this.
