# Incorrect configuration involving Boeing 737, VH-VUB

near Sydney, NSW, on 12 July 2018

**ATSB Transport Safety Report**  
Aviation Occurrence Investigation  
AO-2018-054  
Final – 30 September 2019

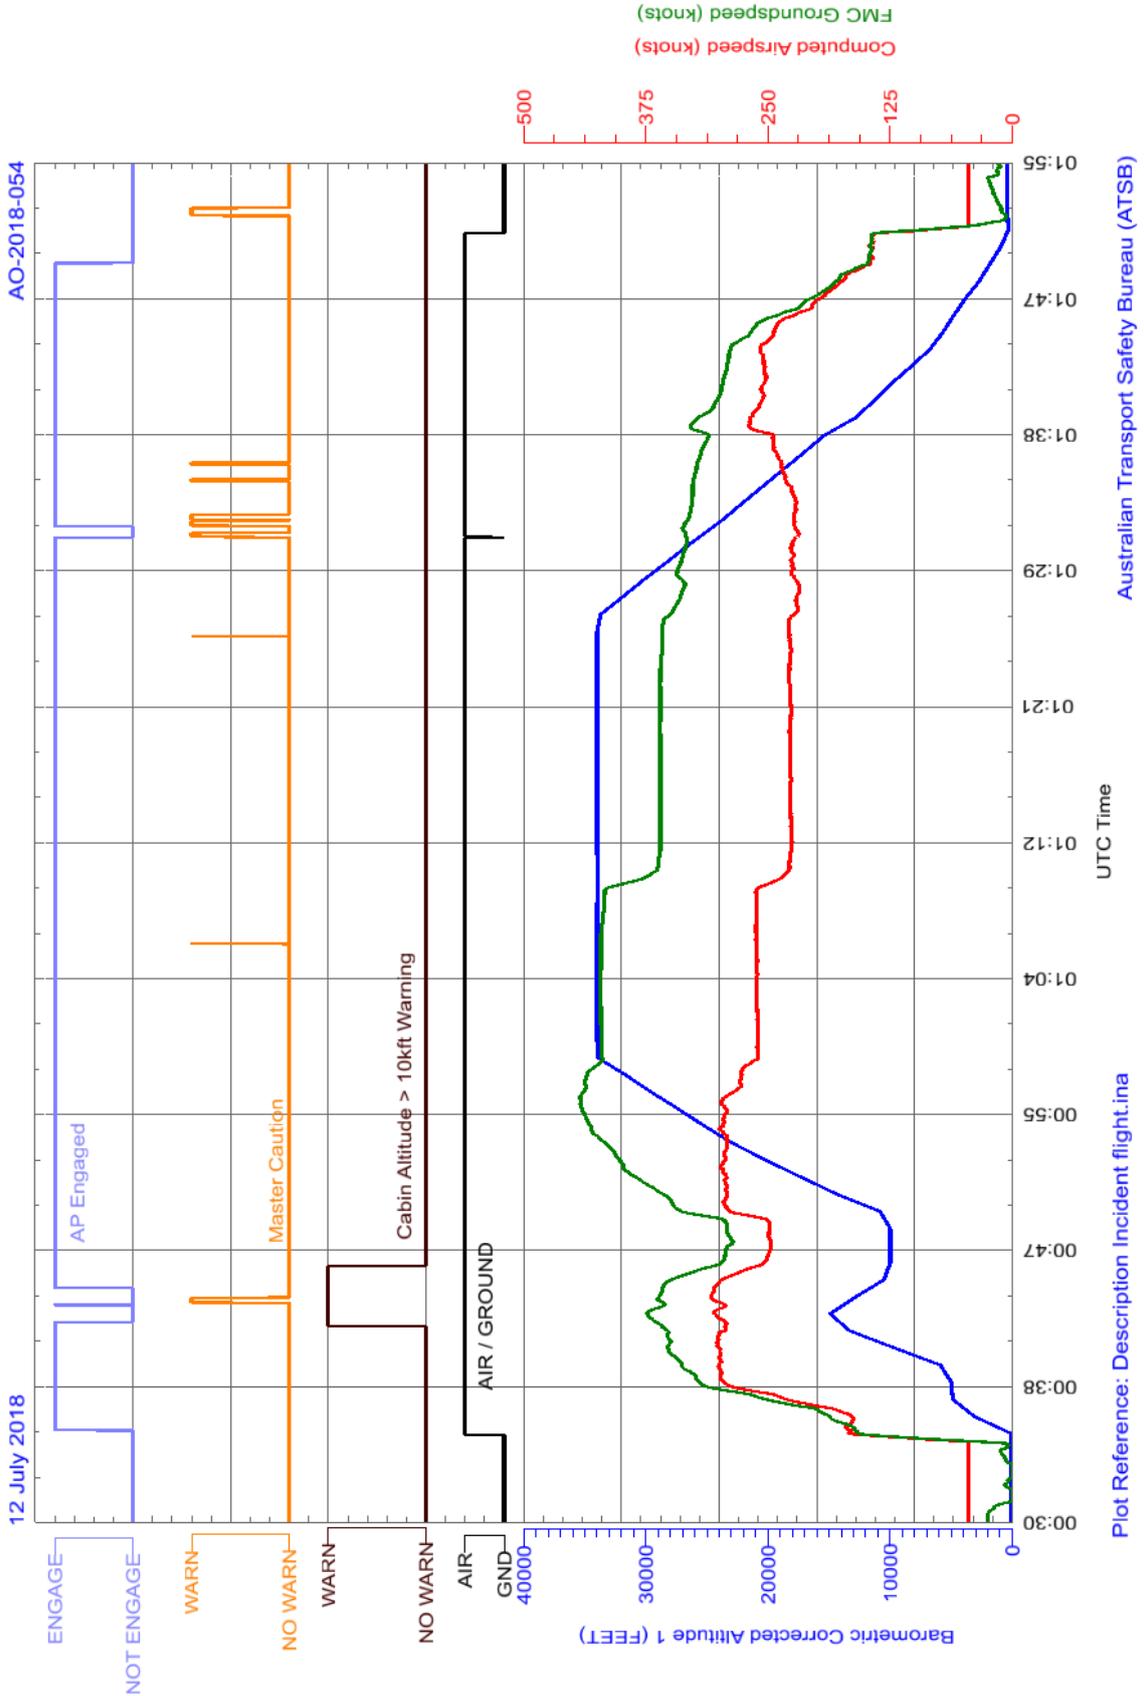
Figure C1: Flight data – Cabin Altitude > 10,000 ft Warning

At about 1142, while the aircraft was still climbing and passing 13,500 ft, the cabin altitude warning horn sounded. The First Officer identified that both air conditioning packs switches were in the OFF position. Both packs were then immediately switched to AUTO. The Captain took over control of the aircraft and selected altitude hold on the autopilot. The aircraft reached a maximum height of 14,900 ft (at about 1144), whereby the Captain disengaged the autopilot and commenced a descent to 10,000 ft. The warning ceased at about 1146. During this time, both pilots donned oxygen masks in accordance with the cabin altitude warning procedure.

The data does not record the highest cabin altitude reached. However, considering that the cabin oxygen masks did not deploy, it is unlikely to have exceeded 14,000 ft. There was nil evidence to suggest settings or events that could have affected the aircraft pressurisation, other than the air conditioning pack switches being OFF.

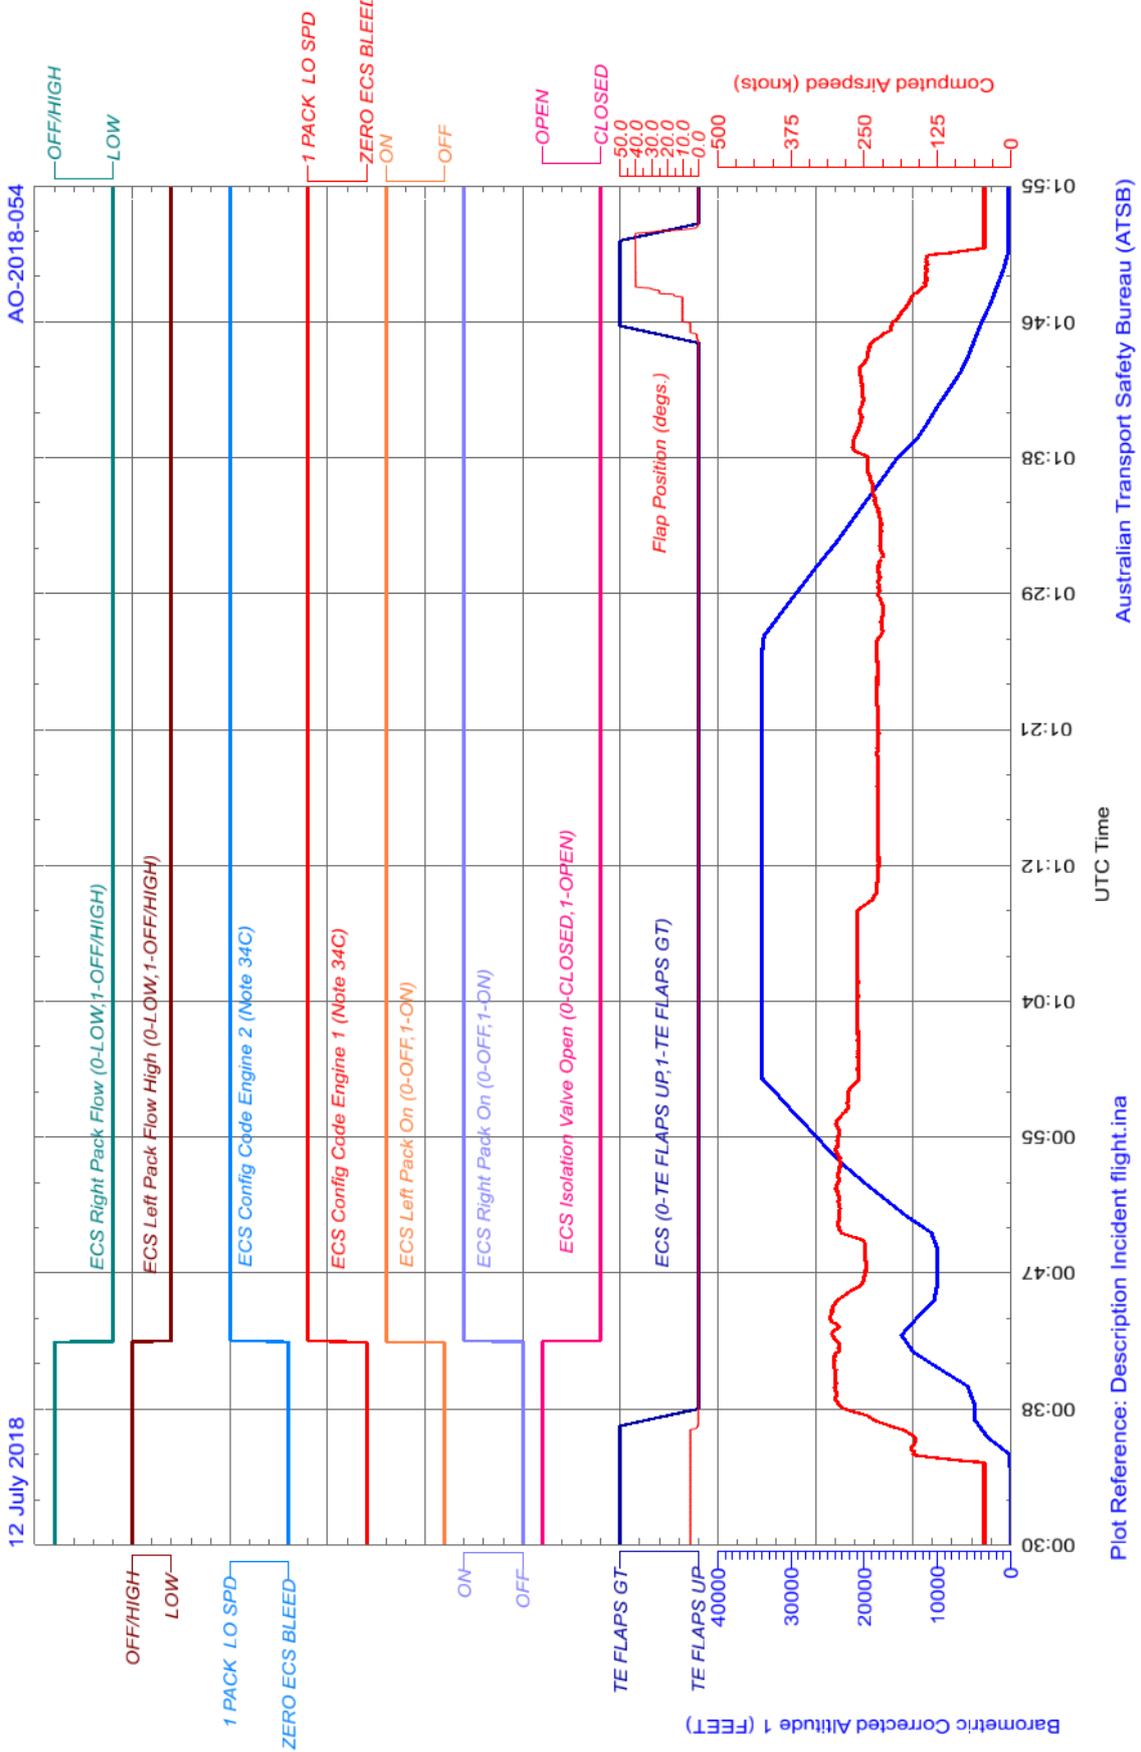
Figure C2: Flight data – Air conditioning pack switch position

- Both engine bleed switches were ON from take-off (departure) until time of warning.
- Both air conditioning packs were OFF from time of take-off (departure) until after warning presented.

<sup>6</sup> Flight data at Appendix C, Figure C2 shows flaps in UP position by 1138.
