# **Aviation Occurrence Investigation**

## **Final Report**

INCID/02/2018

Aircraft Took-off from Engaged Runway

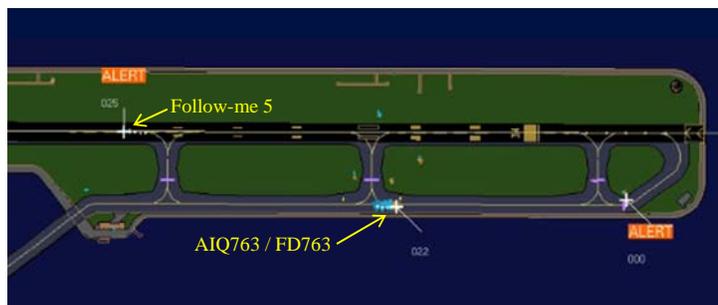
**Figure 3: Position of AIQ763 / FD763 and Follow-me 5 when Take-off clearance was issued**

Tower controller issued take off clearance to AIQ763 / FD763 when Follow-me 5 was on the runway, refer to Figure 3. The status of Follow-me 5 was indicated on the SMR display and flight progress board. Follow-me 5 and AIQ763 / FD763 were moving in the same direction on runway after AIQ763 / FD763 entered runway. The closest distance between Follow-me 5 and AIQ763 / FD763 before airborne was 1,480 meters, refer to Figure 4. According to ICAO Runway Incursion Severity Calculator, the runway incursion is rated as Severity Category C.

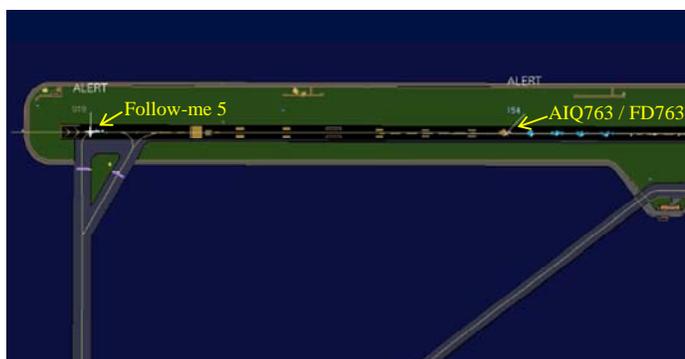
**Figure 4: Closest distance between AIQ763 / FD763 and Follow-me 5**

Follow-me 5 vacated runway at 06:36 and flight AIQ763 / FD763 airborne at around 06:37. According to the positions of aircraft and vehicle indicated on the SMR, the estimated nearest distance between both moving objects was about 1,480 metres or 0.8 nautical miles.

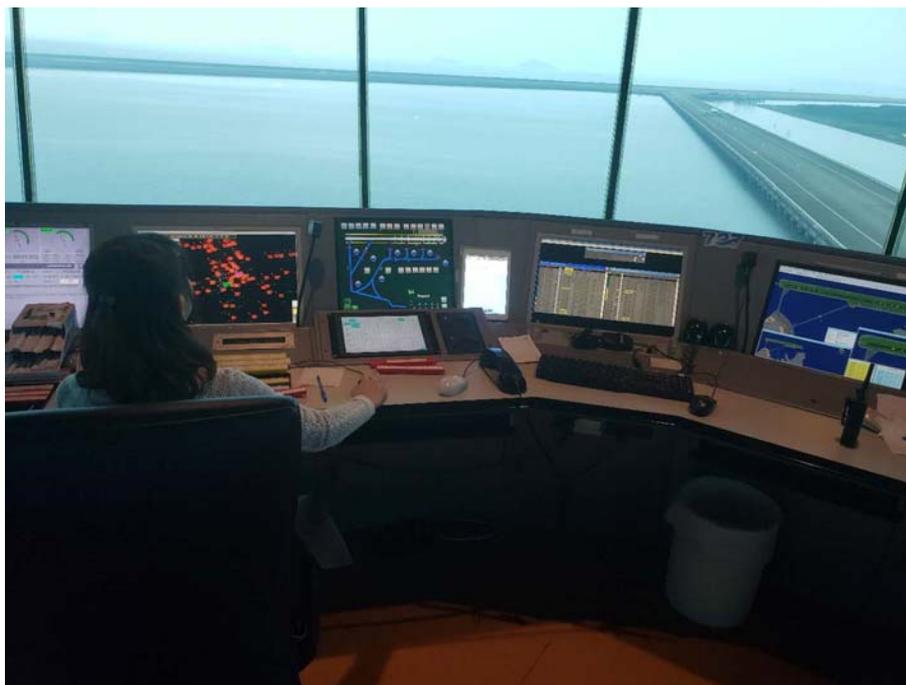
**Figure 5: Controller console (tower position)**

The controller had mentioned during interview that the location of SMR display was a bit far from the tower working position. The controller console (tower position) was setup with total 5 displays being placed horizontally in front of the controller, the controller sat in front of the first and second displays as the flight progress strip was placed there, the SMR display was placed farthest to the right (the 5<sup>th</sup> display).

2. Always maintain the SMR system in good conditions to ensure the ground movement surveillance system is reliable for ATC operations without any adverse effect such as false alert and take into consideration of Human-Machine Interface of controller work stations. Or consider upgrade to a more advance SMR such as Advanced-Surface Movement Guidance and Control system (A-SMGCS).
