Trying too hard?

By Captain Ed Pooley

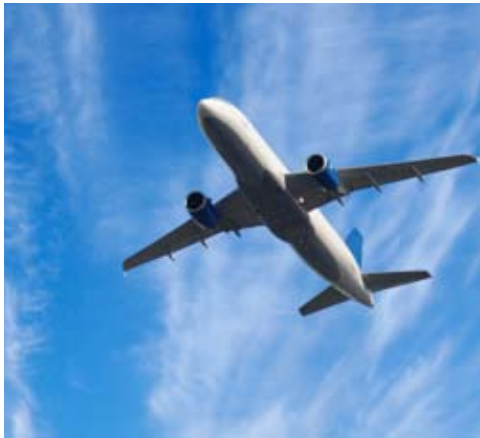
The trainee, having good reason to believe that his mentor was content with the plan, then issued the next aircraft in the departure queue with their "line up and wait after the landing 747" clearance. The British Airways 747 crew then saw the British Midland A321 begin to line up as the mentor at last realised that matters were going to be, at the very least, difficult and took over control of the radio at 1405:10. He advised the 747 to continue and at 1405:20 told the British Midland A321 to "power up against the brakes" and continued the transmission with "you're cleared to take off" - 15 seconds before the minimum one minute departure separation had been reached. Meanwhile the 747 crew realised that their only safe option was going to be to go around and as they were beginning the transition, the mentor followed the A321 take off clearance almost immediately (1405:30) with a cancellation of it and instructed a go around by the 747. The A321 was able to stop after only a short distance as the 747 transitioned to a climb over the top of it. The go around instruction/commencement occurred when the 747 was at about 165 feet agl and the lowest height reached as it commenced go around in the vicinity of the A321 fail fin (just under 39 feet high) was later found to have been 118 feet.....

The Investigation found that what started out as an attempt to be helpful turned into a near disaster because:

- (1) an effective plan to achieve it was not made [poor mentoring];
- (2) when it became clear that it was too late for the plan being followed to work, no action was taken to resolve matters safely [poor judgement and poor mentoring];
- (3) the eventual intervention of the mentor was initially still focussed on achieving the flawed plan [poor judgement].
