# The Ice Particle Threat to Engines in Flight

**This paper discusses jet engine powerloss and damage due to ingestion of ice particles. In the mid-90s several commercial airplane jet engines experienced more frequent powerloss in ice particle conditions, resulting in a focused investigation, and a greater awareness that led to recognition of similar events on other aircraft. Since the mid-90s, events have been more numerous, and costly, and have generated greater industry interest. These events have been predominately associated with flight at high altitude near deep convective systems, often in tropical regions. Data are presented from flight-testing and an event data base to support the contention that the events are caused by ingestion of high concentrations of ice particles, and that supercooled liquid water is either of secondary importance or not required. The basic theory of how ice accretes in the engine by this process is described. Complex issues facing industry to mitigate the problem, and simulation of the ice particle environment are discussed.**

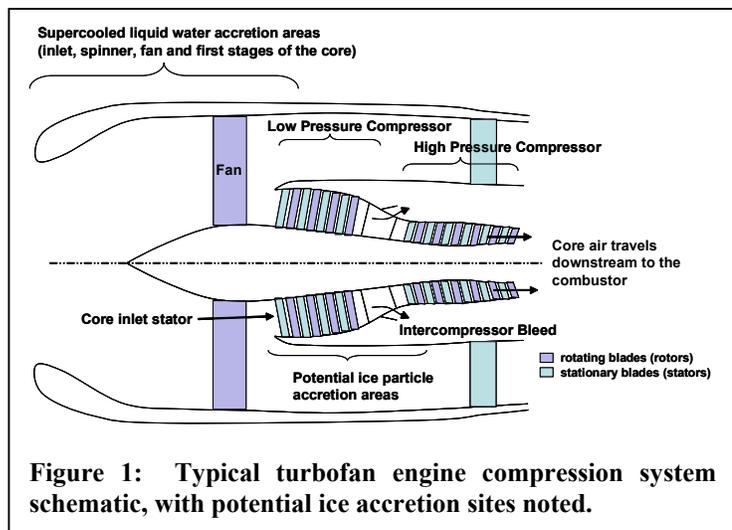
Following considerable research and analysis complemented by flight tests conducted by the airframe and engine manufacturers, the cause of the rollbacks was determined to be the build up of ice on the second stage stator inside the engine core passage (Fig. 1) in ice particle meteorological conditions, and without the presence of significant supercooled liquid water. As the aircraft descended to warmer air at a lower altitude after the event, the ice blockage was released, making the engine recovery process possible. In the case of this specific type of commuter aircraft, results of the investigations have led to successful engine modifications, and events from this commuter aircraft have ceased. The data from one of the flights conducted during this flight test program are described in section IV, and the accretion of ice in the engine is further discussed in section VIIB.

**Figure 1: Typical turbofan engine compression system schematic, with potential ice accretion sites noted.**

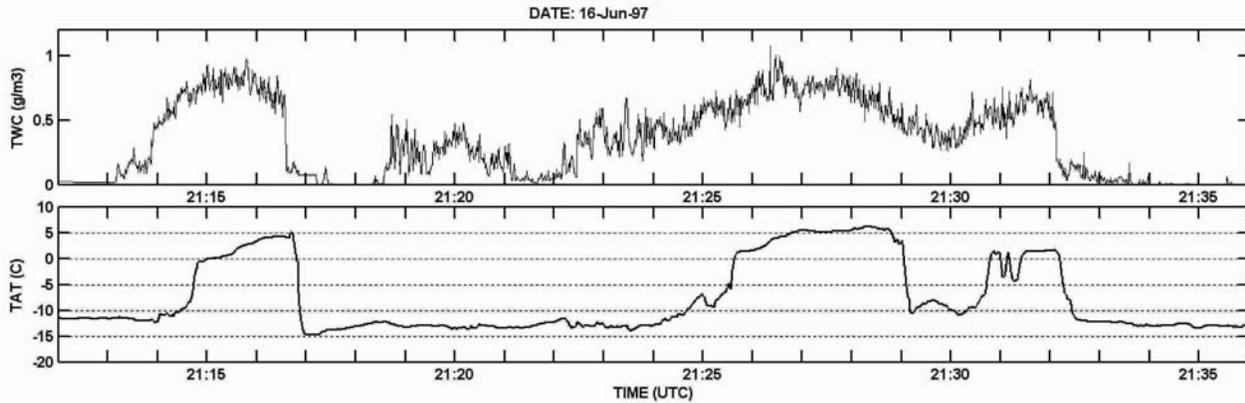
**Figure 6: Time history of TWC (top panel) and Rosemount total air temperature (TAT, bottom panel), showing the TAT ‘anomaly’ caused by ingestion of ice particles, for a portion of the commuter test flight on 16 June 1997.**

The flight test aircraft was equipped with a Rosemount TAT sensor of similar design to those installed on all the aircraft of the event database. Fig. 6 illustrates an example from this project of a TAT anomaly encountered while flying straight and level at an ambient temperature of about  $-26^{\circ}\text{C}$  ( $\text{TAT} \sim -12^{\circ}\text{C}$ ) across a cloud with moderately high IWC. The cloud was determined to contain at most trace amounts of supercooled LWC, because the Rosemount Ice Detector ramp voltage trace was very flat during this entire pass (not shown). Shortly after the estimated IWC (top panel) rose in the first cloud encounter ( $\sim 21:14$  UTC), the TAT (bottom panel) also rose from an undisturbed value of about  $-12^{\circ}\text{C}$  to a plateau value of about  $0^{\circ}\text{C}$ , but then continued to rise to about  $5^{\circ}\text{C}$ . On exit from the high IWC region, the temperature quickly dropped back to approximate pre-cloud values. Similar behavior was observed during a second cloud encounter from 21:22-21:32, although there did not appear to be much TAT effect in a lower IWC cloud between the two high IWC clouds. In fact, for this case, the anomaly appeared to trigger within 60 seconds of the IWC exceeding  $0.5\text{ gm}^{-3}$ , and had cleared within 30 seconds of the IWC dropping below  $0.5\text{ gm}^{-3}$ . Lawson et al. (1998)<sup>1</sup> have discussed the TAT anomaly at length, and have displayed a similar figure illustrating the correlation of temperature change to apparent IWC, and the rapid clearing of the probe after exit from ice particle conditions. They pointed out that a similar TAT experience had been reported by Holland et al. (1984)<sup>9</sup> while flying in a broad convective outflow region of a tropical storm near Australia, and incorrectly interpreted as an intrusion of warm air from the stratosphere. The same misinterpretation of the TAT anomaly as a warm zone was made at the initial stage of this commuter engine event investigation. Lawson et al. (1998)<sup>1</sup> further reported that wind tunnel testing by the probe manufacturer confirmed that it could ice up in super cooled liquid water/ice particle concentrations that could have been encountered during rollback events.

As in Lawson et al. (1998)<sup>1</sup>, in this article we link the TAT anomaly to ingestion of ice particles, presumably which block the airflow through the heated housing, and corrupt the measurement. Further information on the incidence of the TAT anomaly is available from the event database. All the aircraft involved in the 46 engine powerloss cases (both large transport and commuter aircraft) investigated in this report are equipped with a total air temperature (TAT) probe of similar design. The event database contains four engine events in which a TAT anomaly was observed at an outside air temperature below  $-40^{\circ}\text{C}$ , the minimum temperature at which supercooled LWC can occur. Furthermore, of the 35 cases in the event database in which the existence of a TAT anomaly could be determined from available data, in only one of those cases was there a conclusive report of some airframe icing. It is therefore concluded that TAT icing occurs in glaciated cloud, as it did in the case study above, and all but one

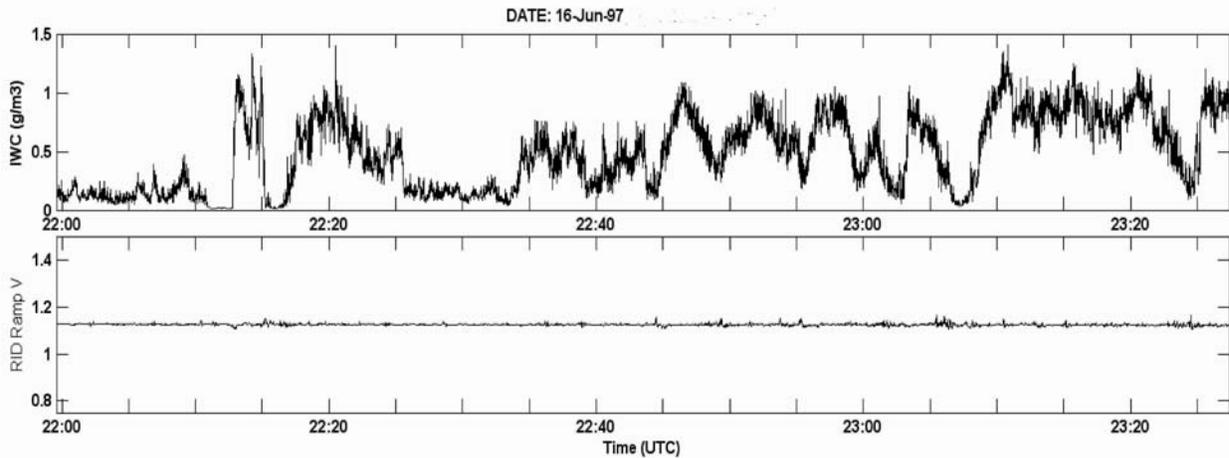
**Figure 7. Time history of estimated TWC (top panel), and Rosemount Ice Detector (RID) Ramp Voltage (lower panel) during an orbit at 8800 m and  $-28$  C downwind of an isolated cumulonimbus cloud. An engine rollback process was completed between 23:13-23:28.**

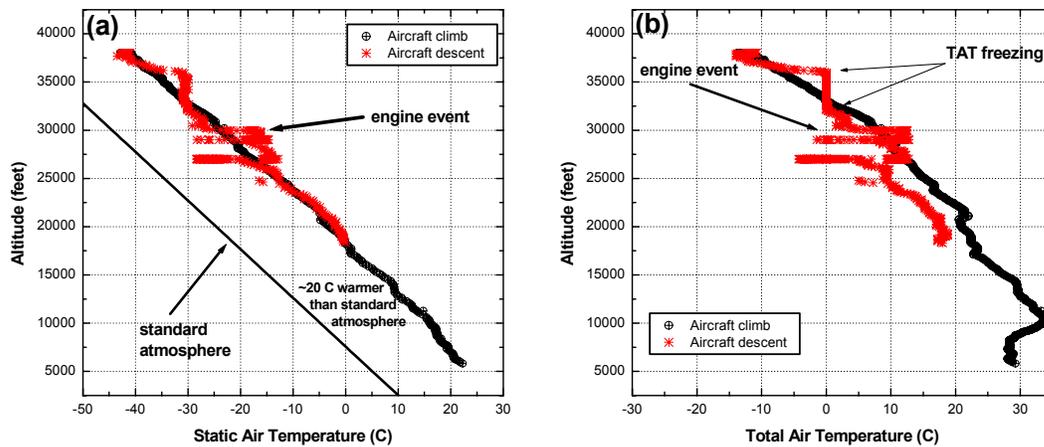
Below 32,000', the TAT is erratic, with perturbations towards warmer temperatures until about 26,000', after

**Figure 10: Static air Temperature (a) and Total Air Temperature (b) measured during climb from Hong Kong (black symbols) and during descent towards Taipei (red symbols), illustrating the TAT anomaly observed before the engine event**

which point it resumes normal behavior. Based on the correlation between TAT and IWC observed in Fig. 6, it is therefore surmised that the aircraft entered a region of high IWC at about 37,000' (~ -40°C) that continued to at least 32,000' (~ -28°C). The timing of the event can be observed in Fig. 11. The TAT anomaly commences shortly after 12:46, and continues until at least 12:50. The engine powerloss occurs at 12:52:58, or about 7 minutes after entering the region of presumed high IWC. It is uncertain what can be inferred from the continued peculiar TAT behavior after the engine event. The elevated readings between 12:51 and 13:01, implying significantly higher than the expected SAT values, may be some unknown clearing behavior of the probe as the TAT goes above 0°C. It is therefore impossible to speculate in this case on whether further high IWC regions were encountered during this later period. However, a second characteristic region of TAT pegging to 0 C is observed at 27,000' and -22°C from approximately 13:01:30 – 13:03:30, and shortly thereafter the temperature probe clears and provides SAT values similar to the climb profile.

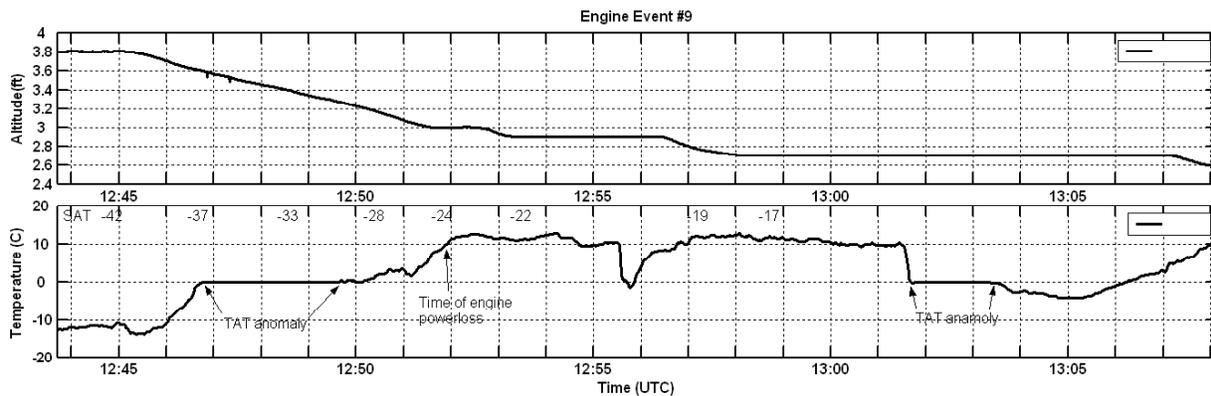
**Figure 11: Time history of altitude and Total Air Temperature (TAT), surrounding the time of the engine event at 12:52:58. The estimated Static Air Temperatures (SAT) are shown in text at the top of the lower panel for reference. Note the time of powerloss is identified in figure.**

The crew reported a multiple engine shutdown at 30,000' (~12:52:58 UTC). The multiple engine failure checklist was immediately performed, and the engines recovered to idle within 75 seconds. The aircraft was flown without further incident to its intended landing in Taipei approximately 20 minutes later.

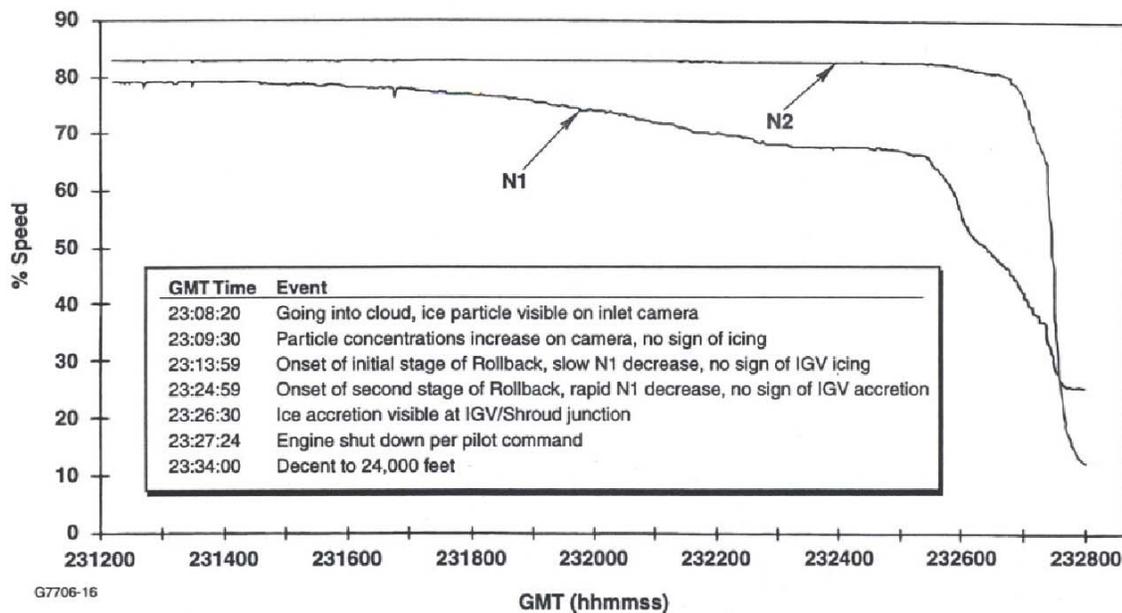
Test results on the rollback engine clearly showed that all engine parts visible on the inlet camera were free of ice during the initial slow speed decay stage of the rollback event. These included the fan spinner, a rotating fan rotor and the first stage compressor stator vanes at the engine core passage inlet. Ice formation on the core inlet vanes was visible after the engine rollback occurred, because the engine core and fan speeds had significantly reduced and could no longer support the energy requirement of the inlet anti-ice system. A correlation of the cloud microphysical data, and the engine data plotted in Fig. 12, showed that the onset of the initial rollback stage took place 5 minutes and 40 seconds after cloud entry. The flight test rollback scenario was similar to all the recorded

**Figure 12: Engine data from the rollback test flight described in section IV, with text description of the cloud and engine observations. N1 and N2 are the fan and core speed respectively**

field events in that the engine remained on a slow decay stage for seven minutes before the onset of a rapid decay stage. The test data supports the theory that icing blockage of the flow path behind the first compressor stator vanes was the root cause of the engine incidents. Thermocouple data, shown in Fig. 13, recorded on stator vanes further downstream of the core inlet also supported this theory. The data taken on the unmodified (build-of-material) compressor second stage stator vanes, also known as exit guide vanes (EGV), indicated a rapid surface metal temperature reduction soon after entry into the cloud. The temperature hovered around the freezing point (within instrumentation errors) until the onset of the rapid decay stage of the rollback. This period of freezing point measurements was an indication that ice was accreting continuously on the EGV surfaces. This temperature data indicated that ice started to accrete on the EGV surfaces soon after cloud entry, creating blockage and initiating the slow decay stage of the rollback. Ice continued to build and pressure loss increased until the final rapid decay stage of the rollback was reached. In the rapid decay stage, the local air temperature dropped below freezing. In this stage, due to the rollback rotor speeds, the fan and compressor could no longer increase the local air temperature and therefore the entire front section of the engine was bathed in cold ambient air, as reflected in the metal temperature measurements. The ice accreted on the EGV and the metal temperatures underneath the ice followed this temperature trend.

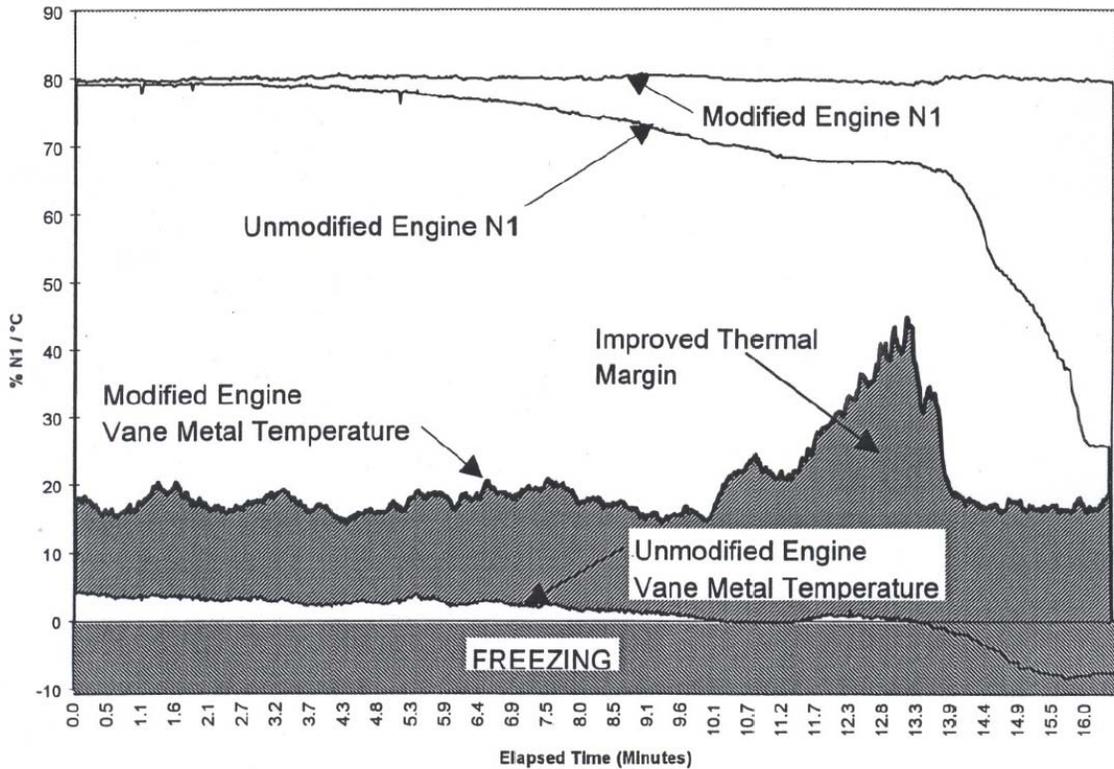
**Figure 13: Modified and unmodified engine vane metal temperature for the period as Fig. 12. Elapsed time is from 23:12:00 UTC.**

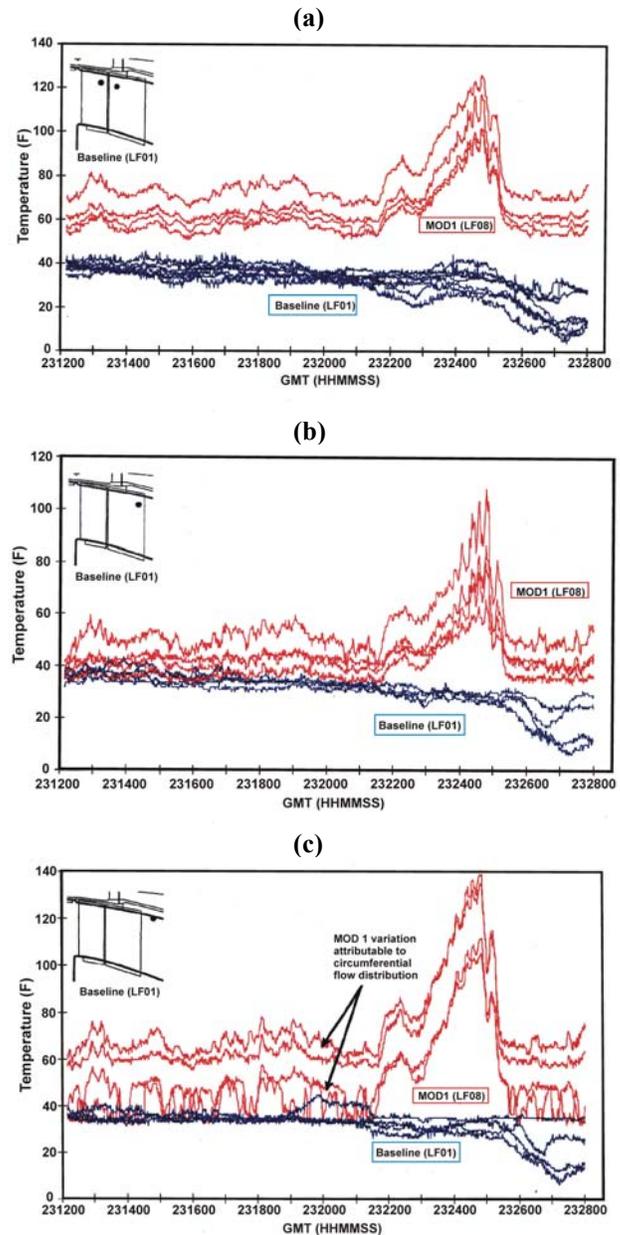
This engine utilized a unique dual-airfoil EGV design as shown in Fig. 14. During the initial investigation of the rollback events, it was suspected that ice was accreting at the junction of the front vane trailing edge and the aft vane leading edge only. However, since freezing point temperature measurements were recorded in many locations on the EGV which included the junction point (Fig.14a blue curve), the trailing edge of the aft vane (Fig.14b blue curve), and the flow path shroud wall immediately behind the EGV (Fig.14c blue curve), these data dismissed the speculation that the dual-airfoil vane was the primary reason for ice blockage. It was concluded that any unheated airfoil located at the EGV location with similar turning characteristics would produce ice accretion and the associated flow blockage.

This flight test yielded the evidence that ice accretion may occur on engine component surfaces where local air temperatures under normal operation are significantly above freezing. The exact mechanism for ice accretion is not fully understood at this time, however, a hypothesis was developed based on the flight test results as follows. As soon as the engine enters glaciated/mixed phase conditions, both liquid and ice particles coexist on the warm EGV surfaces. The presence of liquid on the surface slows down the ice particles, allowing heat transfer between the metal and ice particles to take place. Heat removed from the metal reduces its temperature until the freezing point is reached, and ice forms. After this point, it is contended that further impingement of liquid and ice particles on the metal surface would accrete as ice even with a local air temperature higher than 0 degrees C. Accretion will continue to grow as long as both liquid water and ice particles continue to impinge on the ice surface, increasing the size of the blockage until the engine can no longer function properly. It should be noted that liquid water is a necessary condition locally at the EGV for ice accretion to continue. If there is no liquid water in the air stream, ice particles will bounce off the iced EGV surface in a way similar to what happens on the wing or the inlet of the engine. This phenomenon has also been observed in mixed phase icing tests with supercooled liquid droplets and ice particles performed by Al Kahlil et al. (2003)<sup>25</sup> in the Cox and Co. LeClerc icing wind tunnel. Since significant amounts of supercooled liquid water were not recorded by the weather instrumentation during the flight test, it is hypothesized that either only a very small amount of liquid water, ingested by the engine, is required for this process or that the liquid water impacting the EGV is actually produced by the melting of minute ice particles as they pass through the front section of the engine. Further research is required to identify the source of this liquid.

**Figures 14 a-c: Thermocouple temperatures on the Exit Guide Vanes of the modified (MOD1) and unmodified (Baseline) engines during the rollback flight test described in section IV. Inset geometry shows location of thermocouple for each figure**

The modified engine hardware incorporated an anti-ice heat supply within the EGV. Its metal temperatures remained above freezing during the entire flight test, indicating ice-free metal surfaces throughout (Figs.14a-14c, red

curves). Further analysis indicated that the heat provided was sufficient to maintain ice-free surfaces for the glaciated/mixed phase icing envelope identified for this series of engine incidents.
