Air Accident Investigation Sector

- Final Report -

AAIS Case N°: AIFN/0010/2017

Descent below Cleared Altitude during Approach and FMS not reconfigured following a reset during the Second Approach

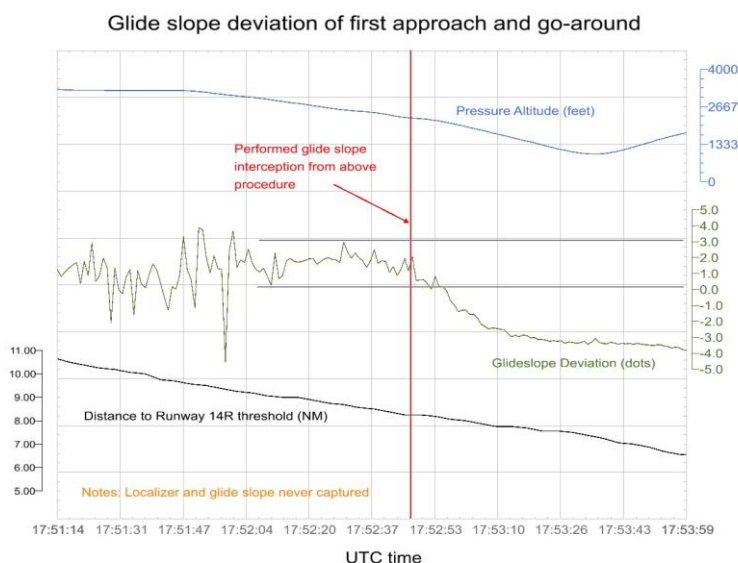
Figure 32. Glideslope deviation of the first approach and the go-around

The Aircraft never captured or established on the localizer, nor did it capture the glideslope.

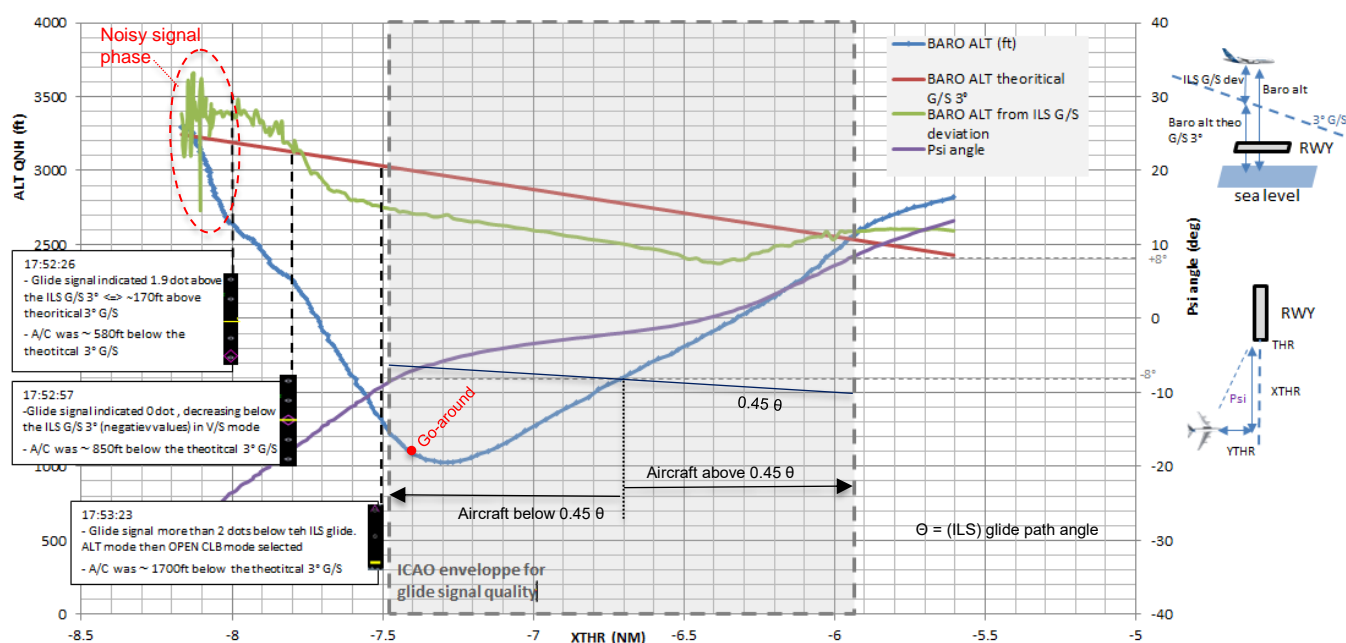
Figure 33. Selected Aircraft parameters as a function of the distance to the runway 14R threshold

deviation indication indicated that the Aircraft was on profile. Following this, the actual Aircraft height continued to decrease.

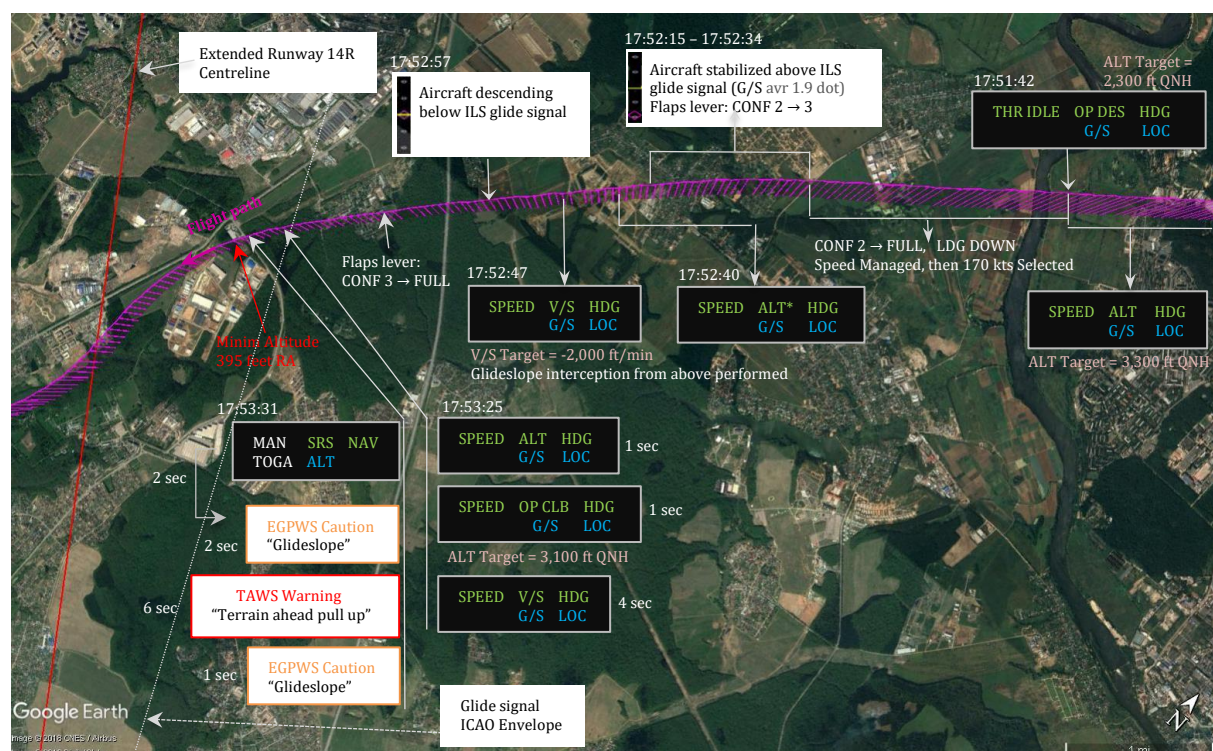
Figure 34. Aircraft trajectory of the first approach and the go-around

Neither pilot was aware that the Aircraft was descending below 500 meters QFE until the instruction 'not to descend further' came from the Radar Controller. On receiving this instruction, the Commander then decided to initiate an immediate go-around. He declared his intention to the Radar Controller approximately three seconds after the "not to descend" instruction.

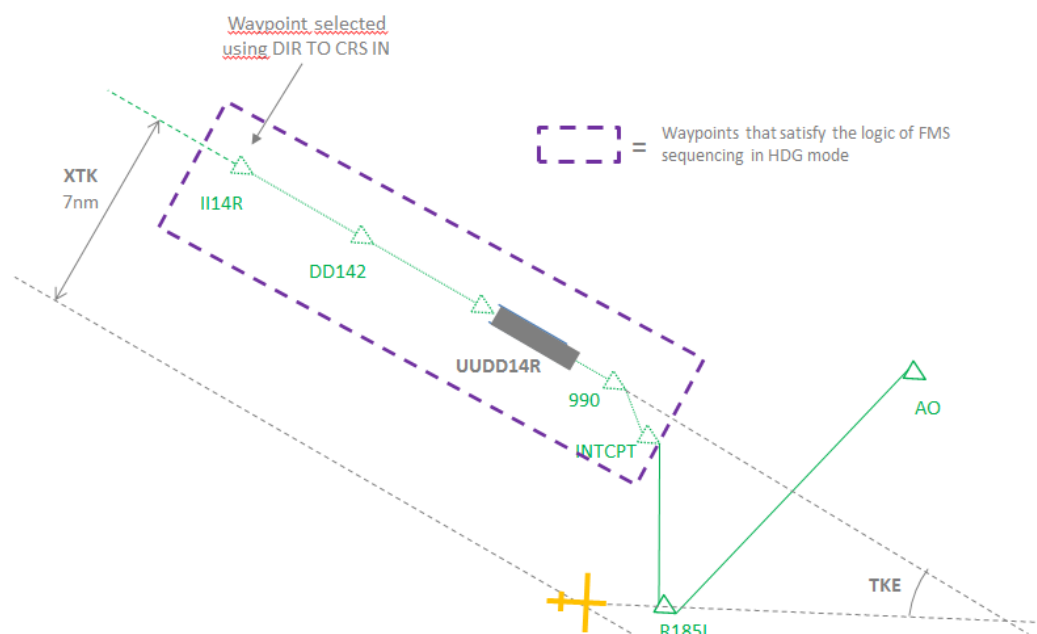
Figure 35. Illustration of the logic of waypoints sequencing

- (f) As the flight crew prepared for the second approach, a multi-waypoint sequencing in a row of the flight plan occurred when the crew performed a lateral revision of the flight plan using the DIR TO CRS IN pushbutton as per the SOP at a location where several waypoints satisfied the FMS geometrical waypoint sequencing rules. A real time computation issue caused an automatic reset of FMS1.

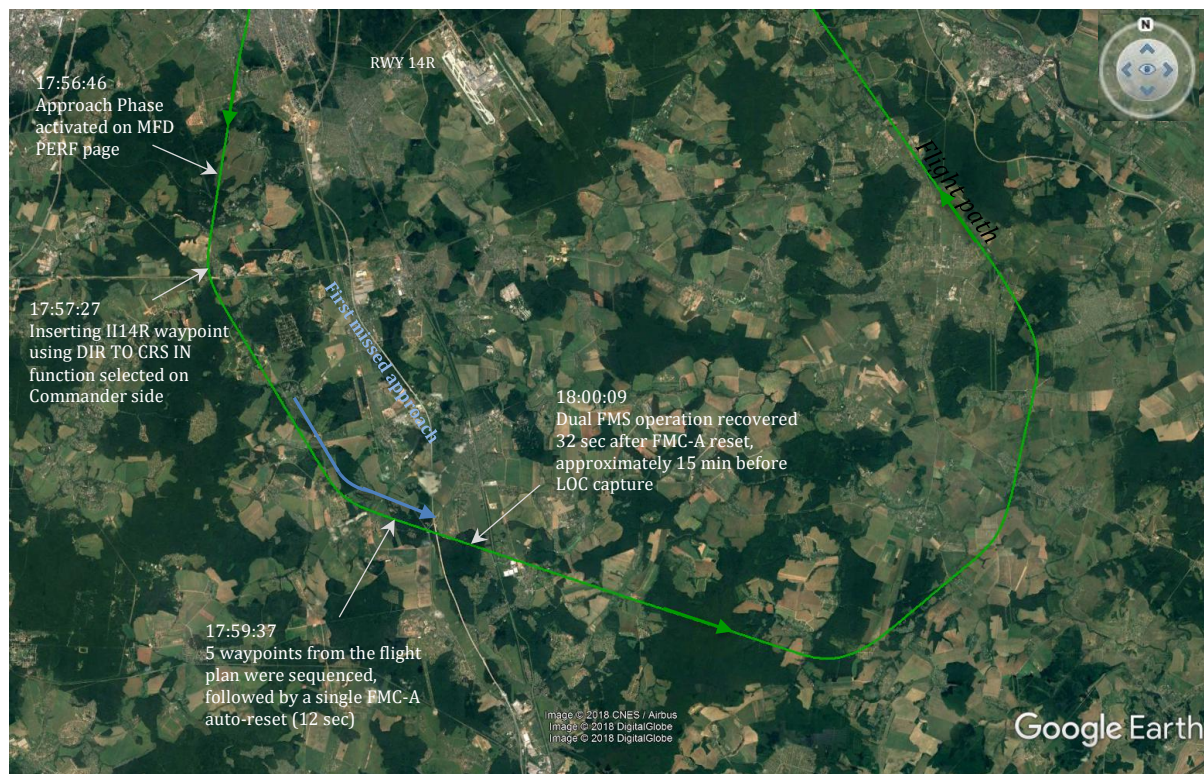
Figure 36. Aircraft trajectory after the go-around and preparation for the second approach

Consecutively to the multi-waypoint sequencing by the FMS, the FMS2 (FMC-B) and backup on standby (FMC-C) remained in its normal state during the FMS1 auto-reset. During this period, 'MAP NOT AVAIL' (in red), and 'FMS PAGE NOT AVAIL' (in amber) messages were displayed on the ND and MFD, respectively, on the Commander's side only. The flight plan was not lost and was still displayed on the Co-pilot's ND and MFD. Nominal dual FMS operation was fully recovered approximately 32 seconds after the single FMS1 auto-reset.

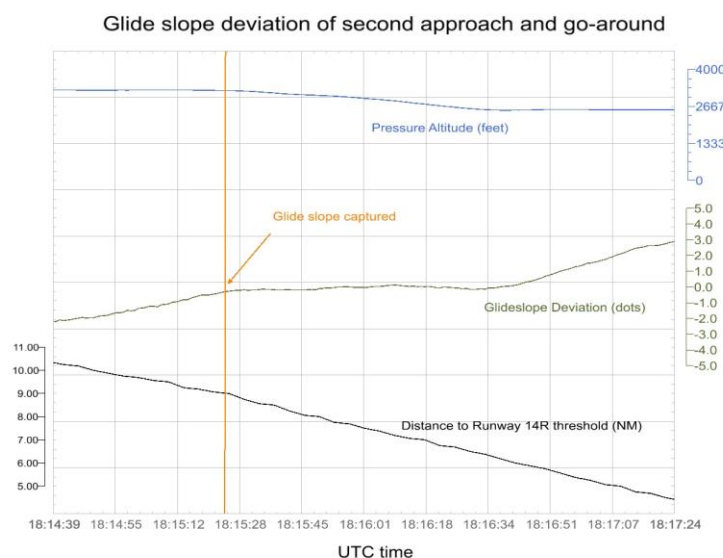
Figure 37. Glideslope deviation for the second approach and discontinued approach

Until the selection of the UDD14R waypoint using the DIR TO function, the Aircraft followed the glideslope, as shown in figure 37, the glideslope deviation indication showed approximately on the profile.

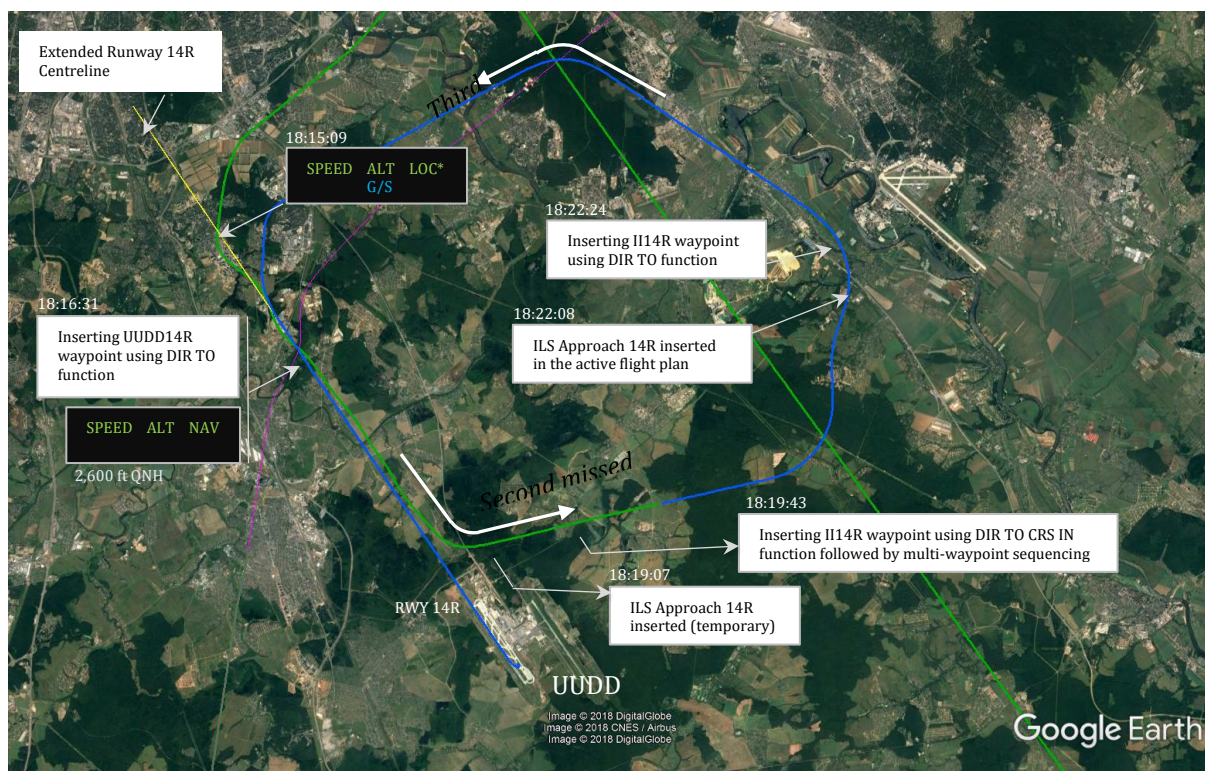
Figure 38. Aircraft trajectory of the discontinued approach, the third approach, and the landing

When the Aircraft was turning left onto the downwind leg at approximately 8.3 nautical miles from the extended runway centerline, the AO waypoint was inserted using the DIR TO function. Twenty four seconds later, a new destination from the AO waypoint was inserted into the temporary flight plan. The Investigation believes that the Commander performed both insertions. The Investigation believes that these insertions were made to anticipate and prevent a similar FMS auto-reset issue on the third approach attempt.

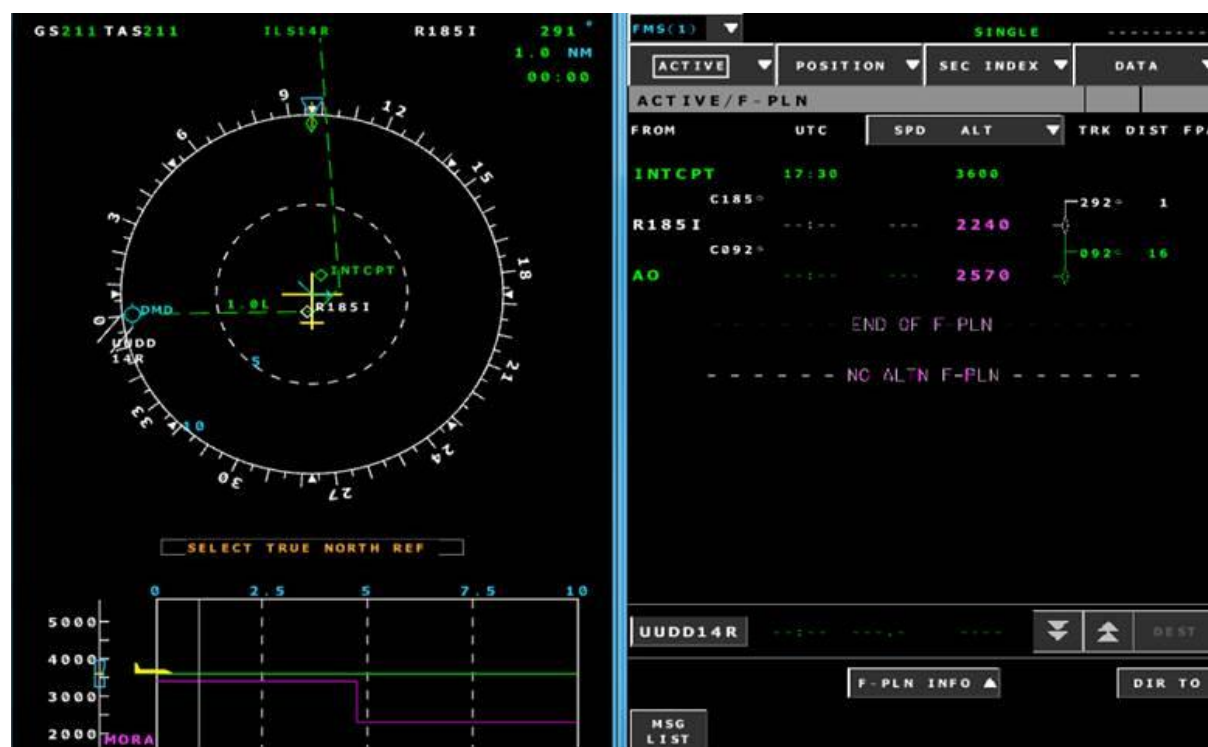
Figure A1.7 – Illustration of FMS flight plan displays on MFD and ND after multi-waypoint sequencing on Co-pilot side and after FMS 1 (FMC-A) recovery on Commander side

The figure A1.7 below illustrates the displayed FMS flight plan on the ND and MFD after the multi-waypoint sequencing on the Co-pilot side, and after FMS 1 (FMC-A) recovery on the Commander side.
