SERIOUS INCIDENT

Aircraft Type and Registration:	Airbus A321-231, G-EUXJ
No & Type of Engines:	2 International Aero Engine V2533-A5 turbofan engines
Year of Manufacture:	2007 (Serial no: 3081)
Date & Time (UTC):	24 November 2019 at 1820 hrs
Location:	On takeoff from Glasgow Airport
Type of Flight:	Commercial Air Transport (Passenger)
Persons on Board:	Crew - 8 Passengers - 208
Injuries:	Crew - None Passengers - None
Nature of Damage:	None
Commander's Licence:	Airline Transport Pilot's Licence
Commander's Age:	57 years
Commander's Flying Experience:	20,593 hours (of which 12,061 were on type) Last 90 days - 148 hours Last 28 days - 62 hours
Information Source:	Aircraft Accident Report Form submitted by the pilot and further enquiries by the AAIB

Synopsis

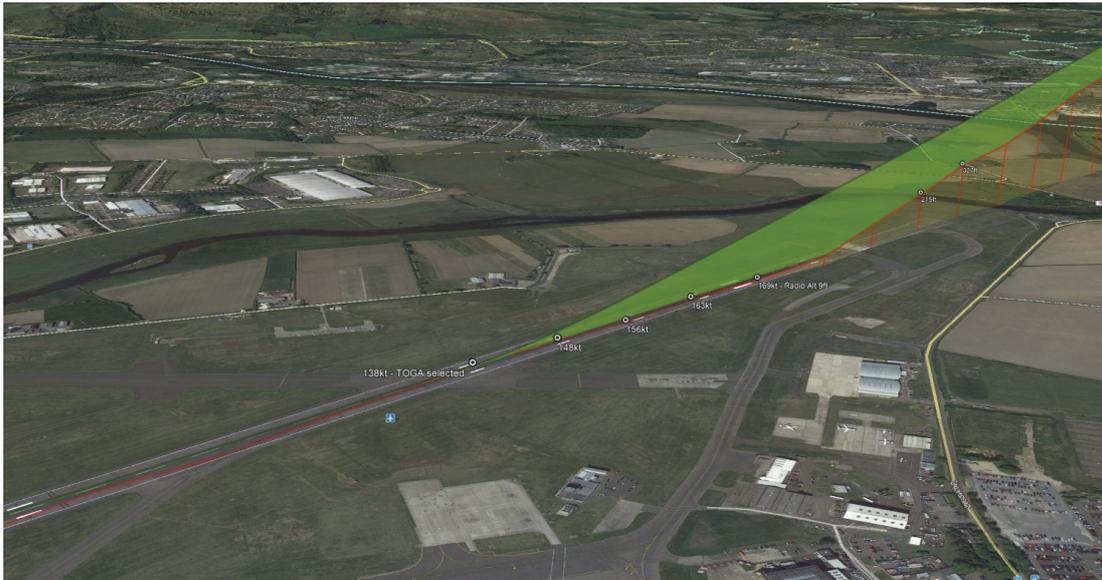
Figure 1
G-EUXJ takeoff profile

During the takeoff roll both pilots reported that they felt something was wrong, they felt the aircraft was not accelerating as they expected. The commander reported that “something was not right but I could not put my finger on it”. At approximately 100 kt the co-pilot verbalised “this does not feel right, have we got enough power”. At 137 kt the commander advanced the thrust levers to TOGA⁴ power. The co-pilot recalled the aircraft had entered the last 900 m of the runway when the aircraft rotated. Subsequent flight data showed that the aircraft crossed the upwind end of the runway at 276 ft. The aircraft continued to Heathrow without further incident.

After takeoff, the flight crew realised they had entered a flex temperature of 79°C instead of 49°C.

The operator provided a copy of the flight data during the takeoff. Figure 1 shows the takeoff profile in red with an approximation of the expected profile in green.
