## Accident to BOEING 777-328ER registered F-GSQL

on 16 September 2018

at Sir Seewoosagur Ramgoolam airport (Mauritius)

## In-flight retail trolley comes loose during take-off run, hitting passengers

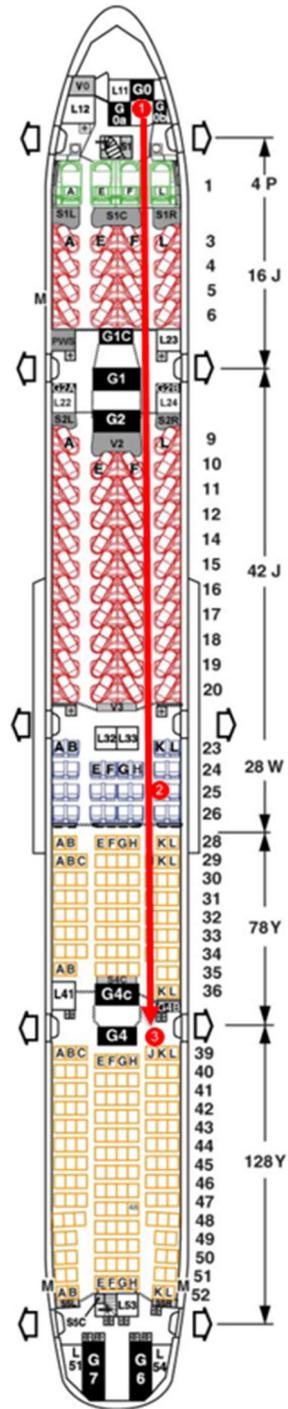
On the application of thrust, an in-flight retail trolley located at the front of the aircraft in galley G0 (point ❶ in Figure 1) came out of its stowage slot, rolled down the right-hand aisle of the cabin and came to a stop at seat 39J (point ❸). The trolley injured eight passengers along the way. The passenger sitting in seat 25K (point ❷), who was leaning over into the aisle, suffered a serious face injury.

Figure 1: Cabin configuration of F-GSQL and route taken by the in-flight retail trolley

On the application of thrust, the in-flight retail trolley, which was not held in place by the locking latches, came out of its stowage slot, without it being possible for the cabin crew member at station 10 to prevent it from rolling away. The trolley hurtled down the right-hand aisle of the cabin, hitting several passengers and seriously injuring one passenger in the face.

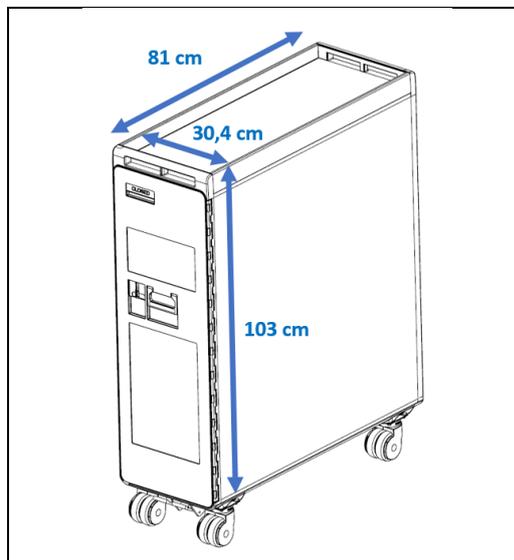
The in-flight retail trolley is located at the front of the cabin, opposite the right-hand aisle. It is locked into its stowage slot using red latches that are located at the top of the slot.

Figure 4: diagram of an in-flight retail trolley

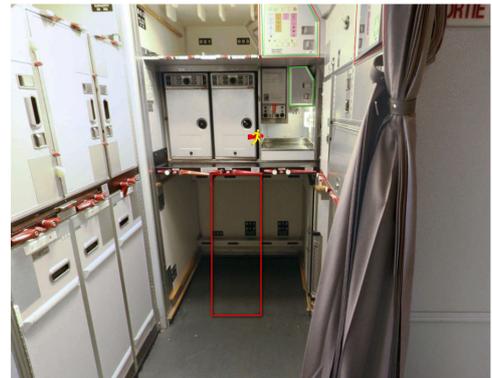
Figure 5: slot in galley G0 where the in-flight retail trolley is stowed (shown in red)

When the cabin crew member at station 10 took up her position, she checked galley G0, for which she was responsible. The investigation was unable to determine whether the position of the locking tabs for the in-flight retail trolley had been properly checked or whether the trolley had been handled after the check.

Following this occurrence, the operator's flight safety department issued an internal "Safety First" memo to all cabin crew reminding them of the general principles of cabin checks and cabin-ready confirmations. In particular, it states that securing the galleys is a priority and must be done before the aircraft pushback. In addition, it is specified that passenger services shall be provided after take-off when necessary, in order to give priority to preparing the aircraft and completing safety procedures. It is also recalled that the "cabin ready message sent" type announcement is not a standard procedure and is to be avoided, as it encourages violations (cabin crew not strapping in immediately after reporting to the purser) and leads to a normalization of non-standard practices and the corresponding risks (cabin crew expecting an announcement at each flight and exposing themselves to injuries).
