Incident to the Airbus A319
registered **F-GRHT**
on 12 March 2014
at Paris - Charles de Gaulle

This is a courtesy translation by the BEA of the Final Report on the Safety Investigation published in January 2020. As accurate as the translation may be, the original text in French is the work of reference.

**Failure of the fuel quantity indicating computer,
insufficient refuelling and shut-down
of one engine during descent**

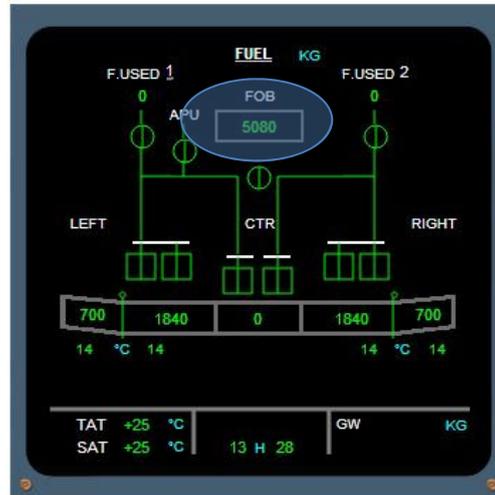
The next crew was to carry out a four-leg rotation departing from Marseille. During the flight preparation, the crew learnt of the complaint recorded in the ATL by the previous crew regarding the fluctuating fuel. For the first leg, the crew decided to carry 5,000 kg of fuel. Because the ATL and the aircraft's gauges indicated an FOB of 3,780 kg (J), the crew requested an additional 1,200 kg of fuel. The crew checked the fuel uplift and that the fuel was distributed normally in the tanks. The crew reported that the outer tanks were full. The aircraft's gauges indicated an FOB of 5,080 kg.

Figure 1: simulation of the FUEL page of the SD⁽⁴⁾ after refuelling

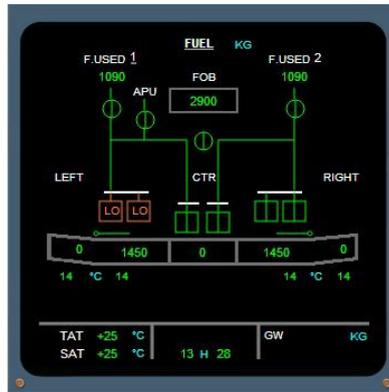
At 13:35:54, while descending to FL80, a drop in pressure in both left engine fuel pumps triggered the “Fuel Left Tank Pump 1+2 Low Pressure” warning. The crew performed the actions of the associated procedure.

Figure 2: simulation of the FUEL page after the “FUEL L TK PUMP 2 LO PR” warning

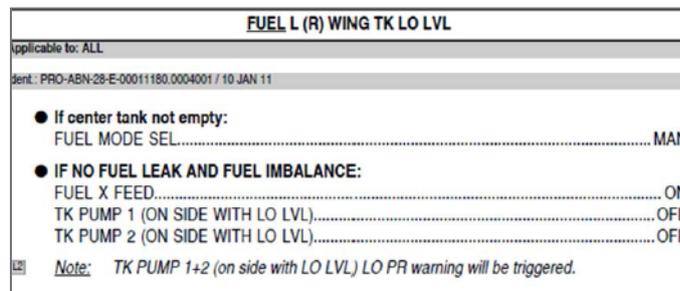
Figure 4: "FUEL L(R) WING TK LO LVL" SOP⁽⁹⁾

When a low fuel level alert is triggered, the crew must carry out a fuel transfer (opening of the X-FEED valve) if they detect an imbalance in the fuel quantity and the tanks are not leaking. To do this, the crew has the fuel quantity information provided by the FQIC.

During the incident flight, the fuel quantity calculations show that, at the time the low level warning was triggered, the information provided by the FQIC did not suggest to the crew that there was any leak or imbalance that would require the cross-feed valve to be opened in accordance with procedure. Thus, if an FQIC malfunction occurs, the procedure associated with the low fuel level alert being triggered does not prevent the engine from shutting down due to a fuel supply failure.

Finally, a safety study carried out by Airbus led at the end of 2018, to an update of the "FUEL L(R) WING TK LO LVL" procedure, which consisted of deleting the imbalance condition. The new procedure requires the crew to open the cross-feed valve from the moment that there is no leak.
