SERIOUS INCIDENT

Aircraft Type and Registration:	Airbus A320-214, OE-LOA
No & Type of Engines:	2 CFM56-5B turbofan engines
Year of Manufacture:	2007
Date & Time (UTC):	1 March 2019 at 2020 hrs
Location:	London Stansted Airport
Type of Flight:	Commercial Air Transport (Passenger)
Persons on Board:	Crew - 7 Passengers - 169
Injuries:	Crew - None Passengers - 10 (Minor)
Nature of Damage:	Left engine contained failure
Commander's Licence:	Air Transport Pilot's Licence
Commander's Age:	44 years
Commander's Flying Experience:	14,128 hours (of which 10,308 were on type) Last 90 days - 195 hours Last 28 days - 71 hours
Information Source:	AAIB Field Investigation

Synopsis

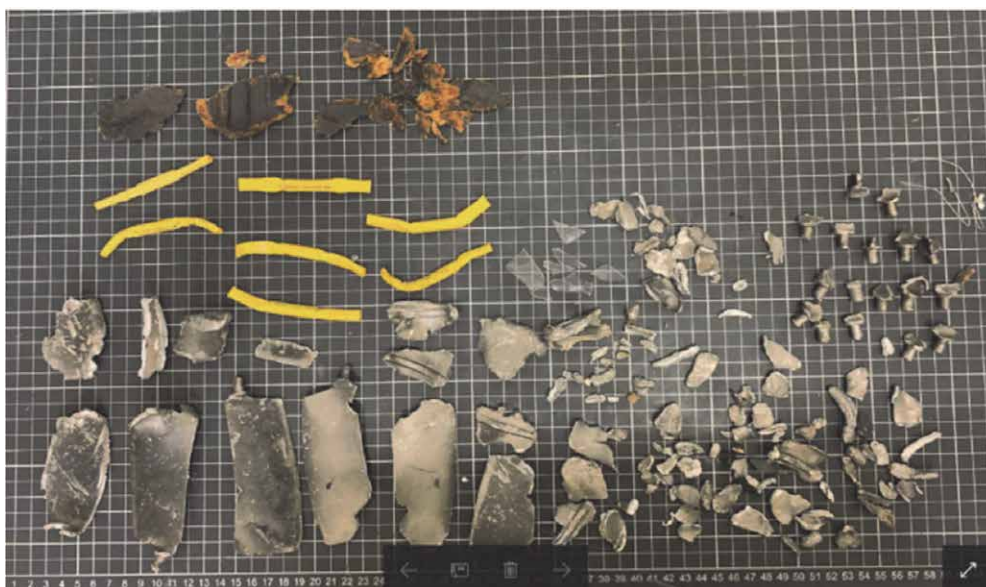
Figure 10

The aircraft had been moved from the runway but debris which had exited the left engine was collected from the runway by the Airport Authority and provided to the AAIB (Figure 10). The items collected included multiple IGVs, fragments of compressor blades and fragments of engine acoustic liner.

Items collected from the runway
