## Accident to the Embraer EMB-550 Legacy 500 registered RA-02788

on 27 November 2017

at Paris Le Bourget airport (Seine-Saint-Denis)

## Activation of angle-of-attack (AOA) limiter protection during flare, hard landing

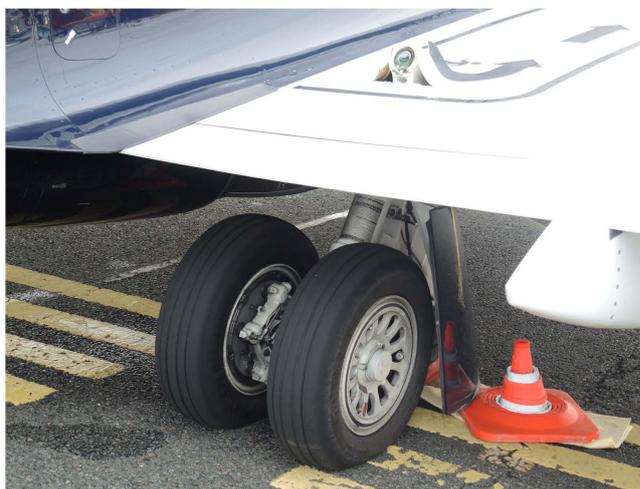
Figure 6: view of right main landing gear broken at top

The aeroplane touched down with a rate of descent of around 1,350 ft/min and a load factor of 4 g. The right main landing gear ruptured and the upper rear hinge made a hole in the upper surface of the wing.

The examinations found that the upper rear attachment fitting of the right landing gear had sheared following the application of substantial loads caused by a landing with a high vertical speed. The aeroplane was slightly inclined to the right.

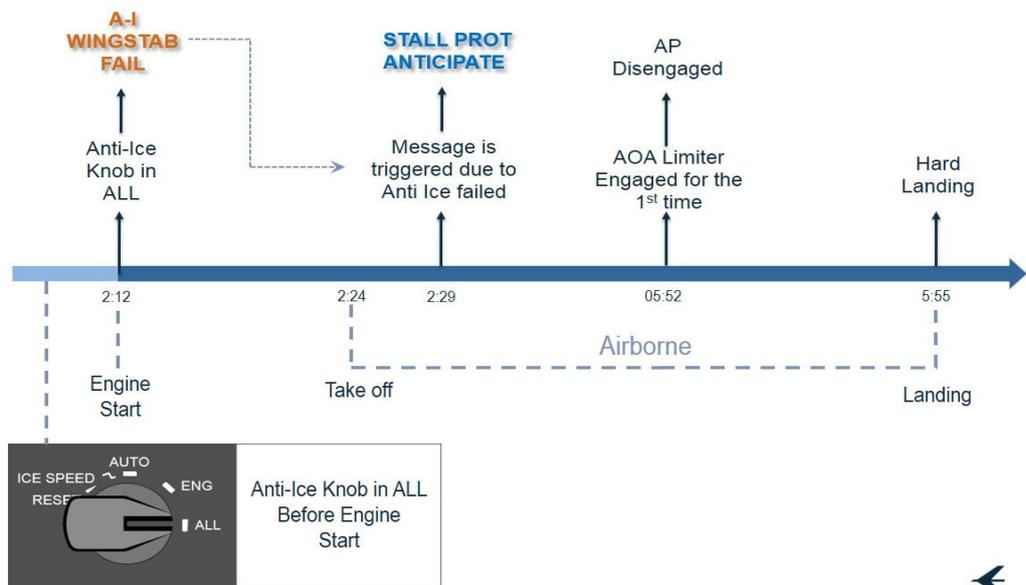
Figure 7: synthesis of FDR and OMS data of the flight, times in UTC

The analysis of this data made it possible to validate and date the appearance of the STALL PROT ANTICIPATE message which was not recorded in the FDR.
