Accident

AAIS Case N°: AIFN/0003/2020

Severe Turbulence during Cruise

Operator:	Emirates
Make and Model:	Airbus A380-861
Nationality and Registration:	The United Arab Emirates, A6-EON
Place of Occurrence:	Airspace over Wyoming, Salt Lake City FIR
State of Occurrence:	United States
Date of Occurrence:	2 February 2020

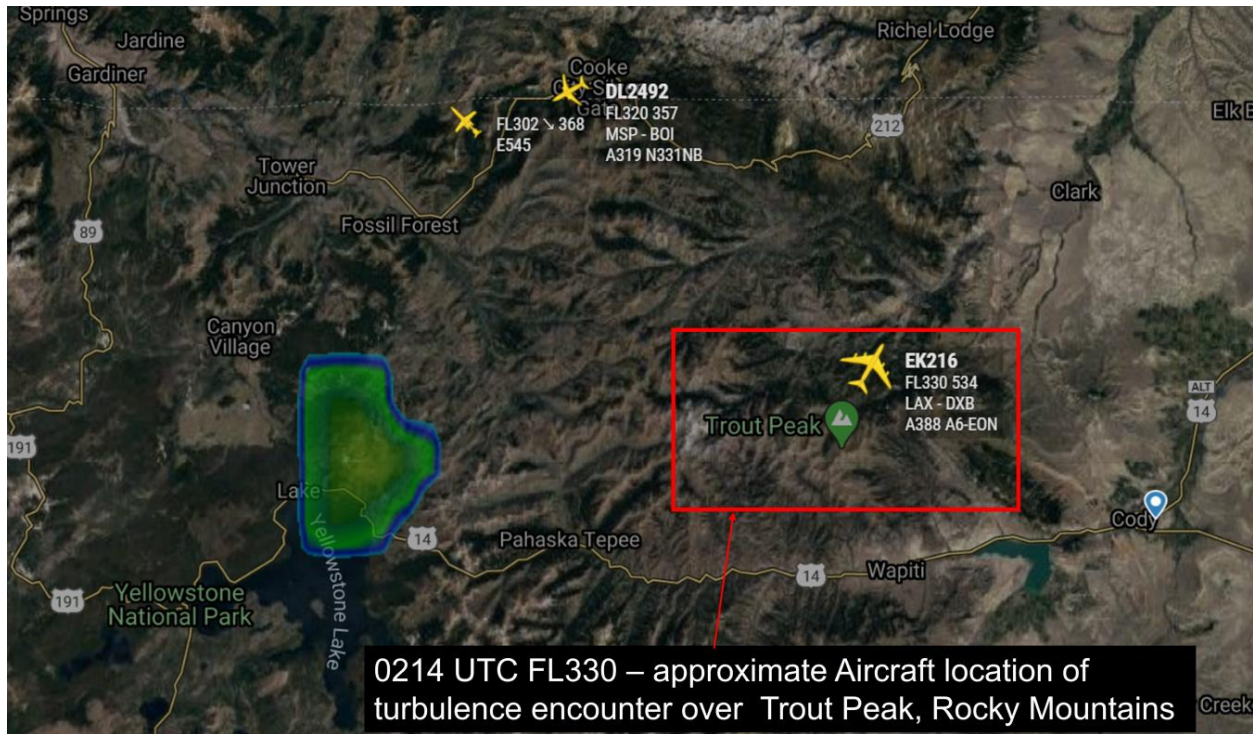
Figure 1. Approximate Aircraft location of the turbulence encounter

Approximately 1 hour 42 minutes after departure from KLAX, between 0214:42 and 0216:36, with the flight crew initiating a climb during the cruise from FL330 to FL350 beyond waypoint KU84Q, the Aircraft experienced moderate to severe turbulence.

See figure 1 for the approximate Aircraft location at the time of the turbulence encounter which occurred in the airspace above Trout Peak. This mountain rises to a height of 3,732 m and is part of several ridges comprising the Absaroka Range¹, Rocky Mountains.

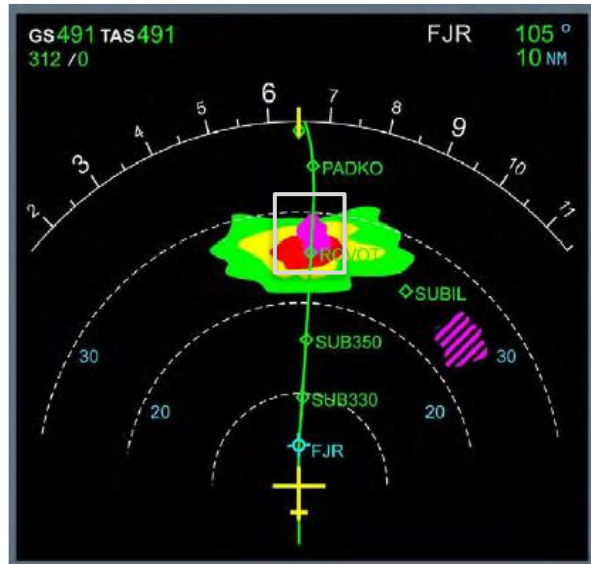
Figure 3. TURB area indication (magenta) on ND
[Source: FCOM A380]

The cockpit ND indicates areas of wet turbulence on-path and ahead of the aircraft in magenta as noted in figure 3 within the white box (the white box is used for illustration purpose only). Figure 3 also illustrates off-path detected wet turbulence that is displayed as hashed magenta.

The TURB function does not detect clear air turbulence or dry turbulence.

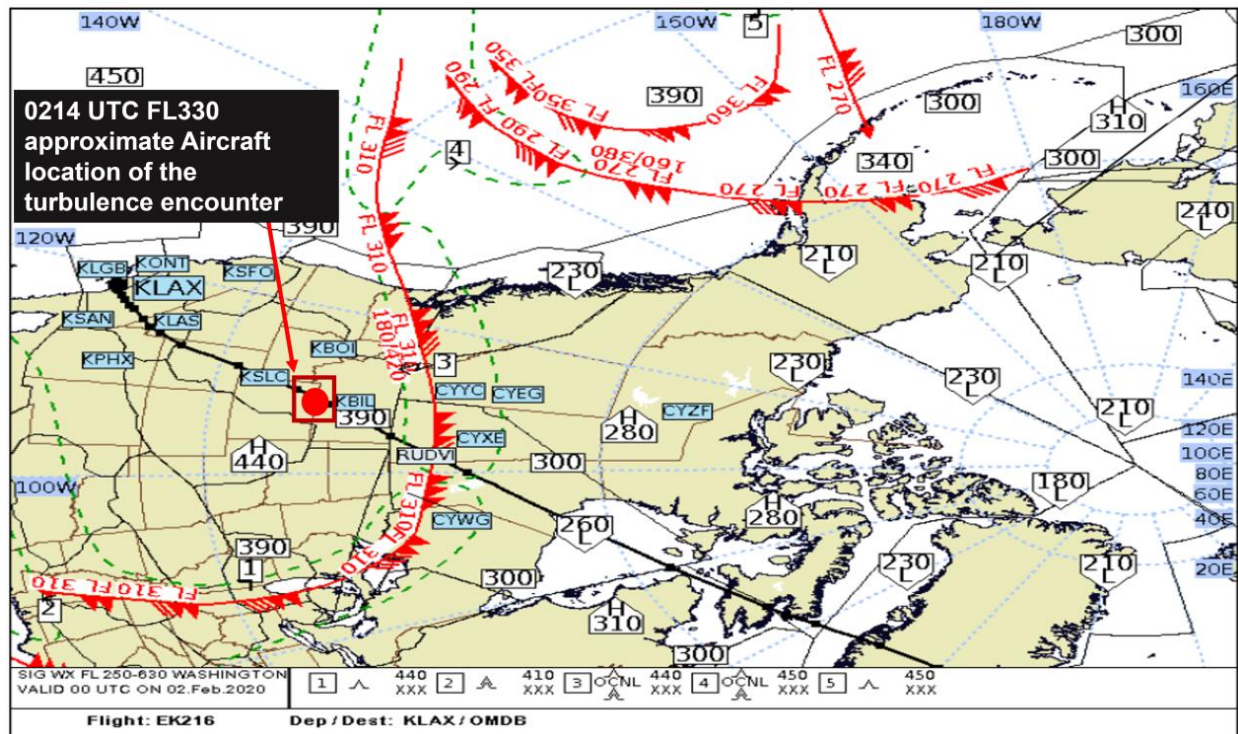
Figure 4. OFP significant weather chart over Wyoming, United States [Source: Operator]

No significant weather forecast was issued, as noted on the OFP that was effective at 0000 on 2 February 2020, which is illustrated in figure 4. The approximate area of the turbulence encounter is indicated by the red dot within the red square.
