# Air Accident Investigation Sector

- Final Report -

AAIS Case N°: AIFN/0009/2019

## Severe Turbulence during Cruise

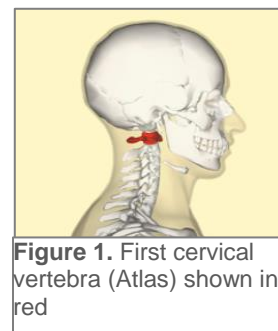
The economy class passenger who sustained a serious injury was in the aft cabin washroom at the time of the severe turbulence encounter and hit her head on the washroom ceiling. The passenger had no lacerations and remained conscious, but complained of neck pain. Upon arrival at OMD, the patient was hospitalized where a computed tomography (CT) scan was performed. After review of the CT scan results, the injury was classified as serious because medical examination revealed that the passenger

**Figure 1.** First cervical vertebra (Atlas) shown in red

had suffered a fracture to the right lateral mass of the first (C1) cervical vertebra (Atlas). See figure 1.

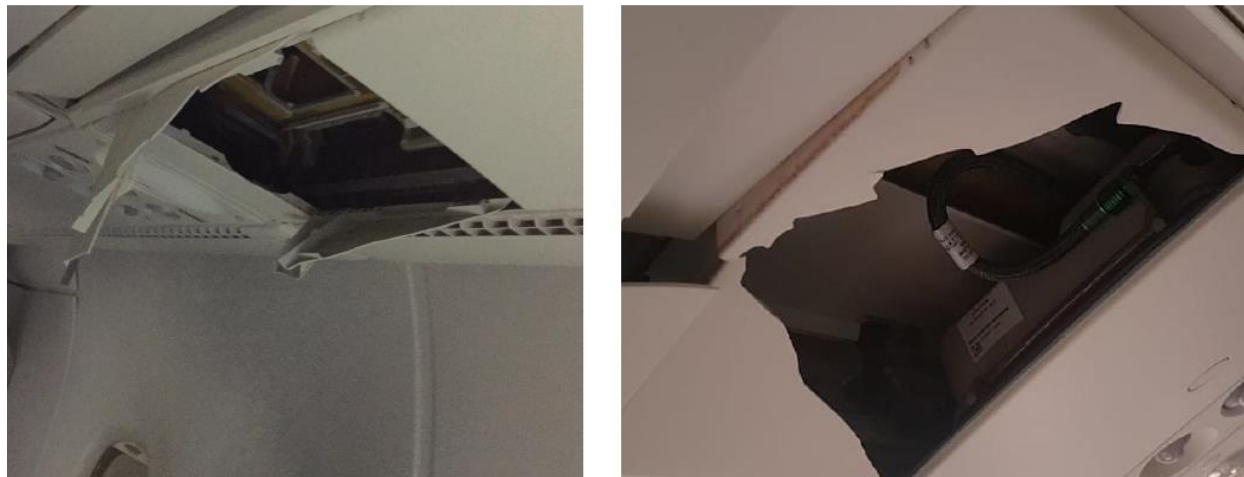
Several cabin ceiling panels in the main deck aft cabin were damaged by the impact of occupants. Several items of loose galley equipment fell to the floor including beverages and food.

Several cabin ceiling panels located in the aft cabin main deck, close to the L5 passenger door, were damaged, as illustrated in figure 2, as a result of impact by persons. Some ceiling panels were also damaged in the upper deck aft galley and several cabin ceiling exit signs had detached.

Figure 2. Main deck aft cabin ceiling panel damage

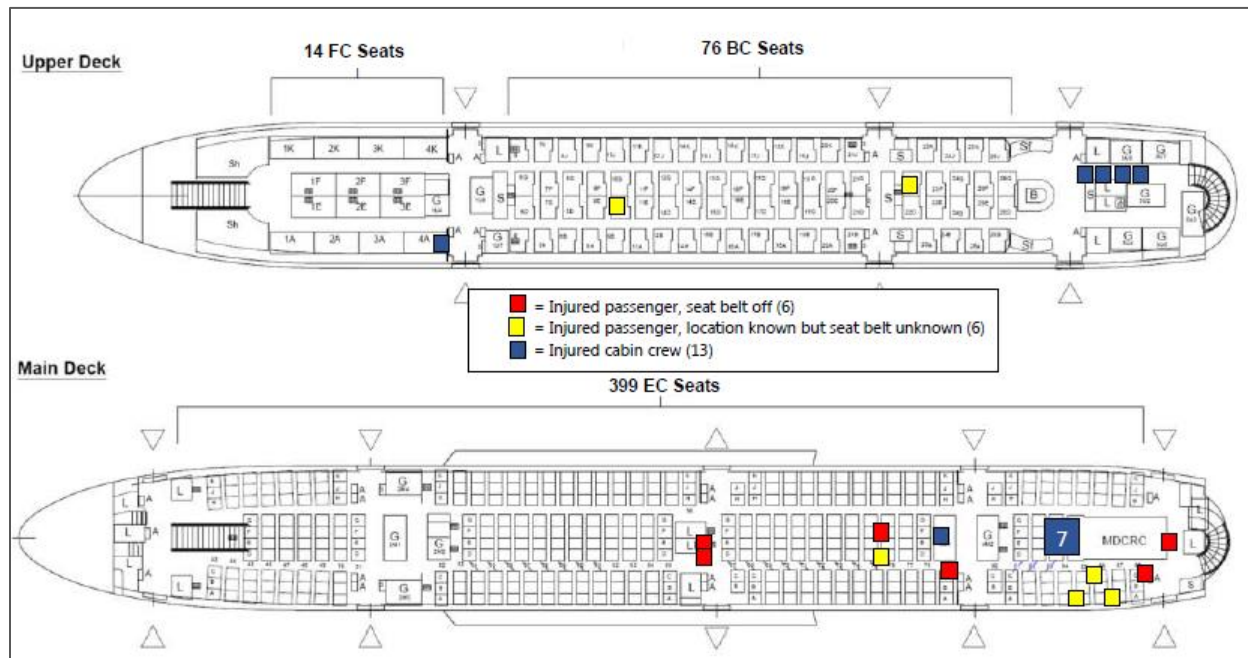
**Figure 8.** Location of the injured passengers and cabin crew [Source: Emirates]

Figure 8 illustrates a schematic of the Aircraft seating and the location of the passengers and cabin crewmembers injured during the turbulence encounter. The Investigation was unable to verify the location of two passengers, one each in business and economy class, and the lavatories where they sustained their injuries. The figure also shows the status of the passenger seat belt sign for the injured passengers.

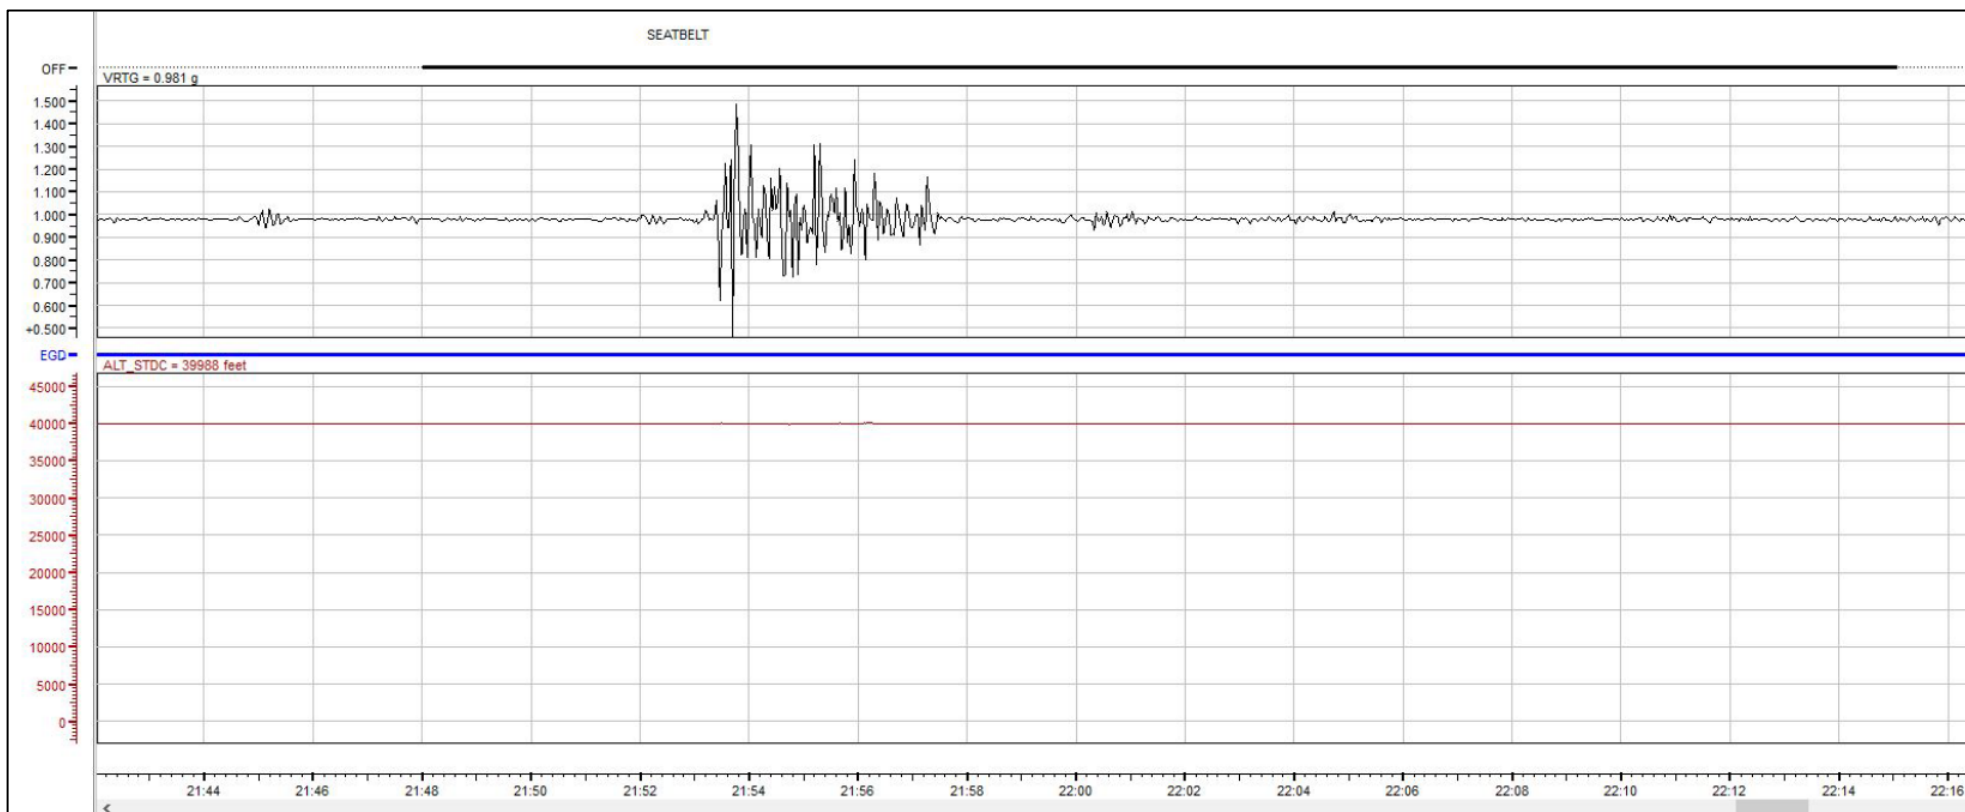
## Appendix B – Seat belt sign status and g-loads [Source Emirates]

The severity of the wind variations resulted in significant vertical g-loads between minus 0.35G and positive 1.65G. As a result, several unrestrained passengers and cabin crewmembers were lifted off their feet and impacted the cabin ceiling causing injuries and damages. The Aircraft movements were more significant in the aft cabin and aft galleys for both the upper as well as the main cabin which resulted in several galley equipment being tossed on the galley floor.

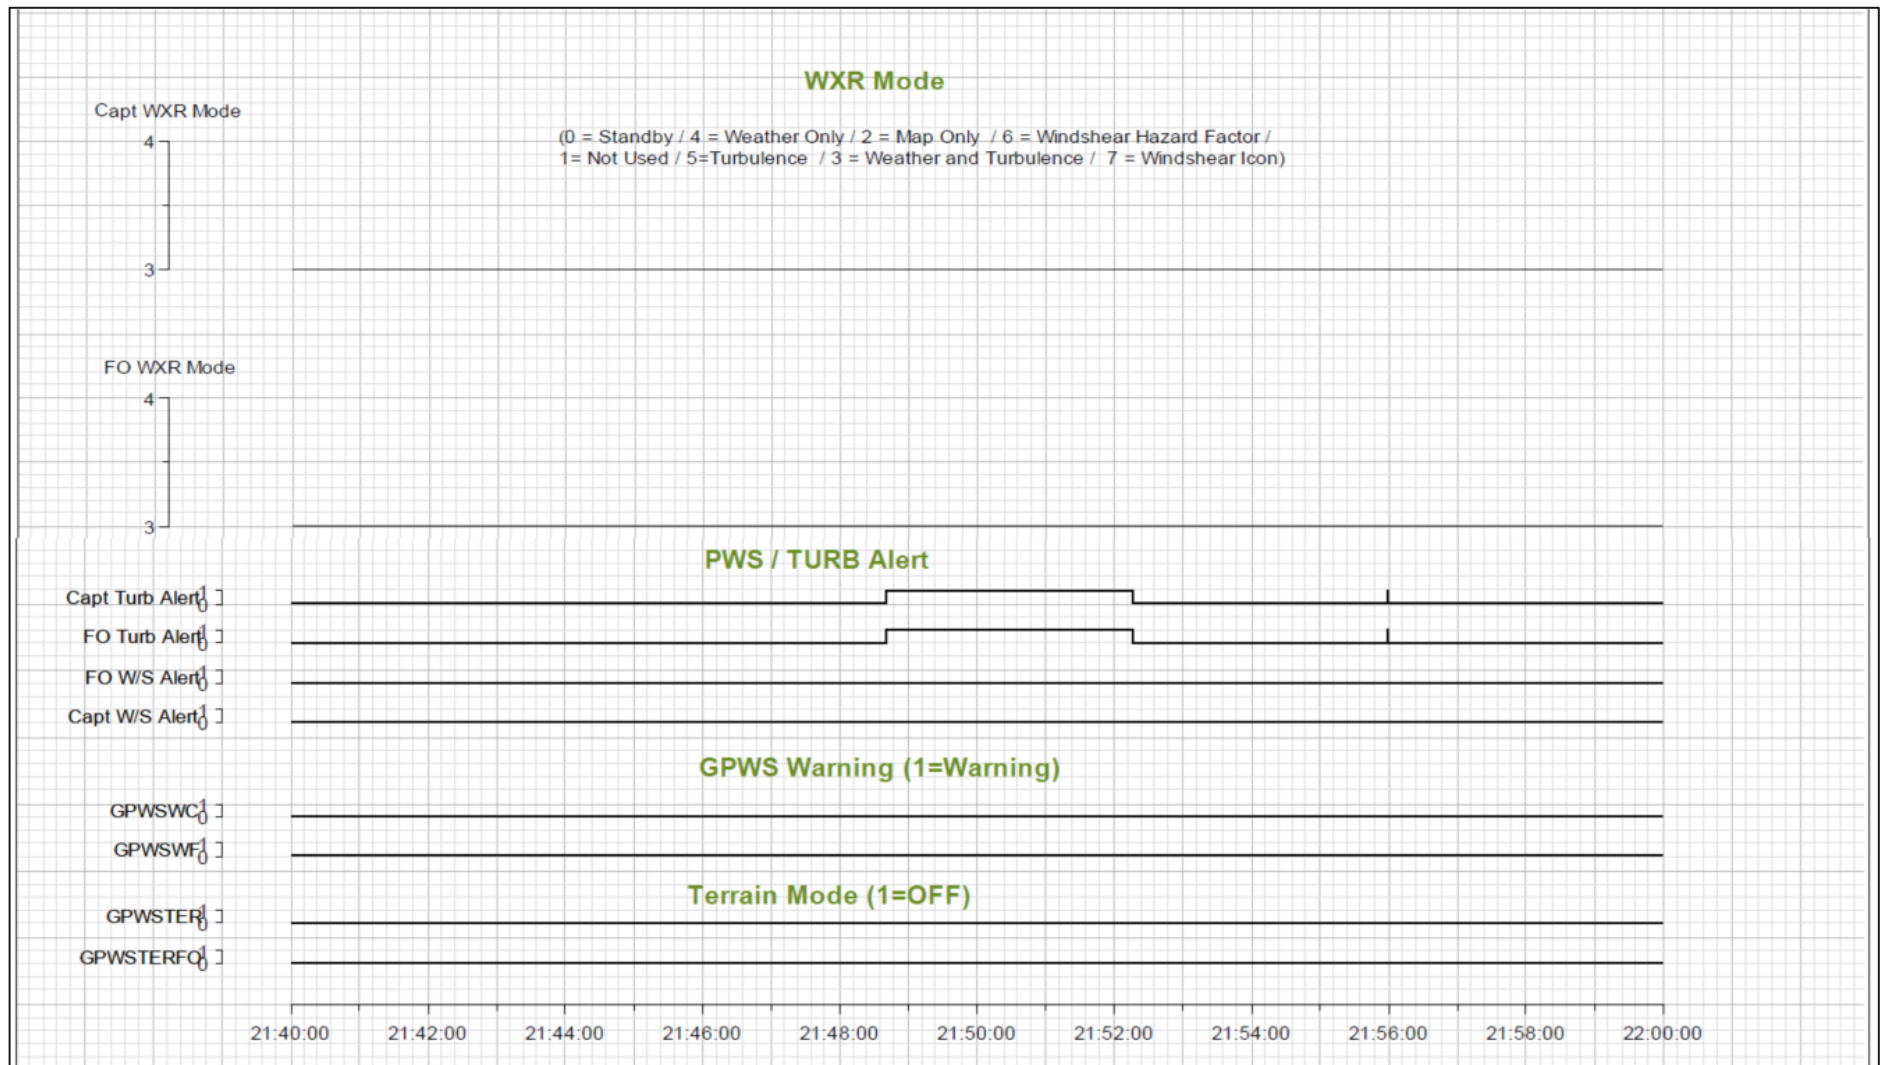
## Appendix C – FDR Data related the weather radar [Source Airbus]

As the decision by the flight on what action is required is based on when the flight crew observes the magenta and then processing this information, in case the flight crew fails to observe the magenta from the onset, means that there is a greater possibility that the aircraft will be affected by wet turbulence. For an aircraft in cruise, the distance covered in one minute is approximately 8 NM, thus the Investigation believes that without any aural cockpit alerting system for when wet turbulence is detected within the 40 NM envelope, reduces the time for the flight crew to make an appropriate decision.

The Investigation recommends that the Aircraft Manufacturer facilitate the flight data recording of adverse weather precipitation detected by the weather radar as displayed on the NDs so that this information can be used to enhance pilot training.
