**AIRCRAFT ACCIDENT
INVESTIGATION REPORT**

**ALL NIPPON AIRWAYS CO., LTD.
J A 8 0 8 A**

February 18, 2021

PASSENGERS INJURY BY THE SHAKING OF THE AIRCRAFT
ALL NIPPON AIRWAYS CO., LTD.
BOEING 787-8, JA808A
AT AN ALTITUDE OF APPROX. 5,500 M
OVER CHENGDE CITY, HEBEI PROVINCE,
THE PEOPLE'S REPUBLIC OF CHINA
AROUND 20:24 JST, AUGUST 15, 2019
(AROUND 19:24 LOCAL TIME, AUGUST 15, 2019)

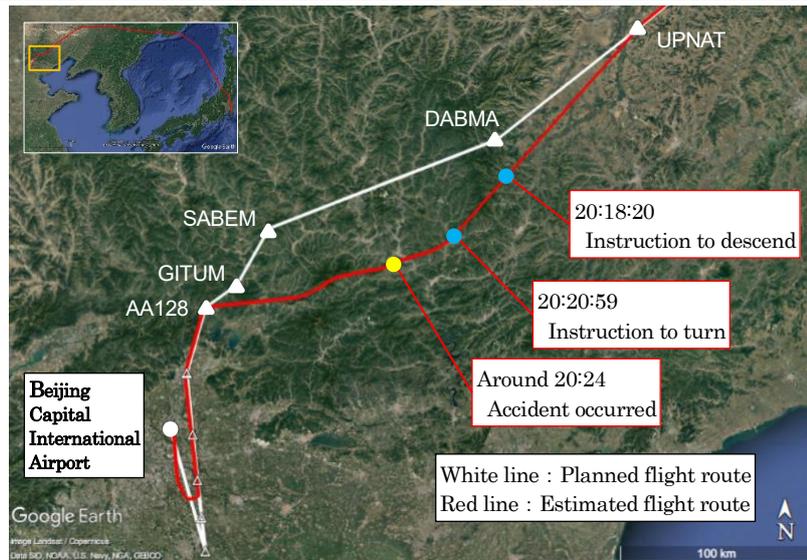
Figure 1: Estimated flight route

After changing its heading, the aircraft was flying in thin clouds spreading to the south of the cumulonimbus, but the airborne weather radar did not display any cloud echo on the course and there was no disturbance, therefore, the PIC flew the aircraft with the fasten seat belt sign turned off. After that, at 20:18:20, the aircraft started descending after receiving an instruction from the ATC to descend to 3,600 m. At 20:20:59, the aircraft made a right turn while continuing to descend because of having received from the ATC an instruction to change the heading to the right to go straight to GITUM and pass it at an altitude of 3,600 m in order to avoid flight restriction area. When the Aircraft moved beneath the clouds during descent, the airborne weather radar did not display any cloud echo, but cumulus clouds were gathering down below, therefore, the PIC informed the senior cabin crew member in the cockpit that the fasten seat belt sign would be turned on as shaking would be expected. After the senior cabin crew member left the cockpit, the PIC stopped temporarily descending and maintained level flight at an altitude of about 5,500 m between cloud layers in order to fly away from the cumulus clouds gathering down below. However, judging that it would not be able to avoid the towering cloud top, the PIC turned on the fasten seat belt sign at 20:23:33. The aircraft instantaneously shook violently when closely skimming the cumulus cloud top at 20:23:58.

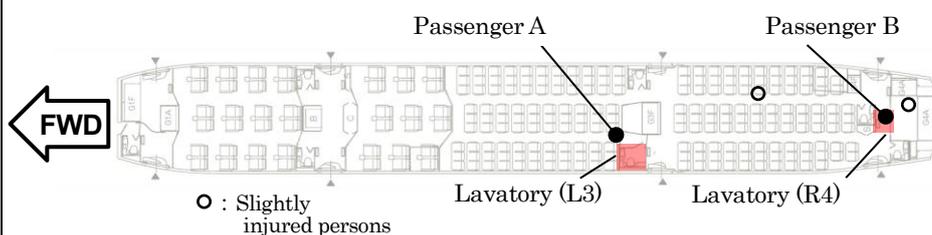
Figure 2: Locations of the injured when the aircraft shook

When the fasten seat belt sign was turned on, Passenger A, who was in line for the restroom waiting and standing in front of the lavatory (L3), encountered shaking, then, lost the balance, fell to the floor, and injured the right foot. In addition, when the fasten seat belt sign was turned on, the other Passenger B was sitting down in the lavatory (R4) and encountered shaking, and suffered an injury to the loin as the upper body was strongly squeezed longitudinally.

2.2 Injuries to Persons	(1) Two passengers were seriously injured. Passenger A (Right foot avulsion fracture) Passenger B (Lumbar compression fracture) (2) Two cabin crew members sustained minor injuries.

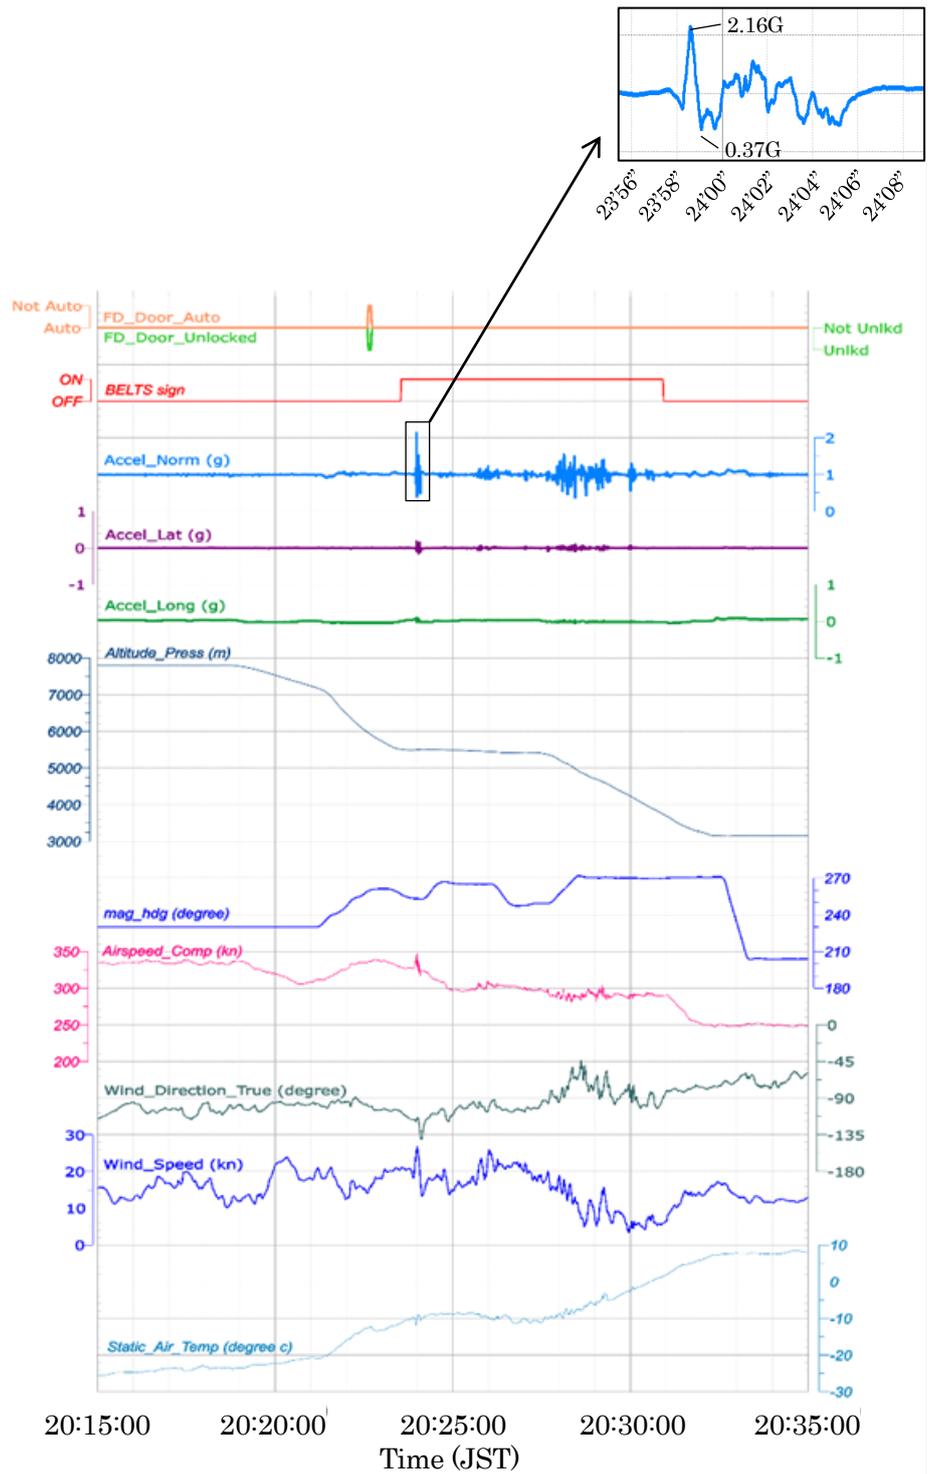
Figure 3: EAFR records

According to the aircraft's EAFR records (Figure 3), which indicate the vertical acceleration was greatly fluctuated between +2.16 G and +0.37 G instantaneously for about two seconds from 20:23:58.

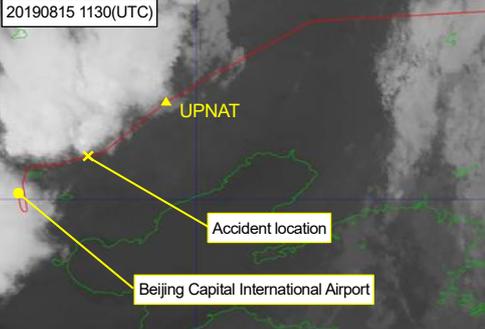
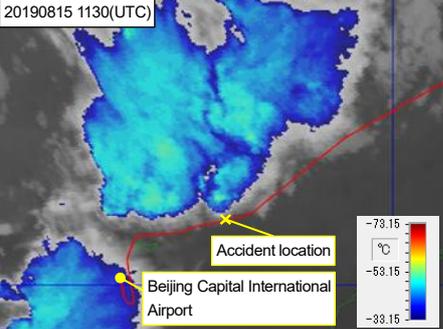
2.6 Meteorological Information	<p>Based on the Meteorological Satellite Images (Figure 4 and 5) announced by the Japan Meteorological Agency (JMA) at 20:30, the cumulus-like clouds swelling like a hump covered around the flight route of the aircraft. In addition, according to the Convective Cloud Information (Figure 6) announced at the same time, the area where the aircraft shook was near the rapidly developing cumulus areas including cumulonimbus area.</p>
