BY LINDA WERFELMAN

Mistakes in determining takeoff parameters are frequent, a French study says, and methods of detecting them are not always effective.

Calculating ERRORS

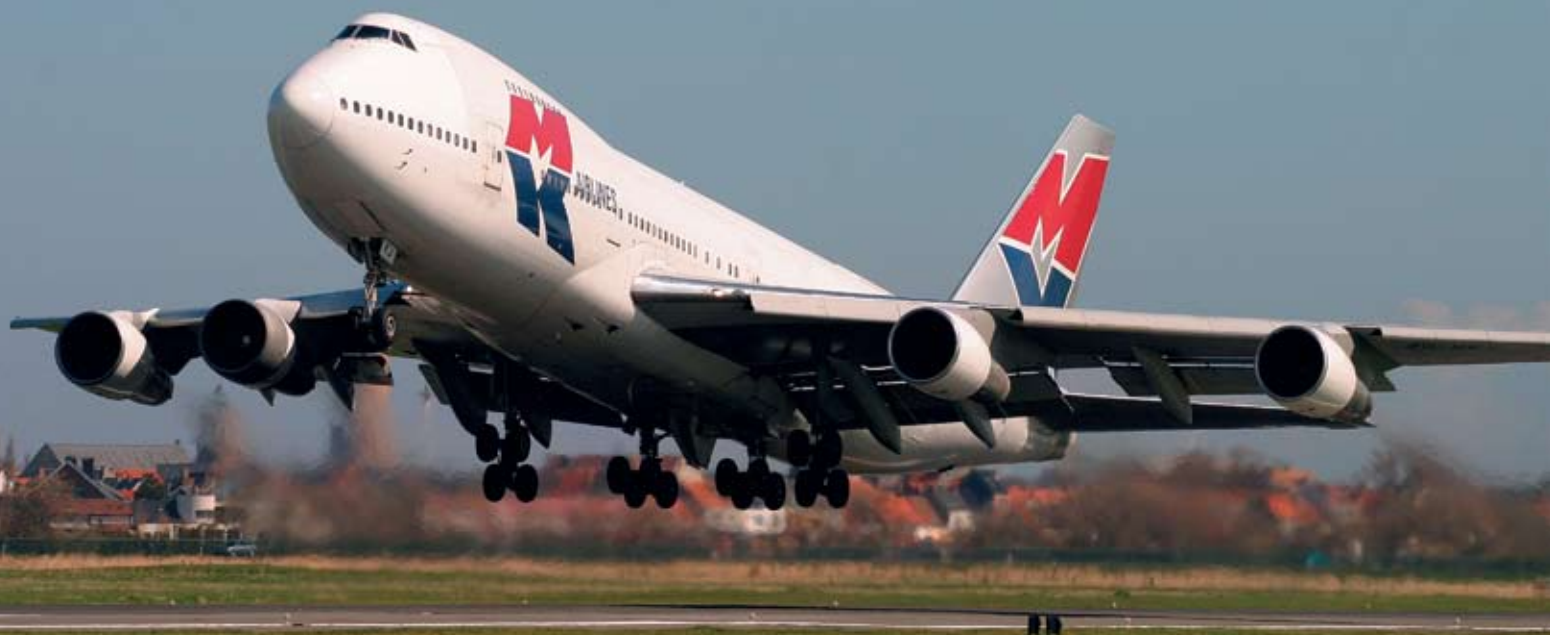
This MK Airlines Boeing 747 crashed on takeoff from Halifax, Nova Scotia, Canada, in 2004, after the crew unknowingly used an incorrect aircraft weight to calculate takeoff speeds and thrust settings, investigators said.
