Applying take-off thrust on unsuitable pavement surface may have hidden dangers

Most flight crews are well aware of the danger jet blast can pose to people and equipment. However, few are aware of the risks associated with applying high thrust while the aircraft is standing on or near pavement surfaces not normally used for take-off or engine run-up.

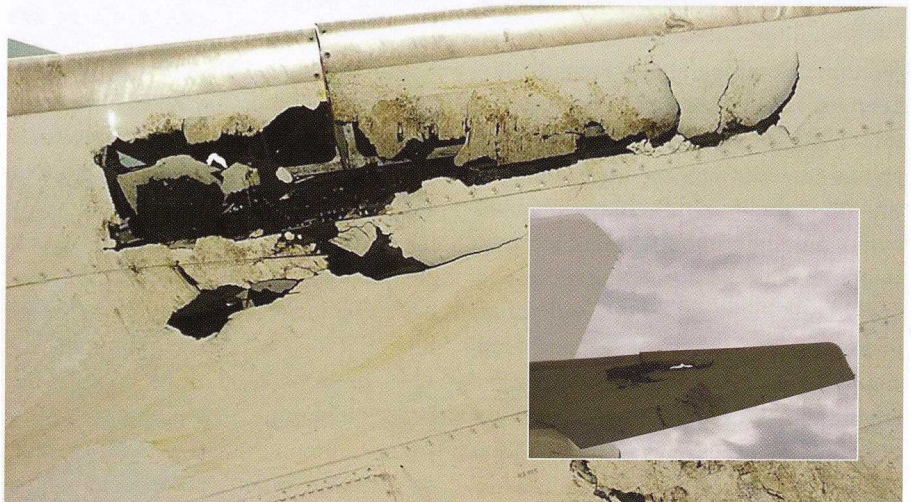
Example of a stabilizer severely damaged by surface debris which had been dislodged by jet blast.
