**AVIATION INVESTIGATION REPORT**  
**A06F0014**

**MISALIGNED TAKE-OFF**

**AIR CANADA**  
**AIRBUS A319-114 C-FYKR**  
**LAS VEGAS, NEVADA**  
**30 JANUARY 2006**

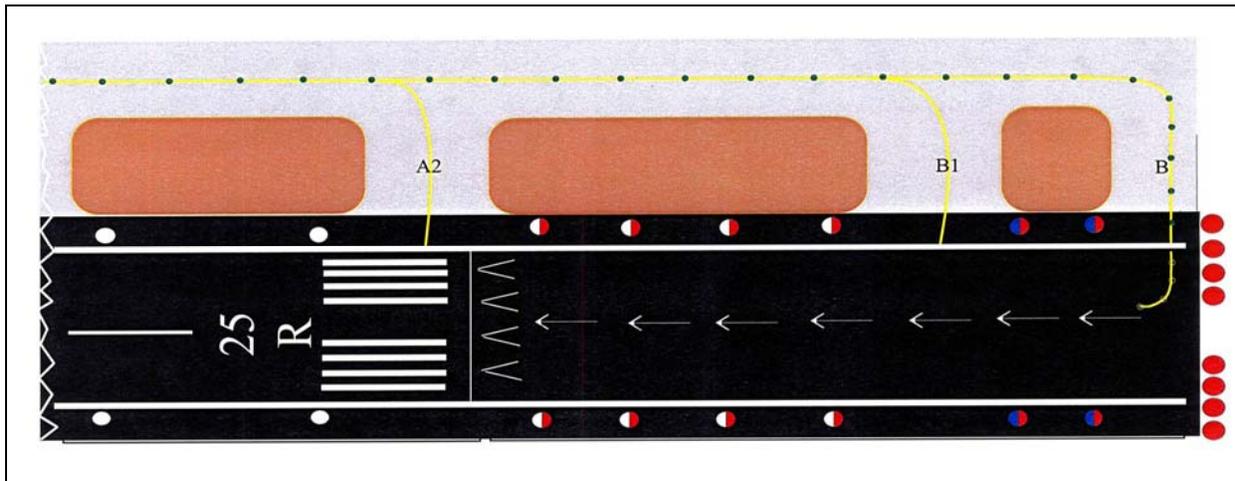
Figure 1. Runway 25R threshold markings

To provide good visual contrast with the runway, a white runway side stripe marking is painted along both sides of Runway 25R (see Figure 1). In accordance with Federal Aviation Administration Advisory Circular (AC) 150/5340-1J and International Civil Aviation Organization (ICAO) Annex 14, Volume 1, Aerodrome Design and Operations, the side stripe marking is a continuous line that is unbroken where the taxiways join the runway. In Canada, TP 312, Section 5.2.1.3, allows for the runway side stripe markings to be interrupted at an intersection of a runway and taxiway. In fact, all Canadian runways marked with side stripes have them interrupted at the intersection of their runways and taxiways.

Had the runway side stripe been interrupted at the runway and Taxiway B intersection, it could have prevented the misalignment. Since the flight crew was more familiar with Canadian airport markings, where side stripes are interrupted at the intersection between the taxiway and the runway merging point, they probably were not expecting to see a white runway side stripe marking.

The lead-in lines from Taxiways B1 and A2 may cause confusion because they lead directly to the runway edge line rather than to the runway centreline. In contrast, the Taxiway B centreline marking continues across the white runway side stripe marking until it merges with the runway centreline. During the day, this marking would provide a strong visual cue to the location of the runway centreline. However, in this occurrence, the taxiway centreline lead-in lights did not catch the flight crew's attention, resulting in a lack of visual guidance toward the runway centreline. The pilot may also have misinterpreted the runway edge line as the runway centreline.

The Las Vegas airport authority made modifications to the taxiway markings following the occurrence. At Taxiway B1, the radius of the taxiway centreline was extended past the runway edge line and now meets with the runway centreline in the displaced threshold arrow area. At Taxiway A2, the radius of the taxiway centreline that curves to the runway edge line was erased, and the taxiway centreline now extends to the threshold markings.
