ATSB TRANSPORT SAFETY REPORT

Aviation Occurrence Investigation

AO-2007-036

Fuel-related event
50 km NW of Swan Hill, Vic.
11 August 2007
VH-TJE
Boeing Company 737-476

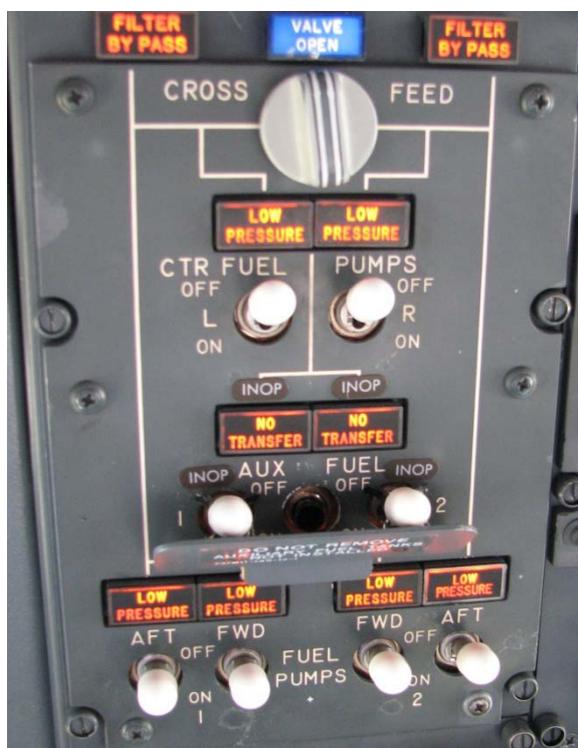
Figure 2: Overhead fuel control panel of VH-TJE photographed from the pilot in command's seat

The pilot in command observed that the centre tank fuel pump switches on the forward overhead panel were selected to the OFF position (Figure 2) and he immediately selected them to the ON position. The main fuel tanks were low on fuel and the investigation estimated that there was about 100 kg in each of the main tanks. The centre fuel tank contained about 4,700 kg of fuel when the master caution occurred.

The fuel system control panel was located on the forward overhead panel of the flight deck above the pilot in command's seat. The panel contained eight fuel pump switches; two pump switches for each main tank, two pump switches for the centre tank and two pump switches for the auxiliary system. As the auxiliary fuel tank was deactivated, the associated fuel pump switches were covered with a small cover plate and secured with locking wire to the OFF position (Figure 2).

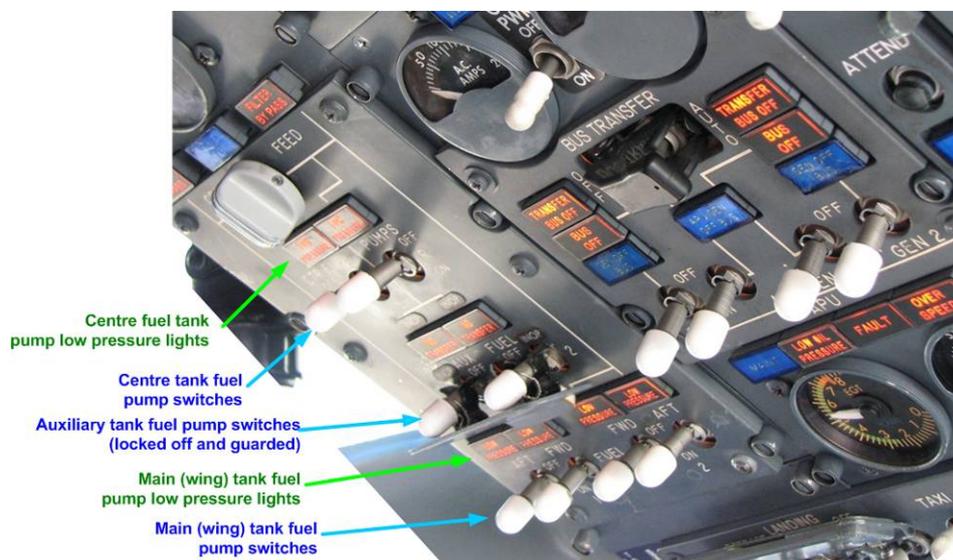
Figure 3: Overhead fuel control panel of VH-TJE photographed from the copilot’s seat

copilot reported that he called ‘13,000 kilograms, pumps on’ and looked up at the fuel control panel. The pilot in command reported that he was probably focused on the fourth item on the checklist at this time (as this required his response), which was to confirm that his cockpit window was closed and locked.

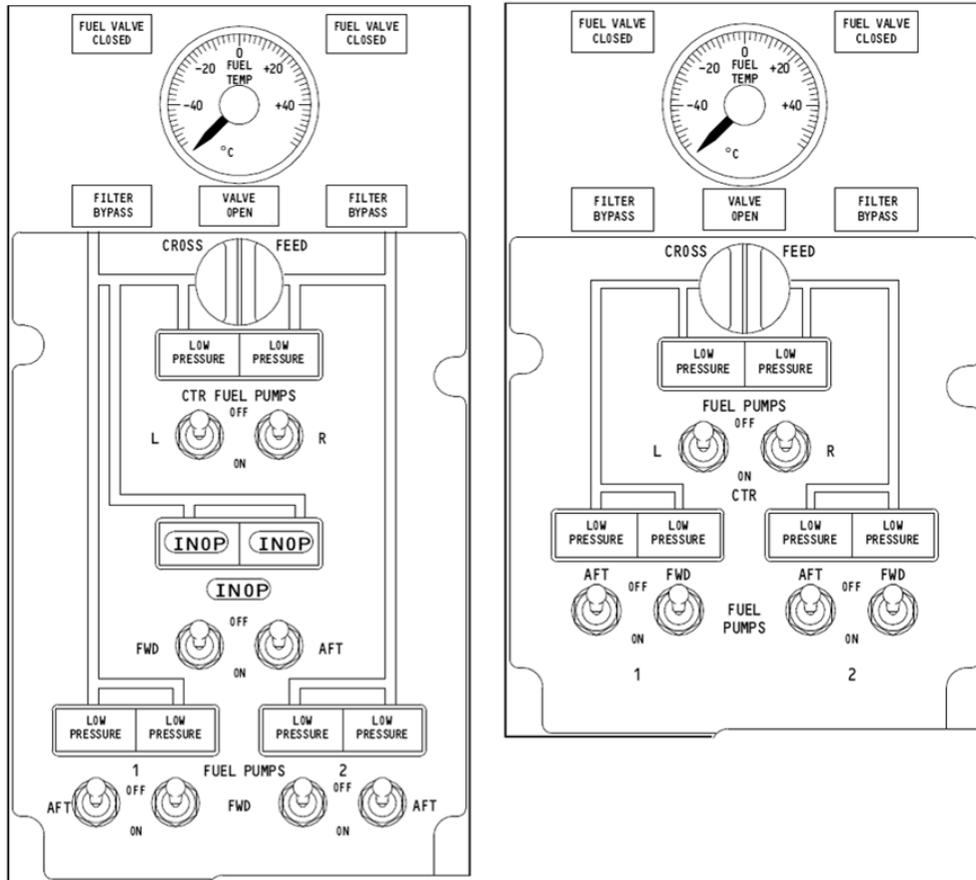
Figure 5: Fuel system control panel for 737-400 series with inoperative auxiliary tank (left) and fuel system control panel for other 737-400 and later model aircraft (right)

The crew reported that the aircraft's overhead fuel control panel was different from some of the operator's other 737-400 aircraft and from all 737-800 aircraft used by the operator, due to the fitment of auxiliary tank fuel pump switches. The centre tank fuel pump switches on those other 737 aircraft were located in a similar position to the auxiliary tank fuel pump switches on VH-TJE (Figure 5).
