State of Israel Ministry of Transport and Road Safety Accidents and Incidents Aviation Investigation

Safety Investigation Report - Final (Final Investigation Report)

Incident File No. 38-21

Fuel Leak that led to Engine Shutdown followed by diversion to an Alternate

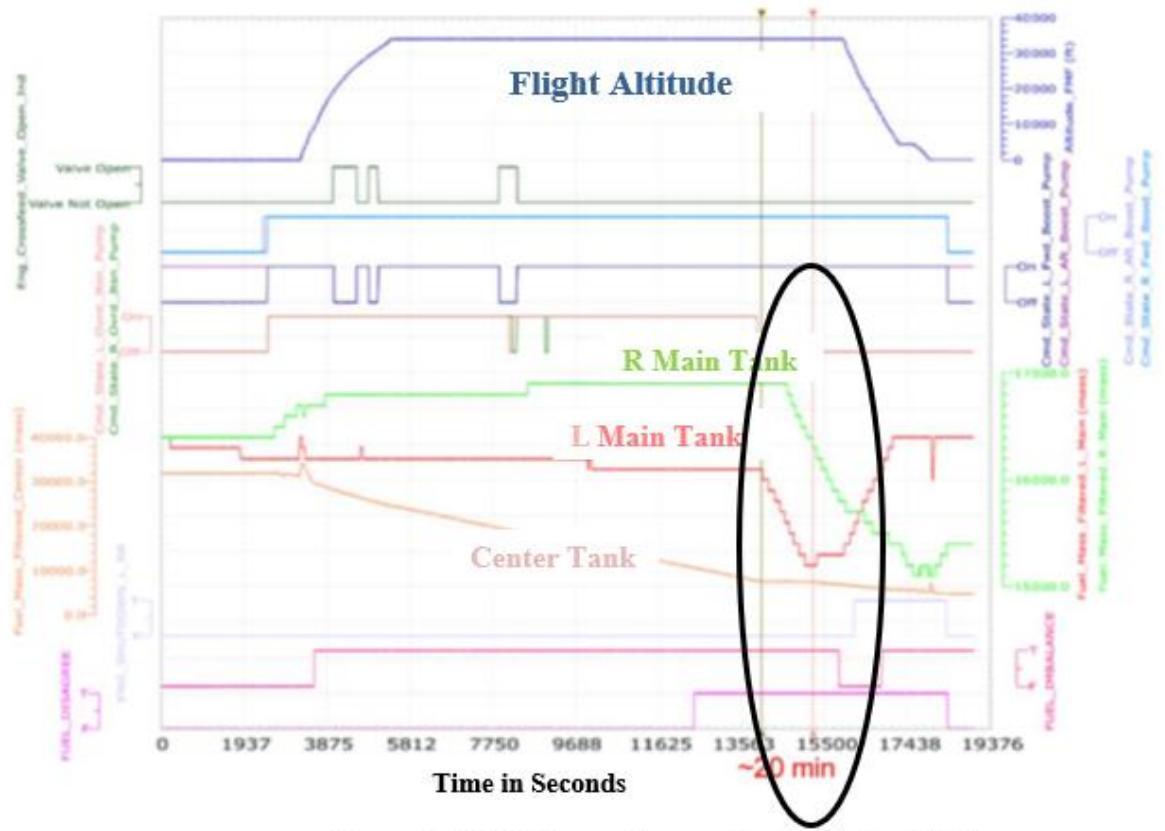
Figure 5 - DFDR recording analysis - Fuel in flight

<u>Note</u>: The marked time frame (20 min) is the stage where "Fuel Disagree" message was on and the center pumps were <u>turned off</u> (fuel quantity in the center tank remained constant). It can be seen that RH wing fuel quantity remained unchanged for about 11 minutes (despite its fuel being consumed by the engine), while LH wing fuel quantity starts decreasing immediately.

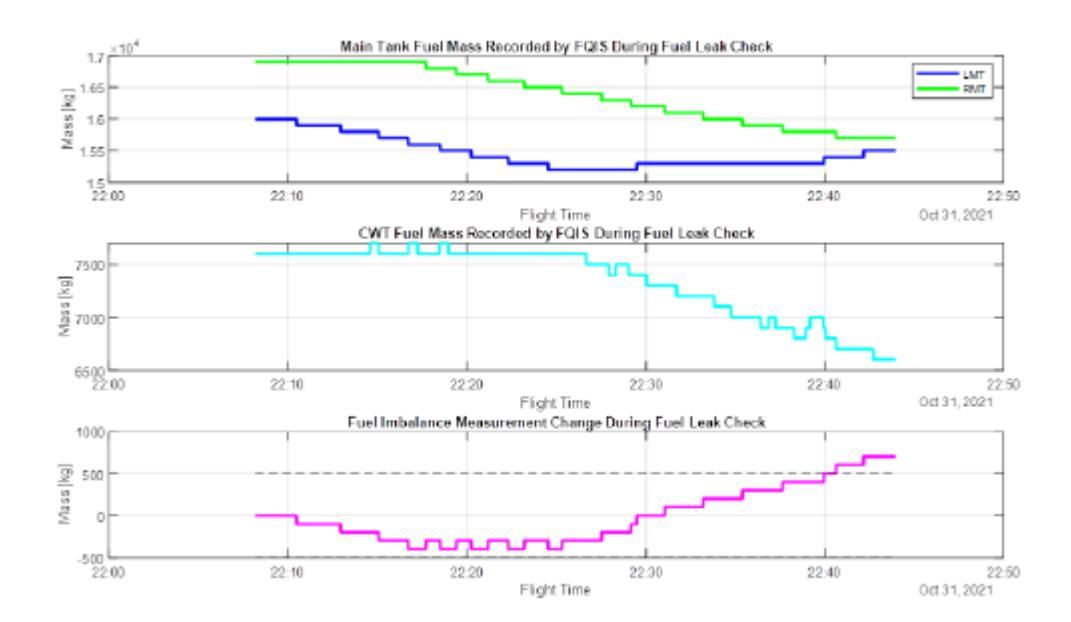
Figure 5 - DFDR analysis of fuel behavior during performance of Fuel Leak checklist

<u>Note</u>: Analysis of DFDR data indicates that the leak rate was approximately 15 kg/minute.

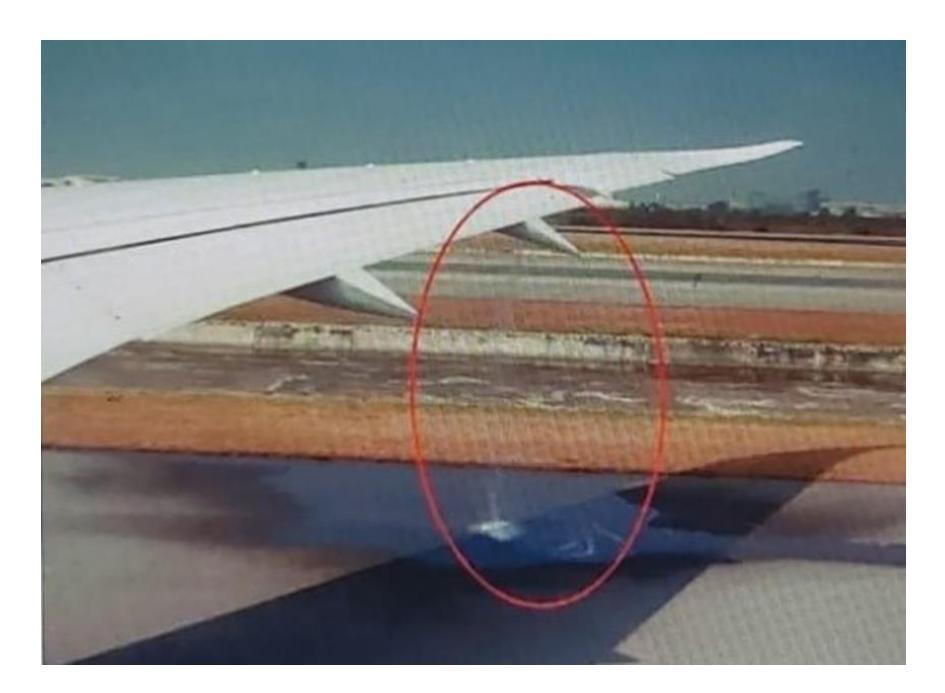
Figure 6 - Air Norwegian Shuttle fuel leak

1.16.4 Another case of fuel leak was reported on a Norwegian Air Shuttle B787-8, flight from Bangkok to Oslo on January 19, 2014. Fuel leak from the RH wing vent scoop was noticed during taxiing. The aircraft returned to the gate for troubleshooting and takeoff was delayed by 19 hours.

Note: It can be seen that the leak source is the wing tip vent scoop

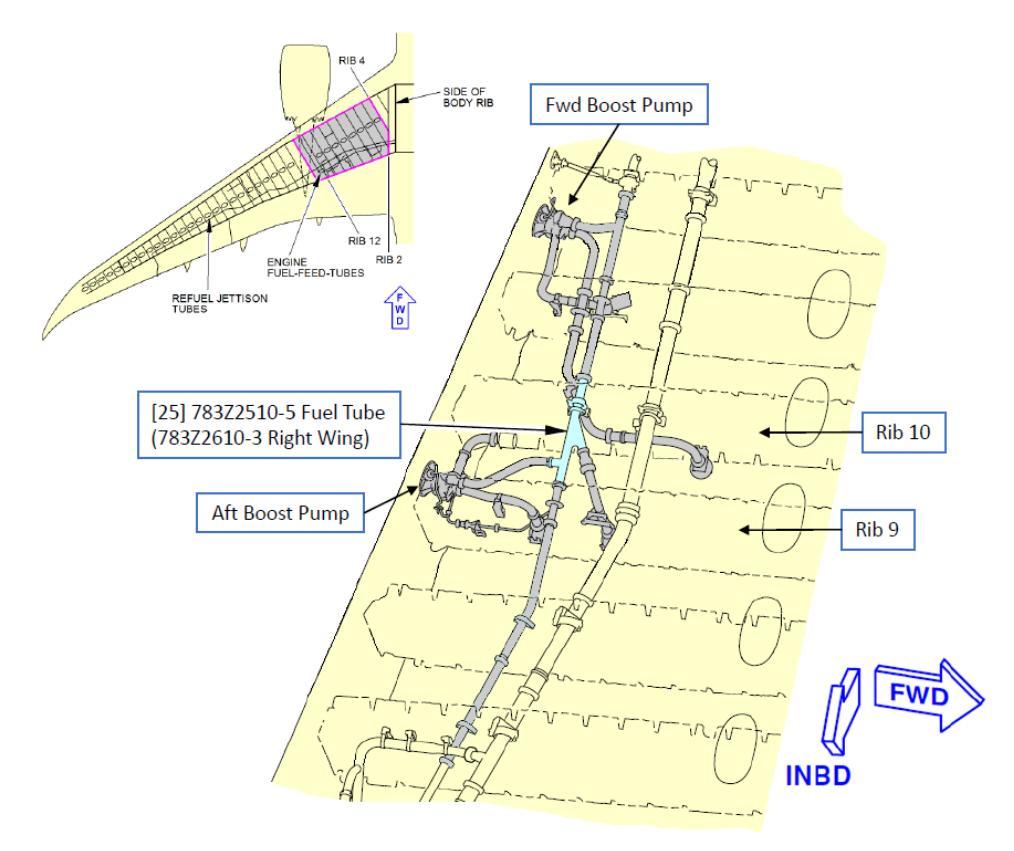
Figure 17 - Location of suspected manifold tube

- Two tubes, Manifold P/N 783Z2610-3/783Z2610-5 were removed from LH and RH wing main tanks and inspected for cracks in accordance with Boeing document 787-FTD-28-18001, which deals with developing of cracks in these tubes after 17,000 flight hours (cracks were found on 18 airplanes). These two tubes were replaced.

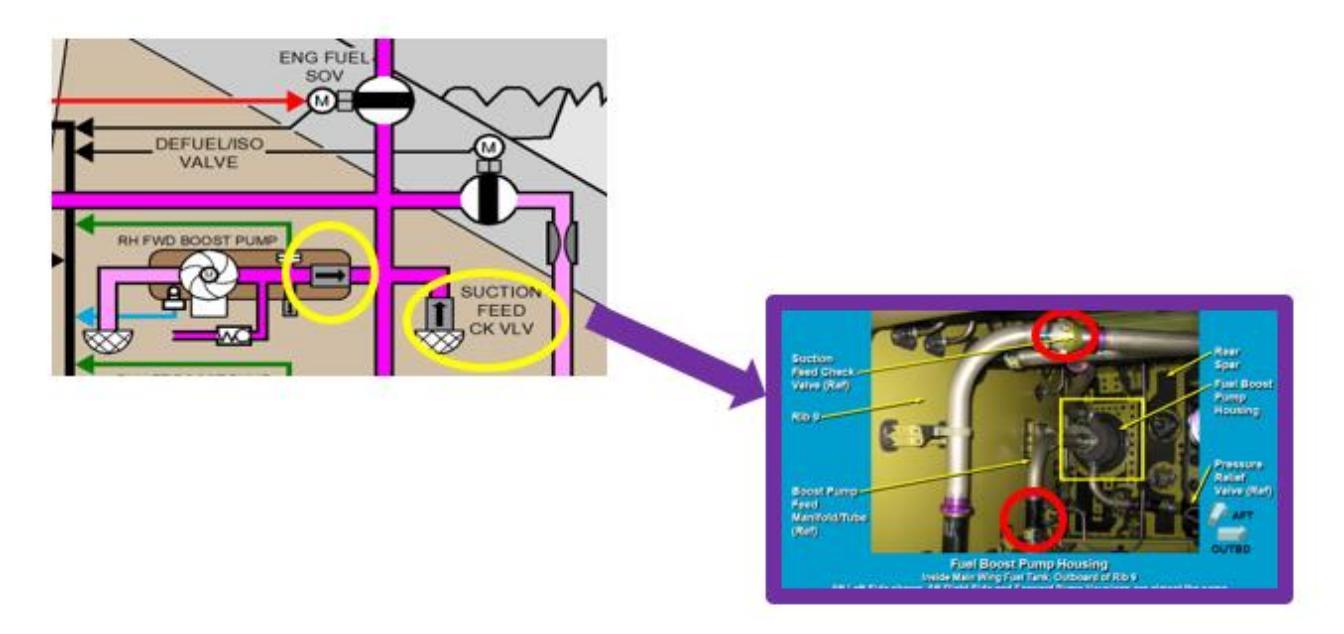
Figure 19 - Check valves suspected as discrepant

- FOD inspections were conducted in the Main tanks, Center tank and valves and filters at the fuel tanks and engines No findings.
- Fuel tanks and tubing were pressurized at 38 Psi for 10 minutes. No leak or pressure drop was detected.
- E Check valves were inspected for functionality and found adequate.

- \checkmark A leak in the tubing from the Center Tank, which is routed inside the wing tank.
- ✓ FOD discrepancy, which causes a check valve inside the wing tank to remain partially open.
