# ACAS II Bulletin

June 2016 | N°20

## Low level events

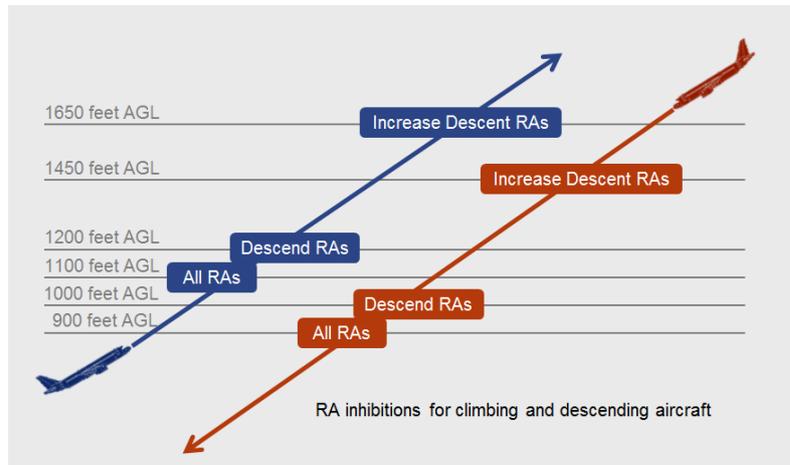
**RA Inhibitions:** To prevent collisions with terrain, Resolution Advisories (RAs) are inhibited based on radio (radar) altimeter reported heights AGL (Above Ground Level) as follows:

- Increase Descent RA: 1550 feet (±100 feet) AGL
- Descend RA: 1100 feet (±100 feet) AGL
- All RAs: 1000 feet (±100 feet) AGL.

Hysteresis values of ±100 feet ensure that the inhibition state does not oscillate rapidly should the aircraft be flying over hilly terrain.

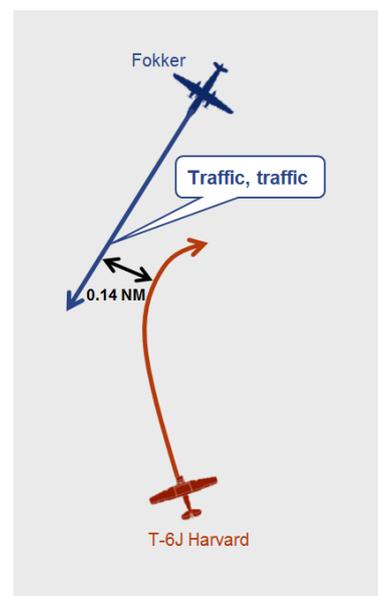
In the meantime the crew of the Fokker is transferred to the tower frequency and can hear the conversation between the tower controller and the pilot of the light aircraft. The Fokker continues its ILS approach and they receive traffic information. When the Fokker is passing through 1350 feet (approximately 875 feet AGL) a TA is generated.

At the Closest Point of Approach the distance between the two aircraft was 0.14 NM at almost the same altitude. The generation criteria for an RA were met but since the Fokker has descended below 900 feet AGL, the RA was inhibited. Neither of the pilots saw the other aircraft.

- All RAs are inhibited below 900 feet AGL.
- TAs are inhibited below 500 feet AGL.

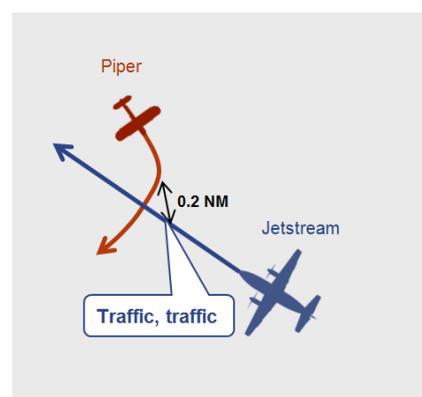
When both aircraft are about to cross and the Jetstream passes 2800 feet descending, its TCAS generates a TA ("Traffic, traffic") against the Piper. The Jetstream pilots, based on the information on the TCAS traffic display, get visual contact with the threat. Assessing the traffic proximity, the Jetstream pilots stop the descent and climb to 3200 feet. The aircraft pass with a vertical spacing of 400 feet and horizontal spacing of 0.2 NM. The Piper pilot could see the Jetstream only after the aircraft had passed each other.

Although the aircraft got very close, TCAS II did not generate an RA as the Piper pilot had not switched the transponder to Mode C.

- If equipped, all aircraft shall operate altitude reporting transponders at all times. Without altitude reports TCAS, as well as ATC safety nets, will not provide appropriate alerts.
- An intruder whose transponder is not providing altitude information may cause TAs to be generated on other aircraft; however, neither data tag nor a trend arrow will be displayed. Both aircraft are deemed to be at the same altitude.

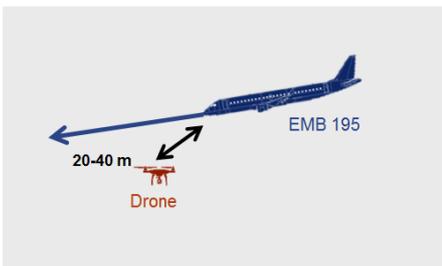
An Embraer 195 is conducting an ILS approach to its destination. While descending through 2500 feet (approximately 2150 feet AGL) the crew observes a drone (quadcopter) passing at 20-40 metres from their aircraft.

The drone has not been shown on the TCAS traffic display and no TCAS alert has been generated. Generally, small drones (or Remoted Piloted Aircraft Systems) are not transponder equipped and, therefore, will not be detected by TCAS or visible to ATC on secondary radars. Moreover, due to their small size, they will remain undetected by ATC primary radars.

TCAS will only detect intruders that are equipped and operating an altitude reporting transponder.

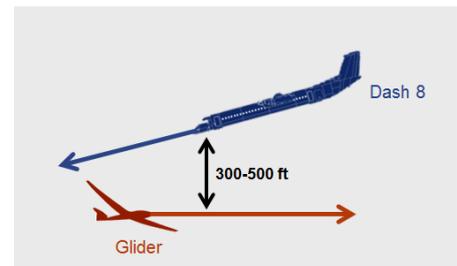
A Dash 8 is descending towards its destination heading south. At 3000 feet (approximately 2900 feet AGL) as they turn onto a westerly heading to intercept the ILS localizer, a glider passes 300-500 feet underneath them heading north.

As the glider was not transponder equipped, it has not been shown on the TCAS traffic display and no TCAS alert has been generated against it.

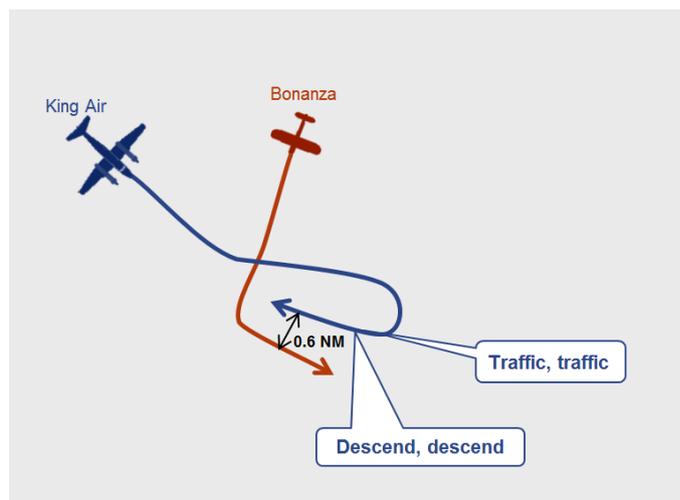
A Beechcraft Bonanza, which is not TCAS equipped, is on an instrument rating check flight while a Beechcraft King Air, which is TCAS II equipped, is conducting an instrument training flight in the vicinity of the same airfield (located virtually at sea-level). Mistakenly, ATC clears both aircraft to 1700 feet. Initially, the aircraft are separated horizontally and although their tracks initially cross there is sufficient spacing. Eventually, following their planned turns, they fly on opposite headings with a horizontal spacing of 0.6 NM.

The King Air gets a TA and soon after a "Descend, descend" RA. The pilot responds immediately to the RA, starts a descent and reports the TCAS manoeuvre to ATC. The King Air descends approximately 500 feet before it gets a "Clear of conflict". The Bonanza pilot reported seeing the King Air passing below while the King Air crew never acquired the intruder visually.

RAs when followed promptly provide mitigation against the risk of midair collision.

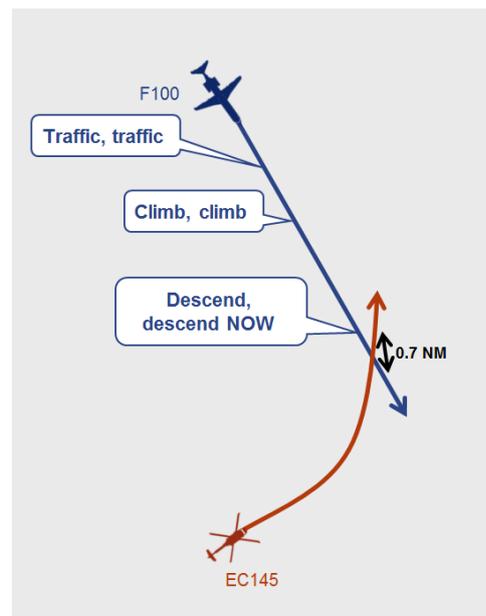
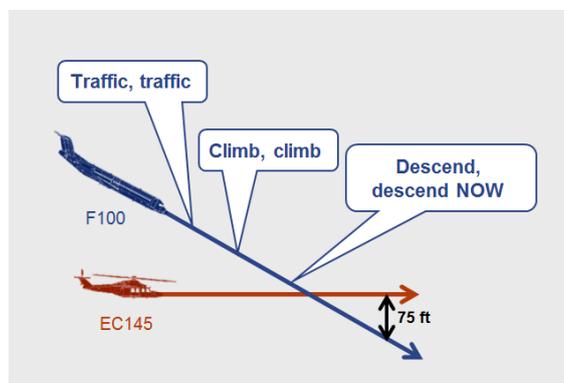
Due to hazy visibility and direct sunlight the F100 co-pilot has some difficulties acquiring the EC145 visually. When he can see the helicopter he reports to ATC "...the helicopter is in sight and we're avoiding". At this time, the F100 is passing through 5000 feet on final and the spacing between the aircraft is 2.8 NM and 675 feet. At approximately the same time as visual contact is established by the F100 co-pilot, TCAS generates a TA. Subsequently, the F100 commander (pilot flying), reduces the rate of descent.

Just 16 seconds later, as the distance between the aircraft further erodes to 1.8 NM and 288 feet, TCAS on F100 issues a "Climb, climb" RA. The F100 commander decides not to comply with the RA and continues descending as the co-pilot has visual contact with the helicopter which is observed turning north.

After 12 seconds, the Climb RA is reversed to "Descend, descend NOW". At this time the aircraft are 1 NM and 20 feet apart. A few seconds later the two aircraft cross with a lateral distance of 0.7 NM and an altitude difference of 75 feet.

Subsequent analysis of this incident indicated that a correct response to the first RA by the F100 pilot (assuming the nominal response time and acceleration) would have given the vertical miss-distance of 579 feet.

- Never manoeuvre in the opposite sense to an RA.
- Visual assessment of traffic can be misleading.
