AIRPROX REPORT No 2017036

Date: 07 Mar 2017 Time: 1349Z Position: 5046N 00009E Location: 4nm W Eastbourne

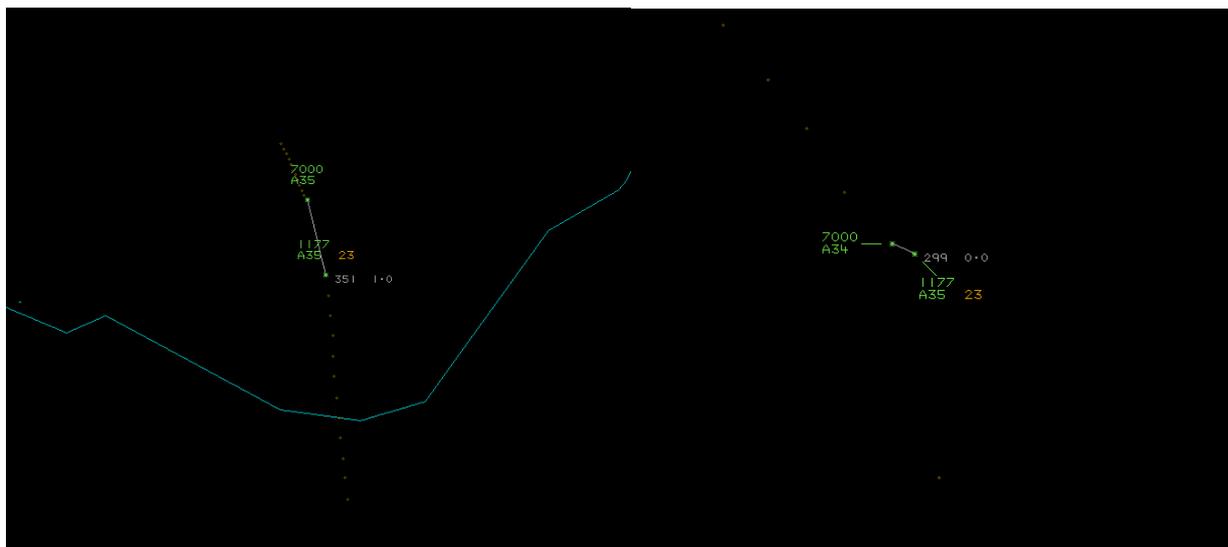
Figure 3 – 1343:42

At 1343:42 the C525 pilot reported crossing the coastline at Eastbourne in the descent to 2300ft. This was acknowledged by the FISO who instructed the C525 pilot to squawk 7000 and to freecall Farnborough Radar giving the pilot the relevant frequency (Figure 3).

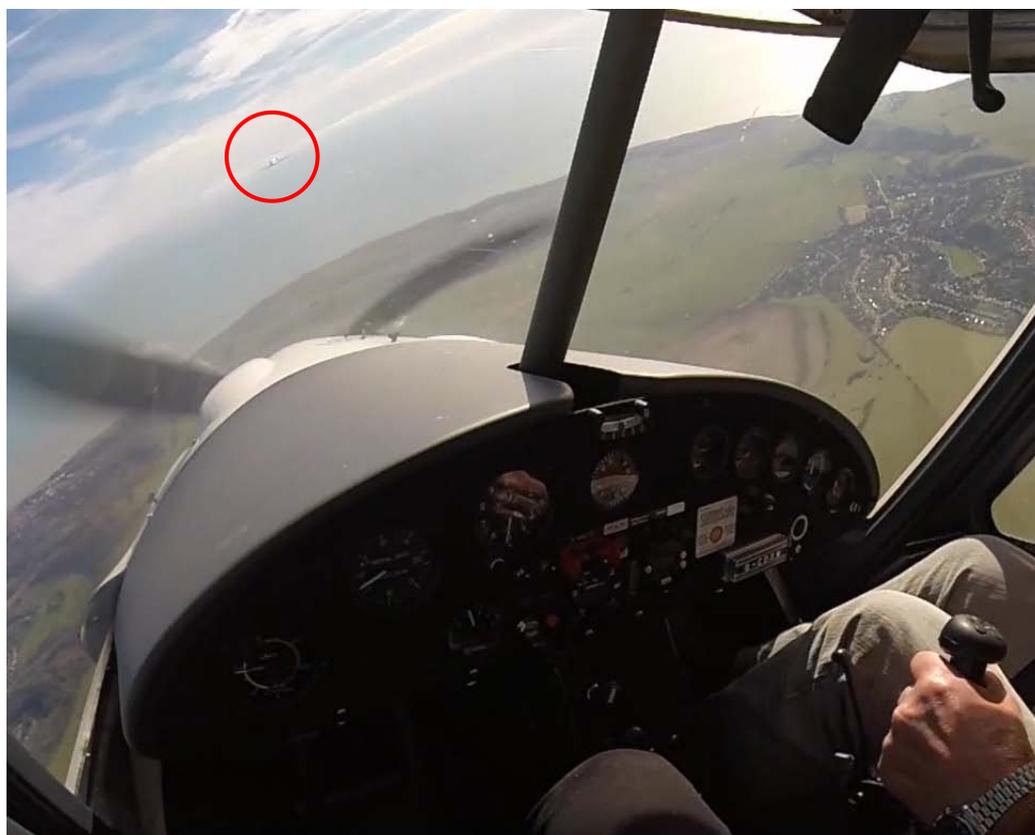
The pilot of the C42 submitted video evidence, from which the following stills were taken. Figure 5 shows the C525 visible about two seconds after the point at which the pilot of the C42 was seen to commence avoiding action. The subsequent stills are taken 1 second apart.
