aibn Accident Investigation Board Norway

REPORT SL 2015/01

REPORT ON THE SERIOUS AIRCRAFT INCIDENT DURING APPROACH TO KITTILÄ AIRPORT IN FINLAND (EFKT) ON 26 DECEMBER 2012 WITH A BOEING 737-800, LN-DYM, OPERATED BY NORWEGIAN AIR SHUTTLE ASA

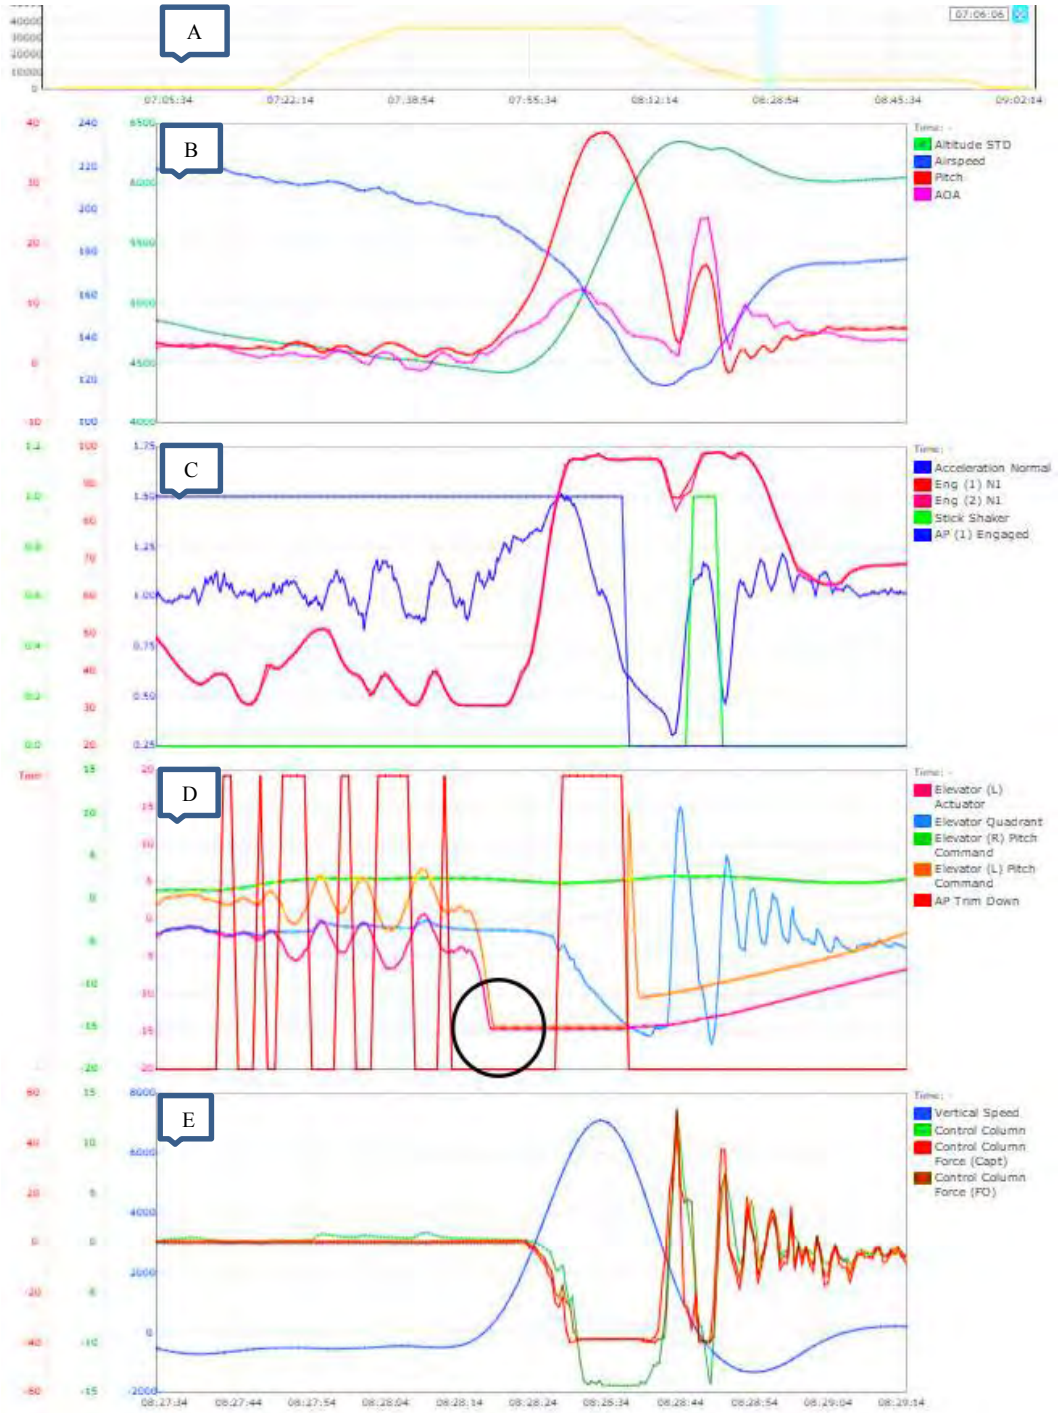
with associated further loss of airspeed. Figure 1 shows an excerpt from the aircraft's flight data recorder in connection with the incident.

Figure 1: Excerpt from flight data recorder during the incident.

Figure 1A shows aircraft flight profile (the whole flight).
Figure 1B shows altitude, airspeed, pitch and angle of attack.
Figure 1C shows engine thrust, status on stick shaker, status on autopilot and acceleration (G load).
Figure 1D shows black circle marks blockage of the Power Control Units.
Figure 1E shows forces on control column.

1.6.3.12 Based on the fact that the flight data recorder proved that blockage of the Power Control Unit had prevented the aircraft's normal elevator function (see Figure 1 and Chapter 1.11.1), AIBN has investigated what may have caused the blockage. These investigations are described in Chapter 1.16.

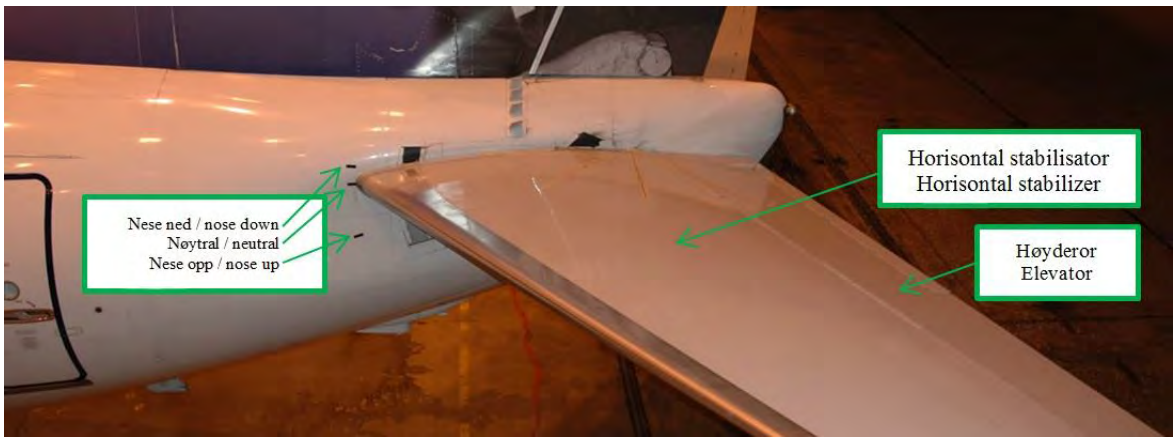
1.6.3.5 The elevator is located on the trailing edge of the horizontal stabiliser. The aircraft is trimmed by changing the mounting angle of the horizontal stabiliser. The trimming is electrical and is controlled automatically or via the trim switches on the control column at the flight deck. The horizontal stabiliser makes up a relatively large surface that largely affects the aircraft's aerodynamic forces around the lateral axis (pitch) (see Figure 3).

Figure 3: Shows the size ratio between the horizontal stabiliser and the elevator, as well as the range of motion for the horizontal stabiliser. Photo: AIBN

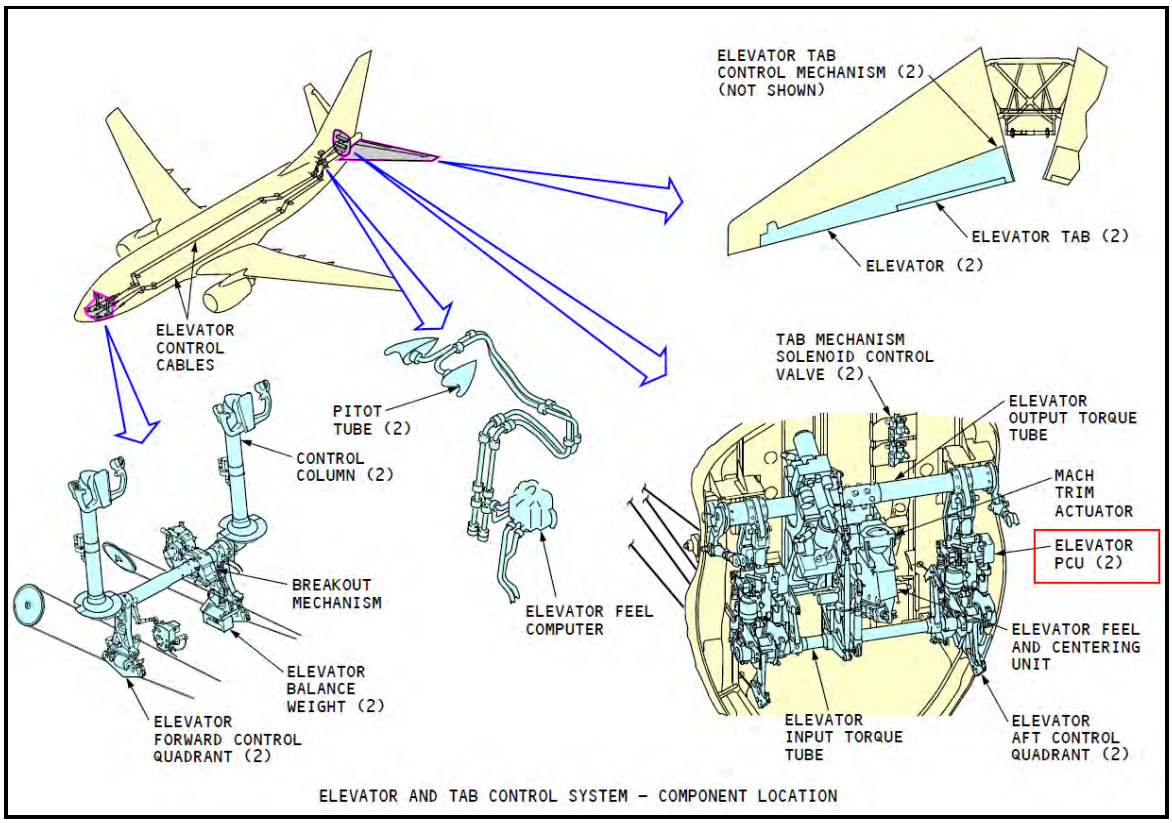
1.6.3.2 The elevator system is located in the Tail Cone Compartment. There is a mechanical cable transfer from the control columns at the flight deck and back to the Tail Cone Compartment (see Figure 4). The cables are connected to transfer arms that twist the lower “Elevator Input Torque Tube”. From there, force is transferred via two compressible rods “Input Pogo’s” to the four Input cranks on the aircraft's two PCUs (see Figure 4 and Figure 6).

Figure 4: Illustration drawing of the elevator system and component location. Source: - Boeing Proprietary Information. Copyright © Boeing. Reprinted with permission of the Boeing Company

1.6.3.7 The aircraft type's two elevator PCUs are identical. Viewed from the direction of travel, the Primary Input crank on the left PCU and Secondary Input crank on the right PCU are located on the outside toward the fuselage (see Figure 4). The minimum distance from the fuselage opening to the outer Input crank on a PCU is approximately 18 cm (7.9 inches) and the equivalent distance to the inner Input crank is approximately 21 cm (8.3 inches).

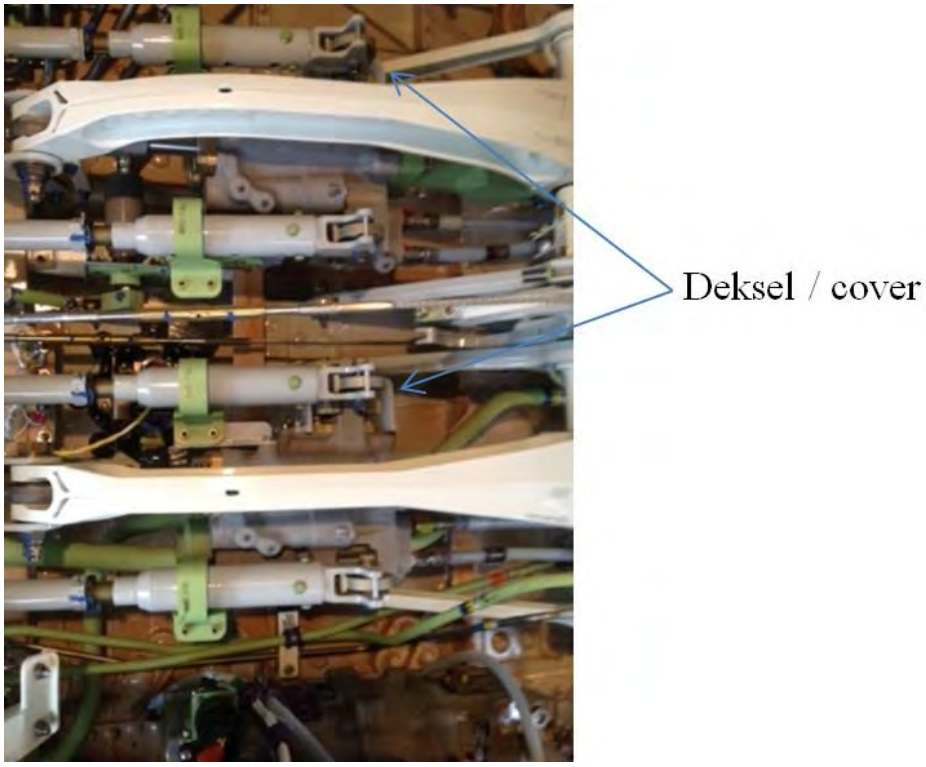
1.6.3.9 In AIBN's understanding, the PCUs are equipped with a cover because the same type of PCU is also used to control the ailerons on Boeing 737. The two aileron PCUs are installed in the wheel well with the input cranks horizontal and are therefore more exposed to foreign objects. In order to help prevent any foreign objects from falling down and blocking the Input cranks on the aileron PCUs, they are equipped with a cover over the top Input crank. See Figure 5.

Figure 5: Photo from a Boeing 737-800 wheel well taken in the aircraft's direction of travel. The photo shows that each PCU have a cover over the Secondary Input crank. Photo: AIBN

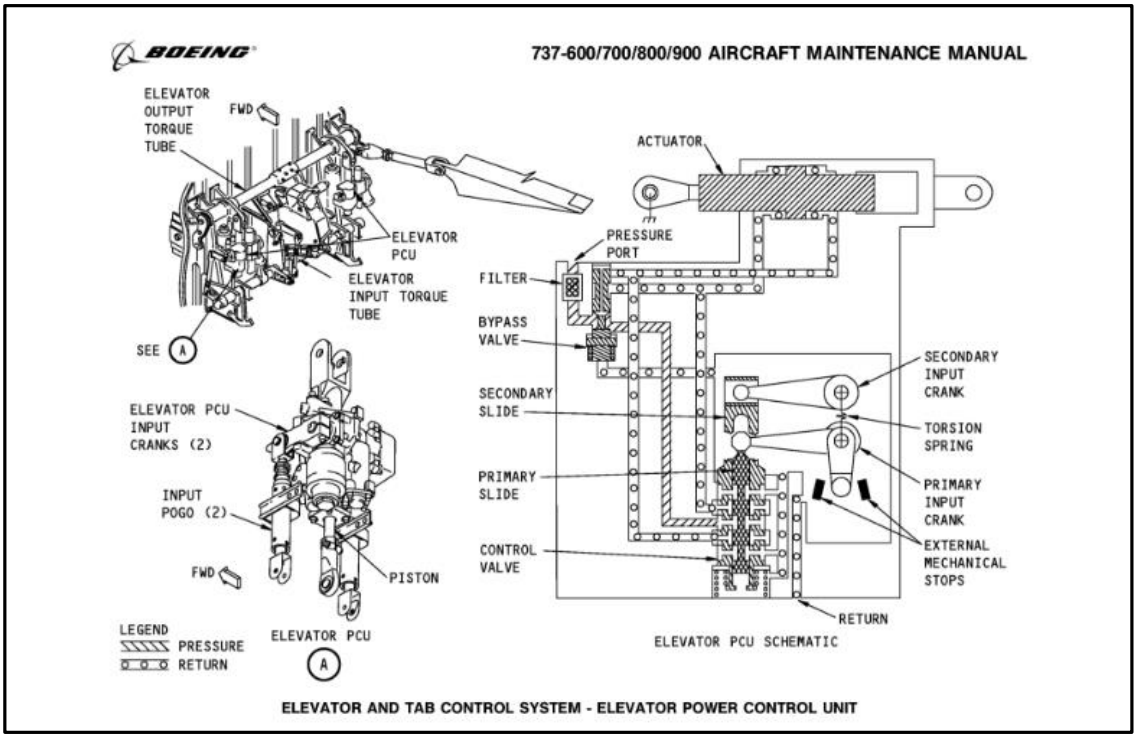
Figure 6: Shows the schematic structure of an elevator PCU. Source: - Boeing Proprietary Information. Copyright © Boeing. Reprinted with permission of the Boeing Company

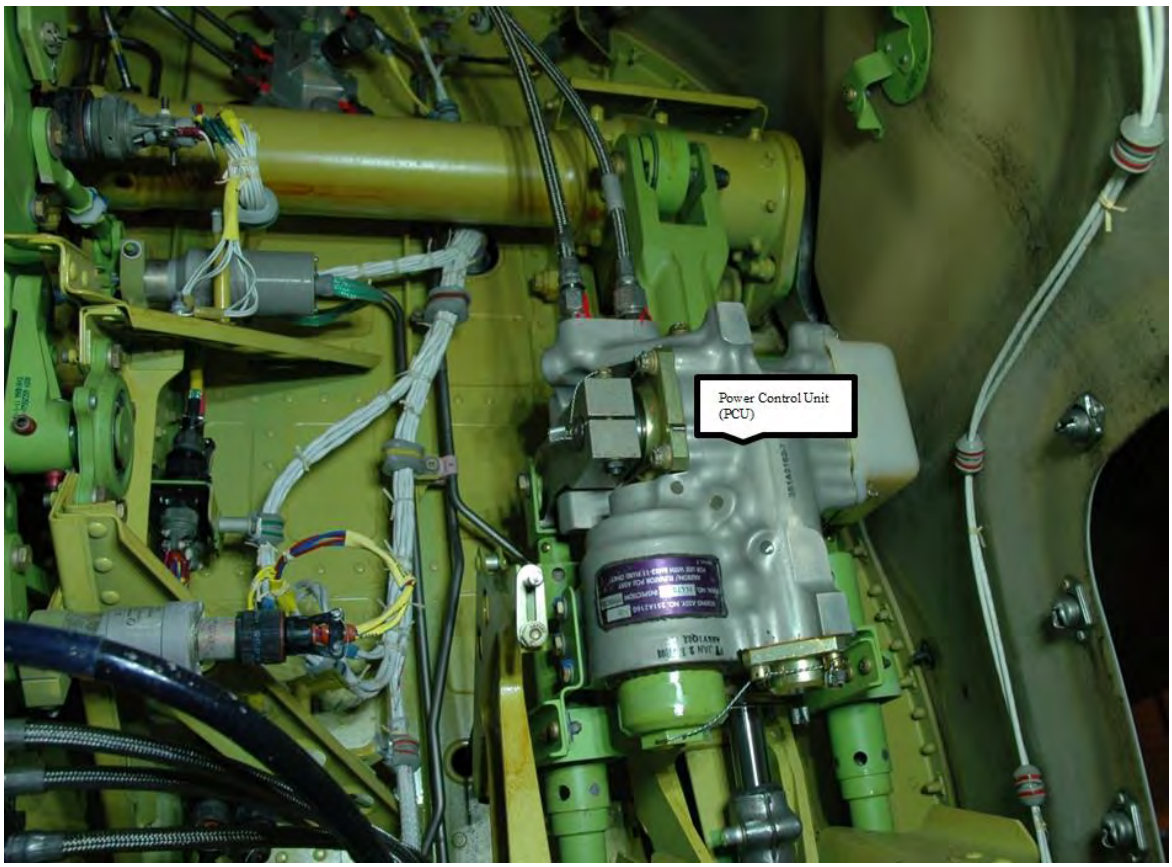
Figure 7: Photo taken inside the Tail Cone Compartment which shows the back of the right PCU on LN-DYM (31 January 2013). Photo: AIBN

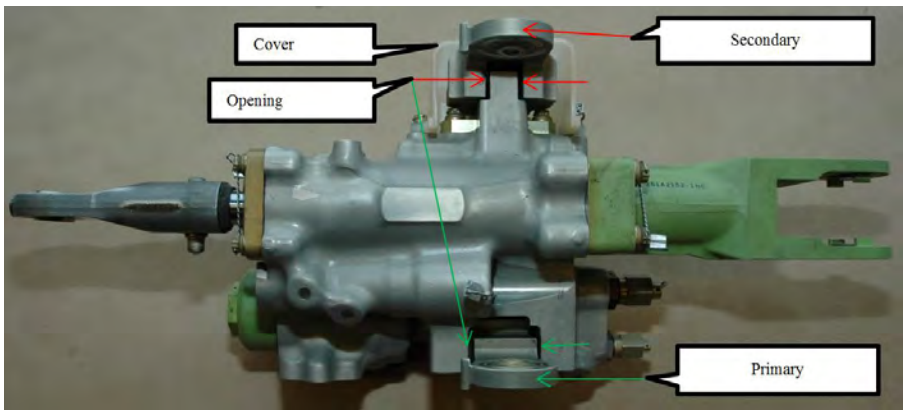
1.6.3.8 As is evident from Figure 8, the Secondary Input cranks on the PCUs have a cover that partially enclosed the Input cranks, while the Primary Input cranks have no protective cover. The cover encloses the Input crank toward the back, but has an opening in the aircraft's direction of travel.

Figure 8: Shows the front of a PCU. Note the narrow gap ("opening") where a foreign object/ice could block movement of the Primary and Secondary Input cranks and thus prevent normal movement on the PCU (actuator) Photo: AIBN

1.6.3.11 AIBN has measured the gap opening on a Power Control Unit to be approximately 1.9 mm (0.075 inch) (marked "opening" in Figure 8). This means that the Input cranks need not move far from the neutral position where the elevator remains in its current position, in order to signal the PCU to move the elevator in the up or down direction. This means that, if a foreign object/ice blocks the gap opening, this will affect normal elevator control.

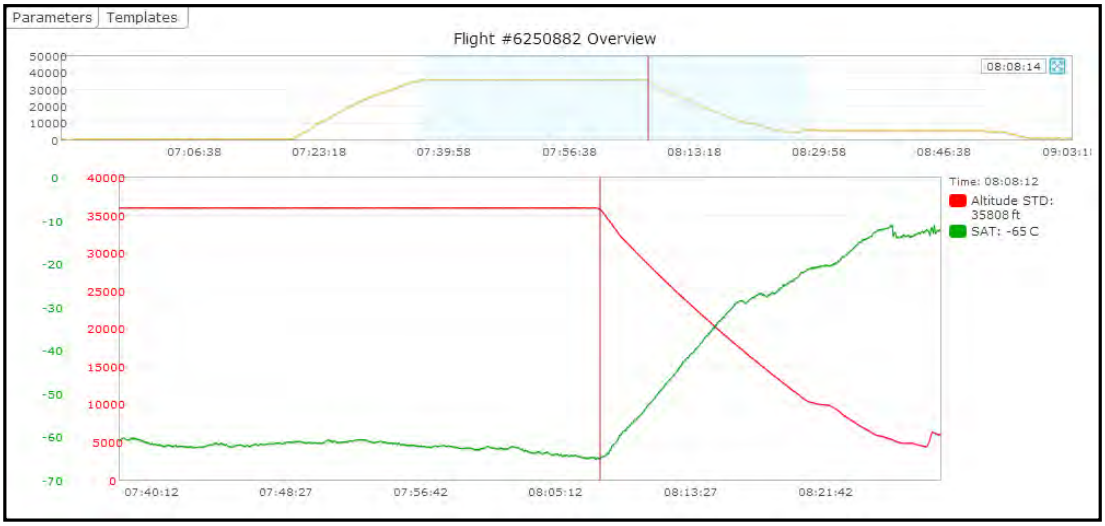
1.7.3 NAX5630 flew Helsinki – Kittilä at flight level FL360, equivalent to approximately 36 000 ft. The aircraft's flight recorder registered an outside temperature of between -60 and -65 °C at cruising altitude (see Figure 9).

Figure 9: Shows outside temperature (SAT) from when the aircraft was established at cruising altitude until just after the incident in Kittilä. Source: AIBN (data acquired from the aircraft's flight recorder)

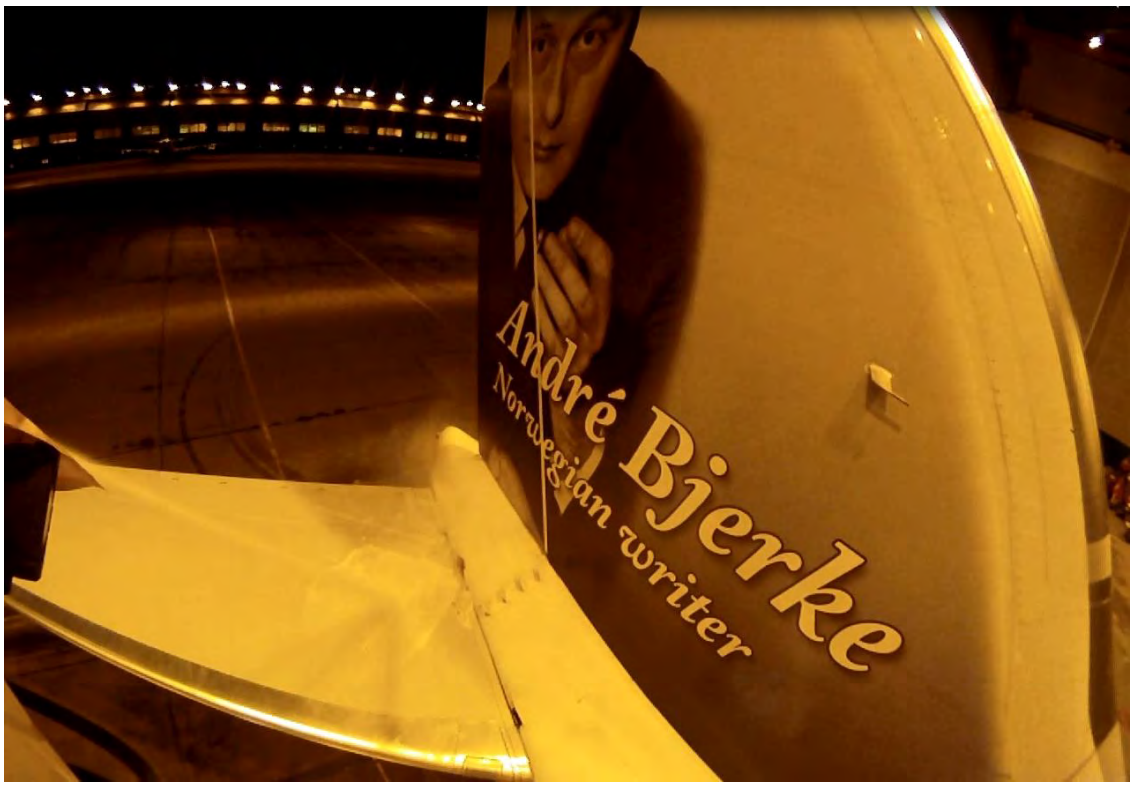
Figure10: “Spray testing” at different marked angles on LN-DYM's horizontal stabiliser and elevator. Photo: AIBN

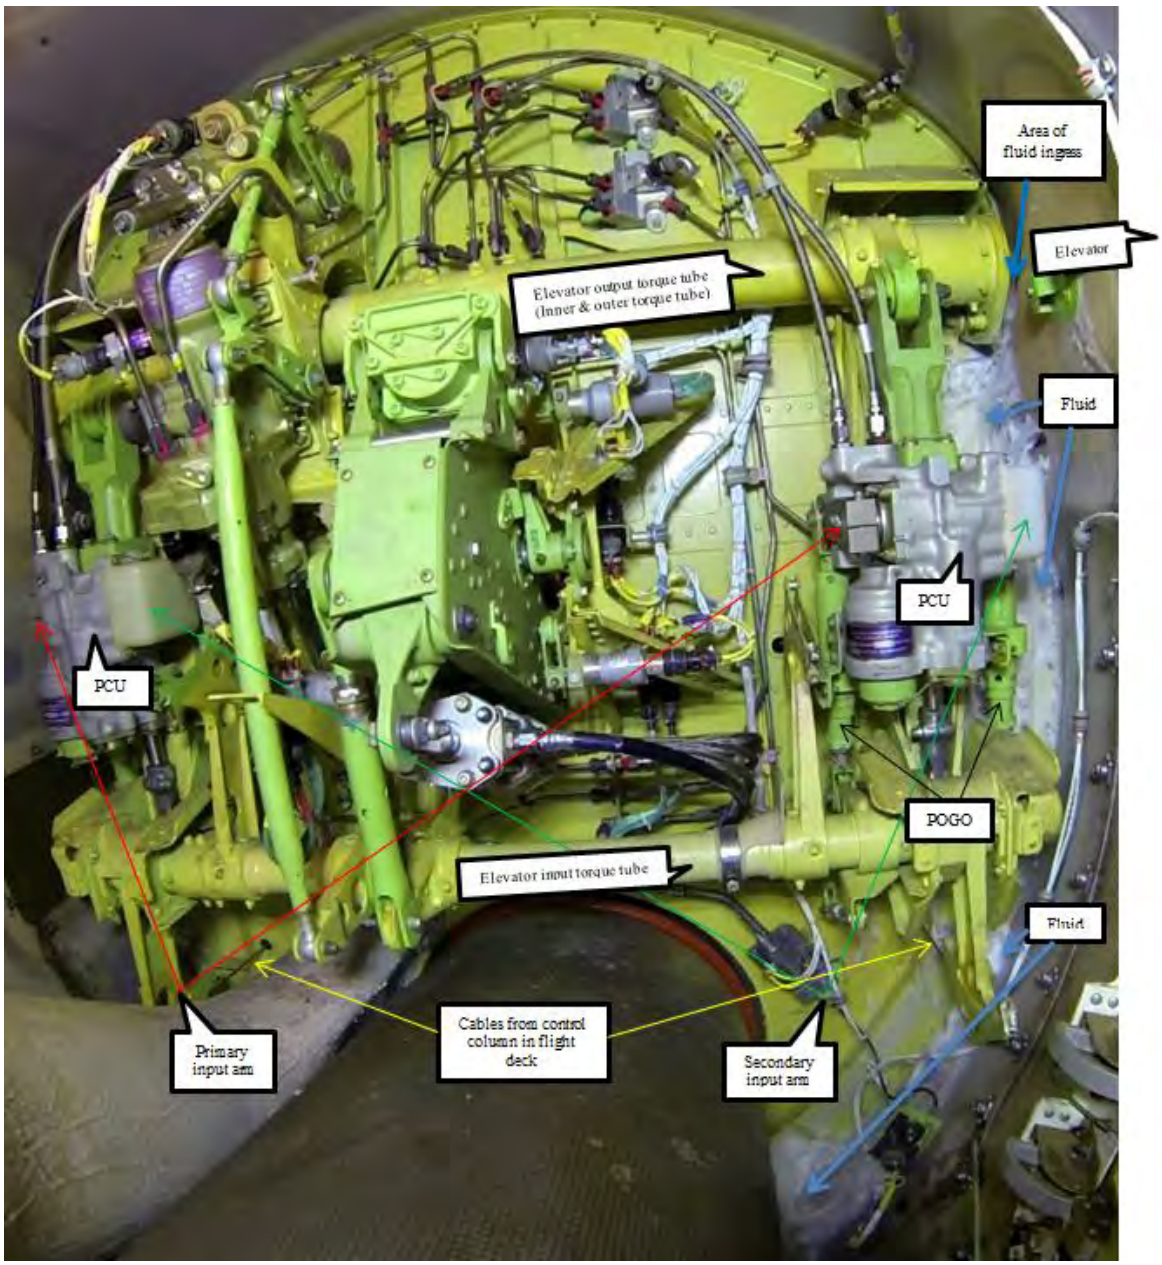
1.16.8.7 While investigating the Tail Cone Compartment, AIBN found that the clearance around the penetrations on both the left and right sides of the fuselage are wide enough for fluid to enter the compartment. When fluid enters the compartment, it is possible for this fluid to splash on the PCUs as are located below and near the mentioned openings in the fuselage. Since the de-icing fluid is warm, steam from the fluid will condense on cold surfaces.

1.16.8.8 The investigation also showed that, if too much fluid is sprayed on the opening in the fuselage, new fluid will penetrate the compartment faster than it can drain. AIBN does not believe that this is an inherent problem and it is therefore not discussed further in the report.

Figure11: Shows fluid penetration and spray potential toward the Input cranks on the PCUs. (Photo taken in the aircraft's direction of travel in connection with simulated de-icing of the aircraft's right side). The pipe at the bottom of the photo is the exhaust pipe from the aircraft's Auxiliary Power Unit (APU). Photo: AIBN

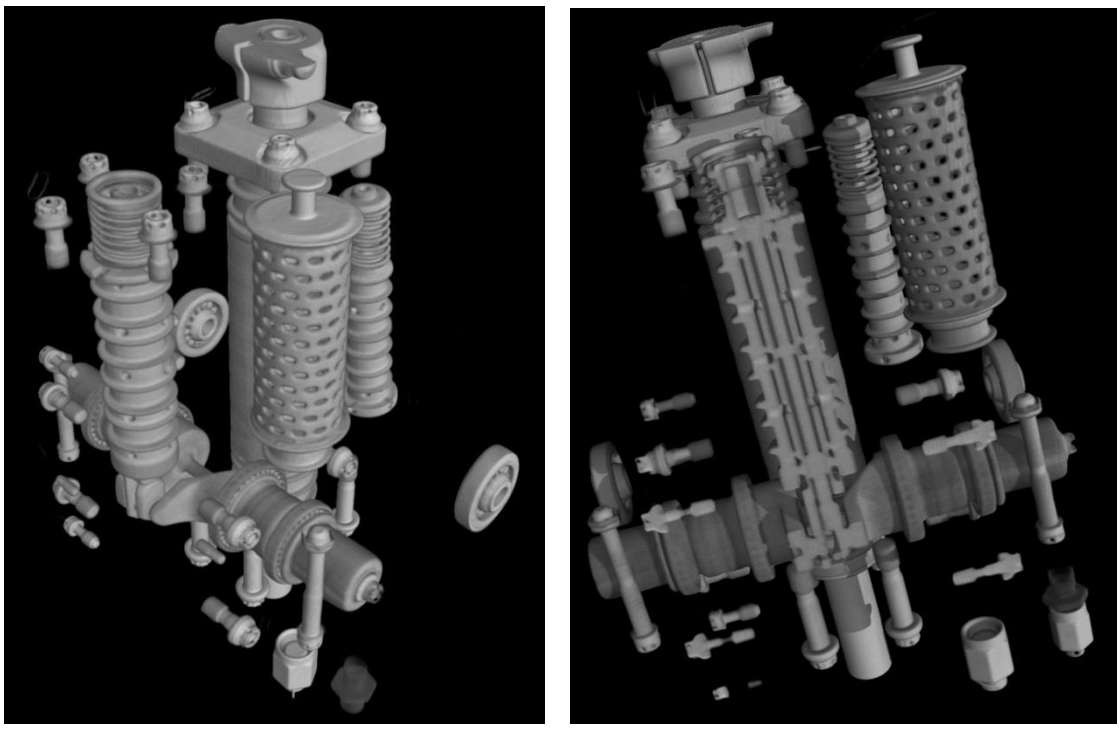
In order to investigate whether any foreign objects inside the PCUs may have caused a blockage, AIBN, in cooperation with the NTSB, requisitioned an advanced CT scan of both units in the US. The CT scans indicated the presence of a small Foreign Object Debris (FOD) inside one PCU, but no foreign object was later found when the unit was opened. This FOD indication is considered to be an artefact from the CT scan from the machined flat feature of the bypass spool. See also Chapter 1.19 for additional information.

Figure 19: Example images from the CT scan. Photo: NTSB

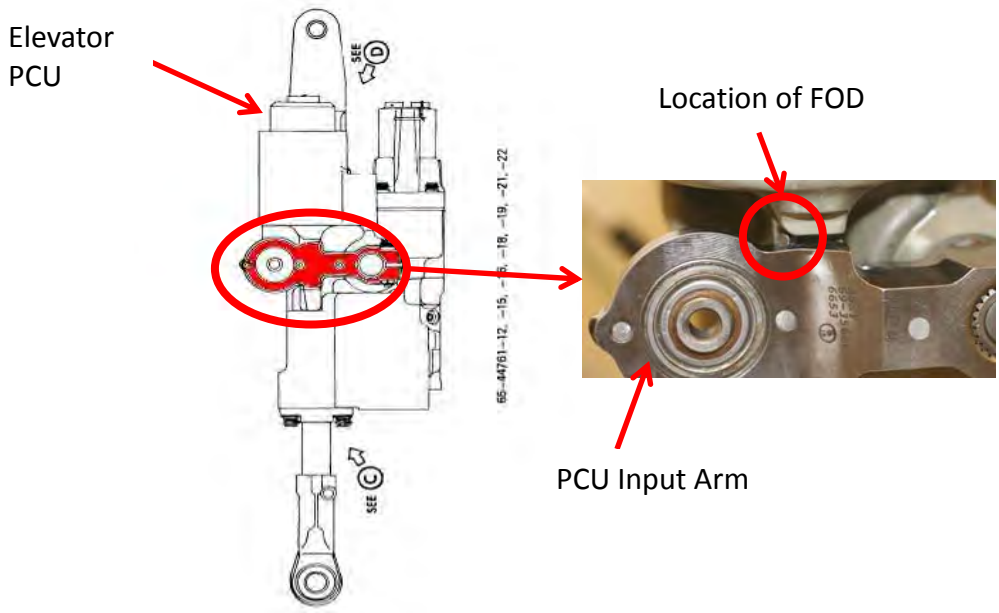
Figure. Location of FOD.

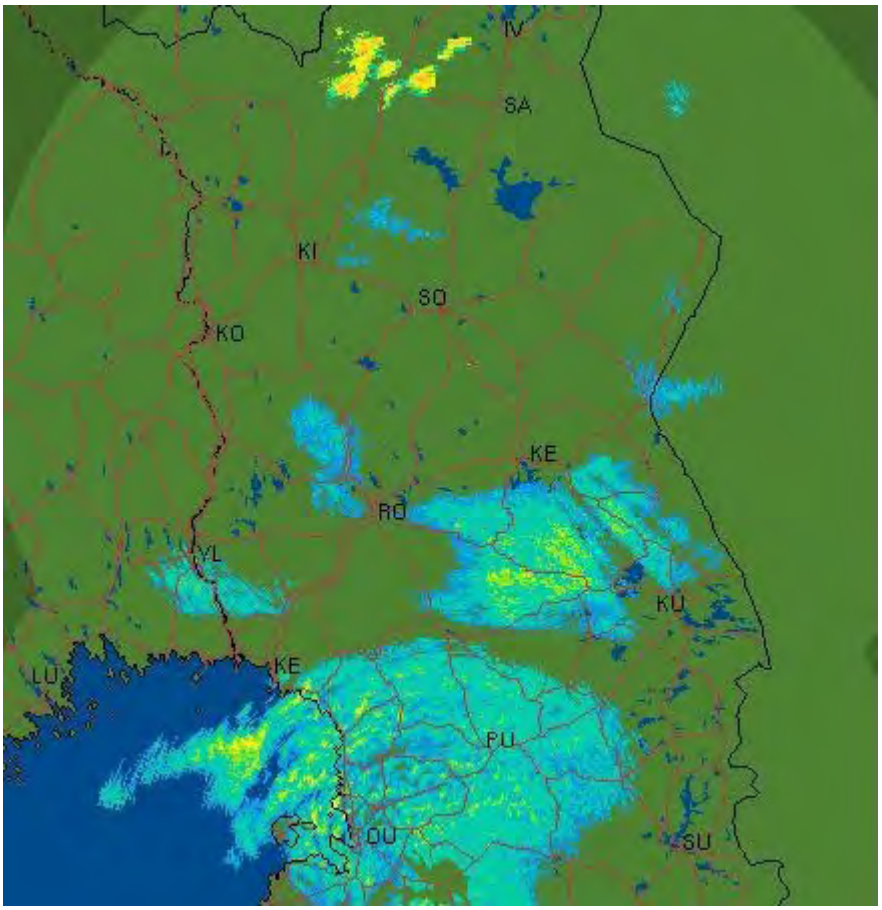
Based on metar's and radar it was dry weather in Kittilä. Picture 2 shows radar picture at time 08.30 UTC. It seems some light snowfall towards northeast from Kittilä (KI) and also towards south near Ro that is city of Rovaniemi.

Picture 2. Radar picture 26.12.2012 at 08.30UTC.

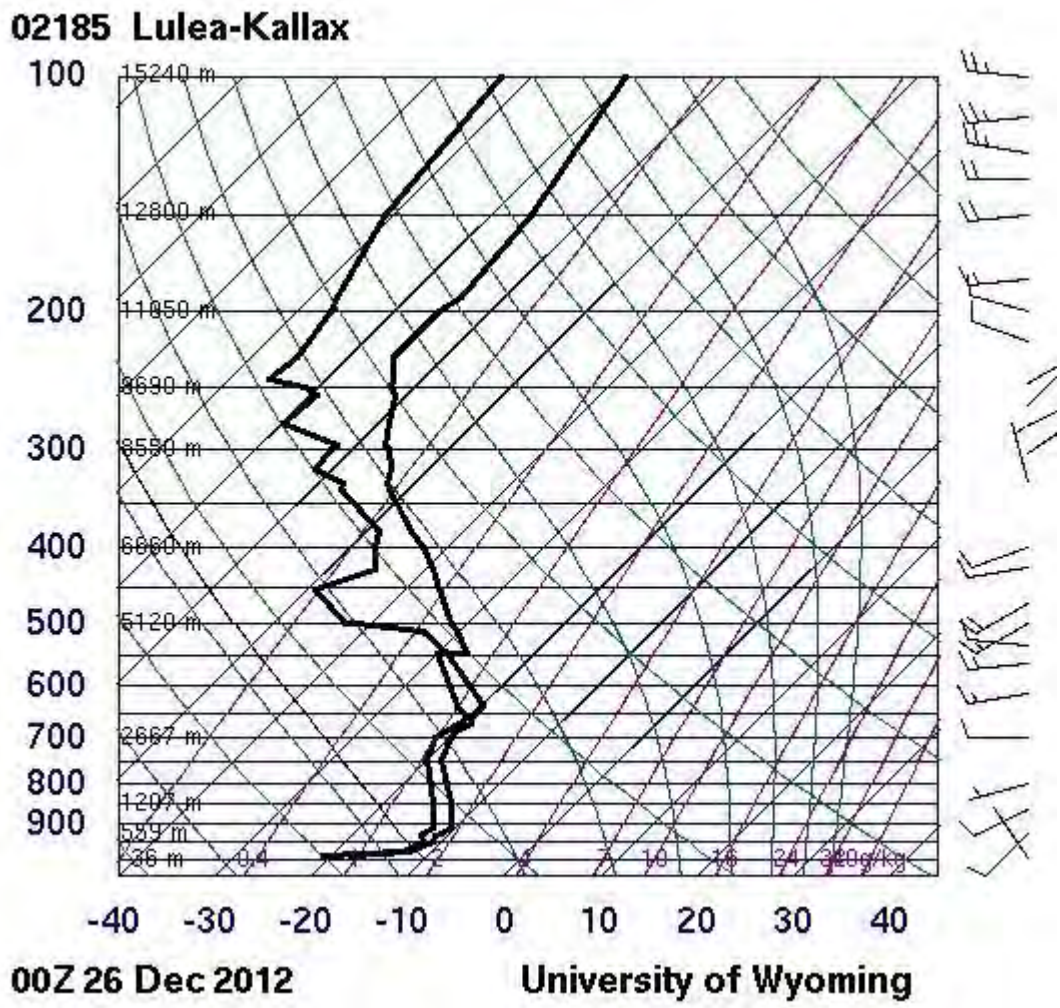
Temperature on the ground was about minus 20 degrees and there were a strong inversion near the ground which can be seen from Laps, picture 4. Also sounding from Lulea 00 UTC picture 3 indicates strong inversion in Northern Scandinavia. In Finland we have Sodankylä sounding at 12 UTC, picture 5. There can still be seen inversion level below one kilometer. An another inversion level is around 5000ft in Sodankylä 12 UTC it's anymore about 5 degrees, but earlier pilot report (Boeing 737) has noticed there 11 degrees inversion at 0911UTC.

Picture 3. Lulea sounding at 00UTC 26.12.2012 is taken from website: http://weather.uwyo.edu/upperair/sounding.html

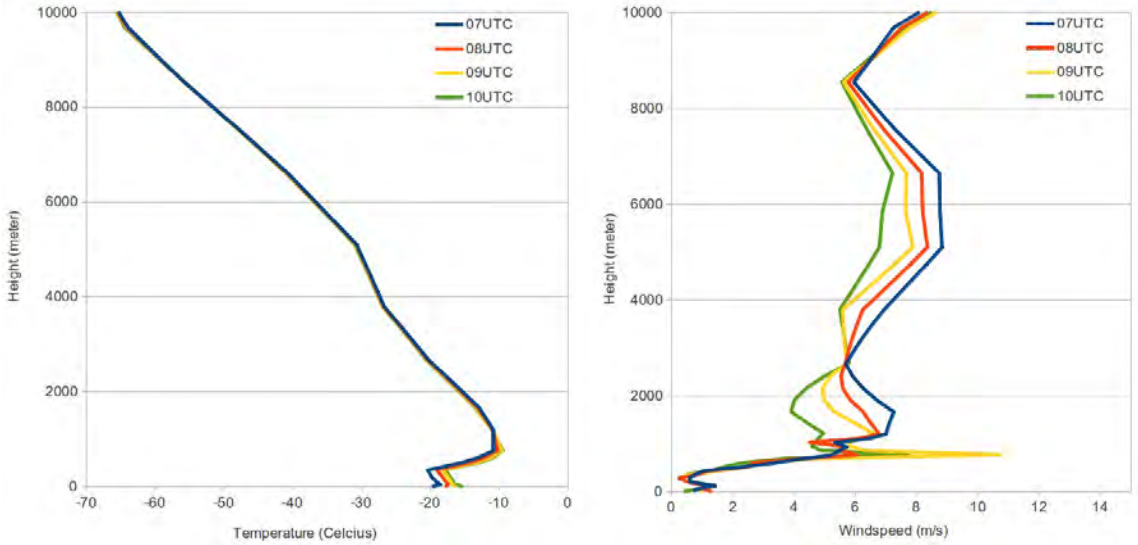
Picture 4. Laps analyze about temperature (on the left) and wind speed (on the right) profiles in Kittilä. Blue colour shows how model has seen the situatition at 07UTC, red 08UTC, yellow 09UTC and green 10UTC.

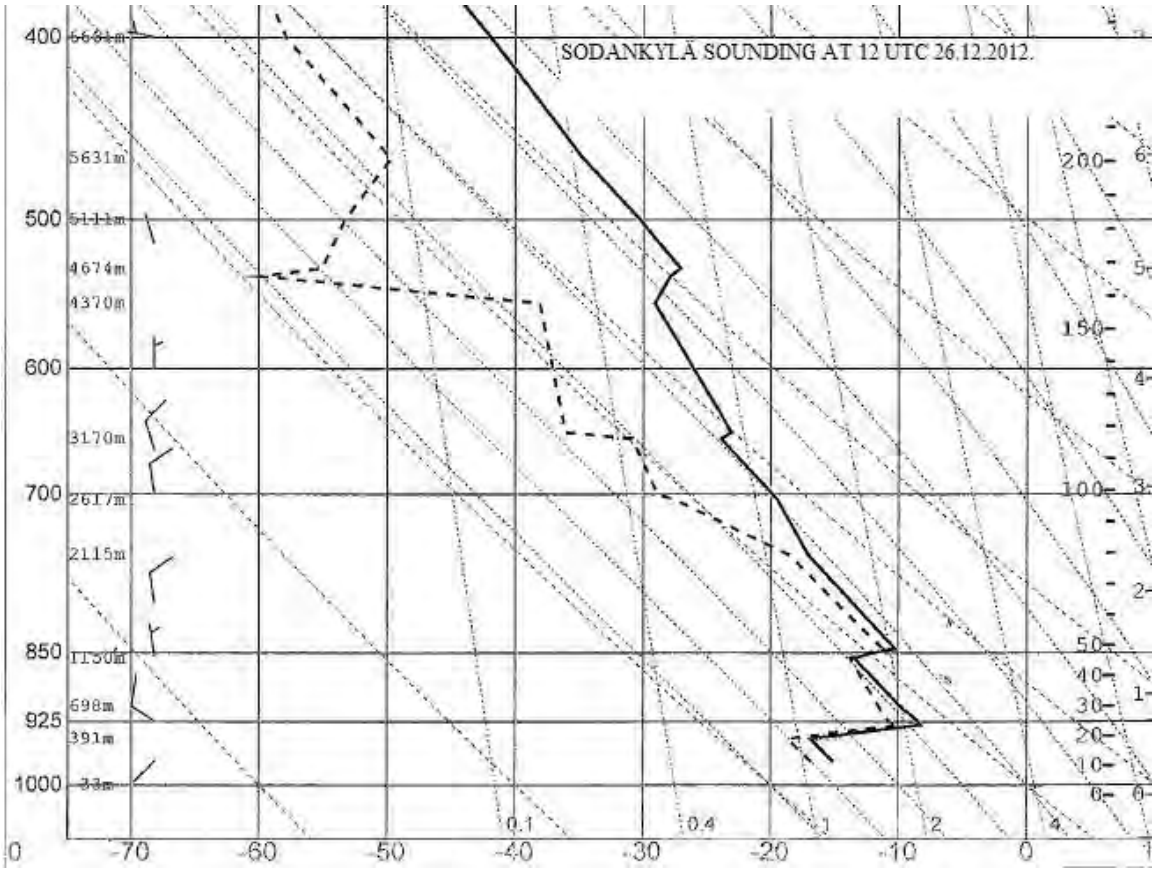
Picture 5. Sodankylä sounding at 12UTC 26.12.2012.
