Investigation report

C8/2008L

Airliner fire at Kemi-Tornio aerodrome on 11 December, 2008

EMB-145LU

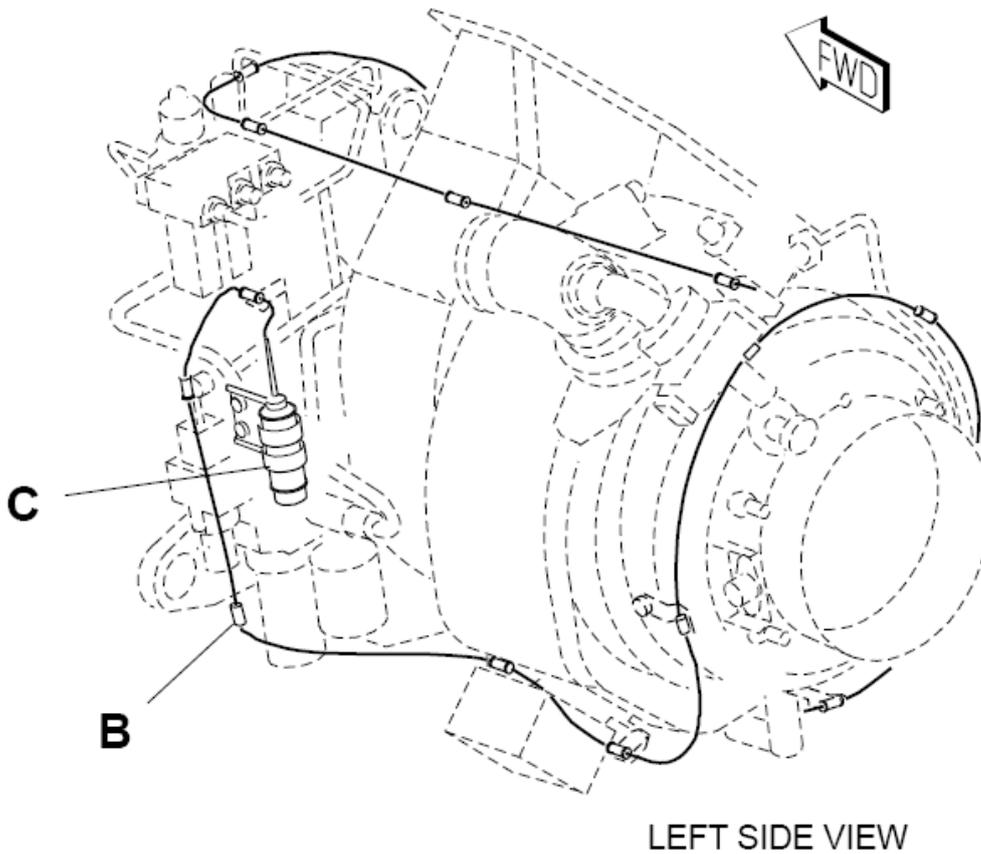
Figure 5. APU fire detector sensing element assembly (AMM)

Apart from one specification the APU's fire detector sensing element passed all tests. Although it passed all of the authorities' minimum requirements (FAA TSO-C11e), the *Low Discrete Test* (470°C at a length of 12 inches, i.e. approximately 30.5 cm) included in the sensing element manufacturer's testing regime, did not result in fire detection. The 12 inch long piece of element that was tested came approximately 50 cm from the end of the sensing element. A repeated test at the same point but at a higher temperature (498°C) also failed to pass. In addition, the same test was done at approximately 114 cm distance from the end of the element and this time fire detection worked as it was designed to.

The flames that reached the APU compartment varied in strength. Other wiring and equipment parts between the flames and the fire detector sensing element reduced the exposure of the element. Since it was impossible to establish the conditions during the fire accurately enough, it is not possible to prove why a fire warning was not signalled. According to the test results it is possible that the fire detector sensing element may have partially functioned defectively in the incident. However, it is more likely that the sensing element was not exposed to sufficient heat at an adequately long distance. The investigators believe that analysis should be done on whether the E-145's APU fire detection system design is sensitive enough, because the flames that touched the fire detector sensing element in the APU compartment did not trigger a fire alarm. The

investigators do not consider it good that the vent between the APU's muffled tailpipe and the APU compartment enables flames to enter the APU compartment.
